Environmental Science Water Research & Technology

COMMUNICATION

Drinking water contamination from the thermal degradation of plastics: implications for wildfire and structure fire response†

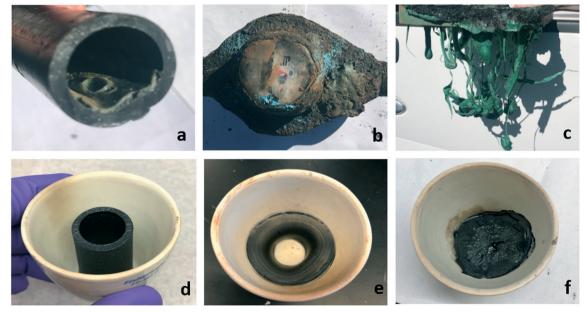
Fig. 1 Images of fire-damaged water system components including (a) a HDPE plastic pipe, (b) a water meter, and (c) a water meter cover following the Camp Fire. Thermally degraded pipe samples in laboratory experiments include the (d) PEX-c pipe degraded at 300 °C, (e) HDPE pipe degraded at 300 °C, and (f) HDPE pipe degraded at 400 °C.

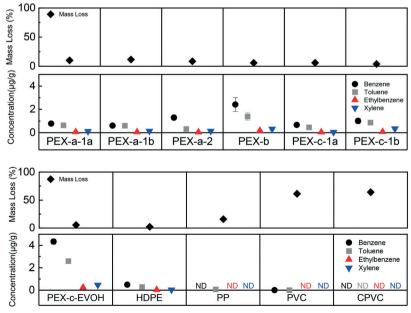
Fig. 2 Average amount of benzene, toluene, ethylbenzene, and xylene leaching observed after burning each material at 400 °C and extracting in water for 7 days. The error bars reflect the standard deviation of the measurements (n = 3). If no error bars are visible, this indicates the error bars are smaller than the symbol size. ND indicates the compound was not detected above the MDL.

Results showed that plastic pipe thermal exposure can generate BTEX, which can then leach from cooled plastics into water. BTEX was not found from new and non-thermally degraded plastics in water, while 10 of 11 thermally degraded plastic pipes leached at least one BTEX component (Fig. 2). The chemical leaching differences between products is likely attributed to differences between plastic characteristics and experimental conditions. PE materials lost less mass due to isothermal heating (5 wt% to 10 wt%) compared to the PVC and CPVC samples (61 wt% and 64 wt%, respectively) (Fig. 2). A detectable, but significantly lower amount of benzene and toluene was observed for the PVC pipe, and no BTEX was found for the CPVC pipe (Fig. 2). Additionally, there was a general trend of compound concentration leaching across the plastics where benzene > toluene > ethylbenzene \approx xylene (Fig. 2). This trend could be attributed to several factors including compound production, water solubility, air volatilization, polymer solubility parameters, and/or partitioning into the aqueous phase. Octanol-water coefficients and solubility values mirror the trend of concentrations observed (Table S4†), indicating that benzene would most readily partition into the aqueous phase.

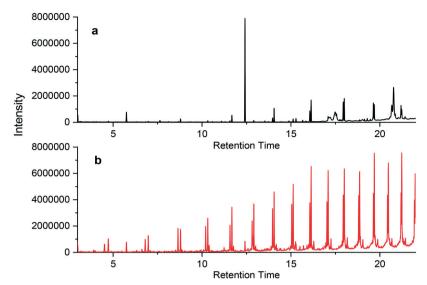
Fig. 4 Chromatographs of PEX-c-1a when (a) unburned and (b) burned at 400 °C, where samples were extracted in n-hexane. The internal standard is the peak at 5.8 minutes.

Leaching promoted by hexane extraction. As expected, a greater number of peaks were observed in the n-hexane extracts (32 to 134) compared to the water extracts (3 to 22) for all plastics (see example for PEX-c-1a in Fig. 4 and all other pipe types in Fig. S17-S26†). For the degraded PEX, HDPE, and PP pipes, between 100 to 134 unique compounds were leached into n-hexane, whereas for the degraded PVC and CPVC pipes between 30 to 41 compounds were leached (Fig. 4 and S17-S26†). While most compounds extracted from the new pipes were either straight chain or branched alkanes of varying lengths (Table S3†), thermal exposure led alkenes to represent the majority of compounds detected in the leachate (Table S5†). These aliphatic hydrocarbons are products of alkane hydrocarbon chain scission and are not typical drinking water contaminants. They have low aqueous solubility, which is why they were only detected in the hexane extracts and are generally less toxic than their cyclical or aromatic counterparts. 56,57

Generally, both the magnitude of the peak and the number of compounds increased after burning the materials. However, one notable exception occurred for the PEX-c pipes; one peak (retention time of 12.5 min) for the unburned pipe was significantly larger than that of any of the burned peaks (Fig. 4 and S21†). This peak likely represented the compound, di-tert-butylbenzene, which has been shown to be an ultraviolet light or radiolysis degradation product of the antioxidant Irgafos 168®.58,59 This compound was only observed in the leachate of the PEX-c materials, in which the crosslinking occurs using beta irradiation. This may explain why the magnitude of this degradation product was so large.60 This peak decreased substantially in the burned plastic extract (Fig. 4 and S21†), indicating it may have been thermally decomposed.
