Cite this: *RSC Adv.*, 2021, 11, 29323

Understanding the effect of HF-based wet shallow etching on optical performance of reactive-ion-etched fused silica optics†

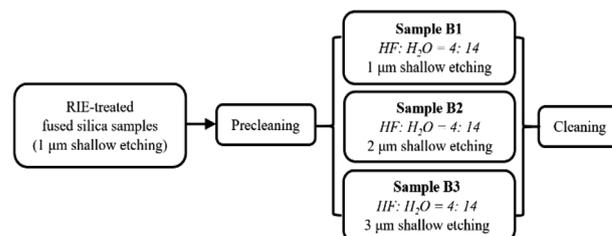
Fig. 1 Preparation of the samples for HF shallow etching with different depths.

Seven square polished fused silica samples (Corning 7980) were utilized for the etching experiments. All the samples (named A, B1, B2, B3, C1, C2, and C3) were typically 50 mm in side-length and 5 mm in thickness. The polishing of each sample was conducted *via* the same process utilizing 0.4 μm CeO₂ abrasives. Sample A was not etched to be kept as a reference. For other samples, two types of wet etching processes were performed using HF or HF/NH₄F chemical solution.

The RIE-pretreated samples were then treated again using dynamic cleaning and an HF-based chemical etching technique (described as DCE in our previous study²²). Two sets of three samples were treated with different HF-based etching depths (1 μm, 2 μm, and 3 μm, respectively), as summarized in Fig. 1 and 2. The first set (samples B1, B2, and B3) are the polished surfaces treated with RIE and HF etching, while the second set (samples C1, C2, and C3) are the polished surfaces that underwent RIE followed by HF/NH₄F etching. The HF/NH₄F etchant, which was more commonly used in our previous study, consists of HF (49 wt%), NH₄F (30 wt%), and H₂O (ultra-pure water) with a volume ratio of 1 : 4 : 10. We chose an HF-only (49 wt%) solution containing approximately 78 vol% H₂O because its etching rate (100 nm min⁻¹) was equal to that of the HF/NH₄F solution we typically used.

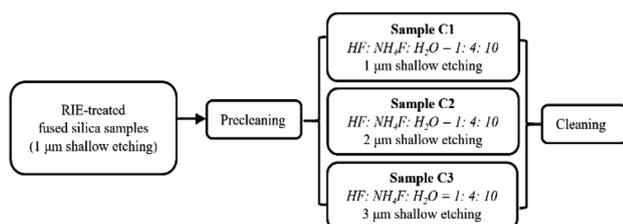
Fig. 2 Preparation of the samples for HF/NH₄F shallow etching with different depths.

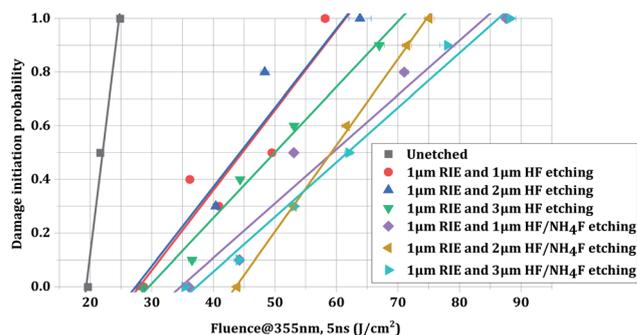
Fig. 3 Laser damage probability of various surfaces treated with different HF-based etching processes. The quality factor (peak energy/average energy) of the laser beam spot was approximately 2.2. The energy density uncertainty of the testing system is 4.5%.

After RIE and HF-based etching, the treated samples and the as-polished sample were subjected to the LIDT test. Fig. 3 shows the relationship between the laser fluence and the 1-on-1 damage probability of the samples. Similarly to in our

previous work,^{23,25} the damage threshold of the combined etched surface was much higher than that of the unetched surface. This great improvement was attributed to the effective removal of the subsurface damage layer, which contains abrasive residues and other polishing-induced contaminants. It can also be noted from the figure that the second set of samples (those treated with RIE followed by HF/NH₄F etching) exhibited an increased LIDT compared to the first set of samples (those treated with RIE followed by HF etching). The results indicated that the addition of NH₄F to the HF solution was beneficial for improving the LIDT of fused silica.

As shown in Fig. 3 and Table 1, a significant improvement in the laser damage threshold was observed for all the samples treated with the combined etching process. The morphology of the damage sites shown in Fig. 4 also indicated that the combined etching can form a relatively pure fused silica optical surface with a homogeneous damage precursor type. This improvement has been largely attributed to the traceless removal of the fractured subsurface defects, which either absorb laser energy or cause field intensification.²² The etchants utilized in the wet etching play an important role in fully exploiting this technique. Combined treatment using 1 μm RIE and shallow HF etching can achieve at most a 1.60-fold enhancement in the 0% probability damage threshold (sample B3). A further increase in damage threshold (up to 2.3 times for sample C2) can be created by adding a certain amount of NH₄F to the HF solution. Based on the previous study by Suratwala,¹³ ammonium hexafluorosilicate [(NH₄)₂SiF₆] precipitate can form when using HF/NH₄F as an etchant, and the solubility of SiF₆²⁻ scales inversely with the square of the ammonium fluoride concentration. The precipitation reaction and corresponding solubility of SiF₆²⁻ are given by

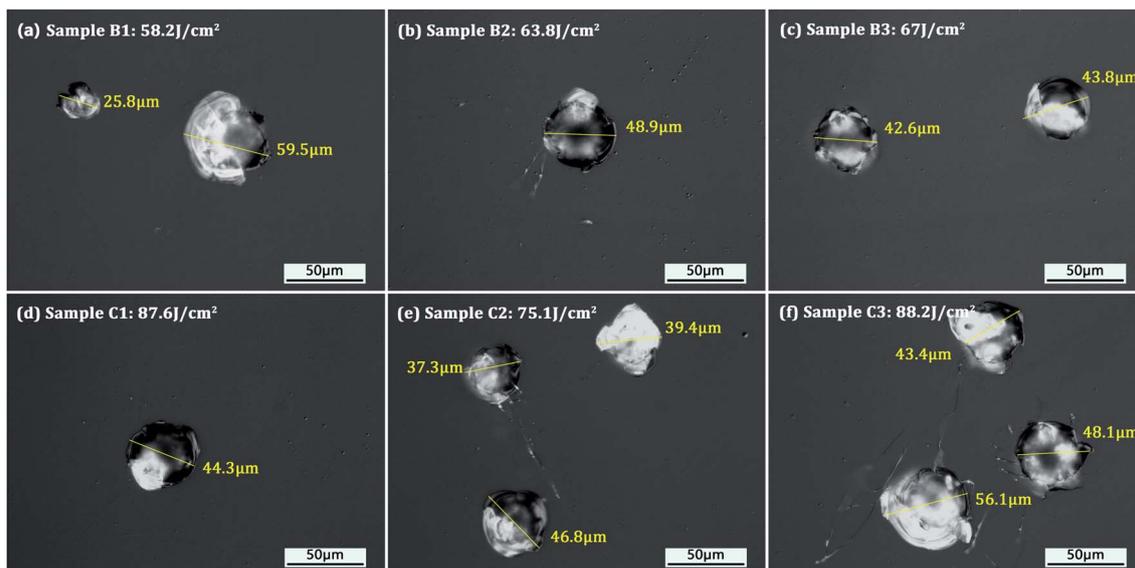
Fig. 4 Morphology of 100%-probability laser-damaged locations of the two sets of the combined etched samples. The first row of images (a–c) shows the damage sites on the HF-etched fused silica surfaces. The second row (d–f) shows the damage sites on the HF/NH₄F-etched fused silica surfaces. The laser fluence for each sample is noted. The yellow line across each damage crater indicates the approximate size (ranging from 25.8 μm to 59.5 μm) of the crater.

The surface morphologies of the 100%-probability laser-damaged locations for the two sets of the combined etched samples are illustrated in Fig. 4. No obvious differences in the damage morphologies of the samples were observed, regardless of which HF-based etchant or etching depth was chosen. The morphologies of the damage sites are generally smooth and disperse, and exhibit small microscale ablation craters (~20 μm to ~60 μm wide), suggesting that the damage precursors were

relatively homogeneous. The formation of these smooth craters might be attributed to the energy deposition and shockwave acceleration at high laser fluence.²⁶ In this case, the molten residues were substantially removed from the damaged craters. Additionally, slight amounts of ejected materials were observed near the edges of several craters (see Fig. 4(b), (e), and (f)), which was probably due to redeposition after fast ablation and vaporization of the materials. In Fig. 4(f), it can also be noticed that the damage produced plastic deformation near the craters.

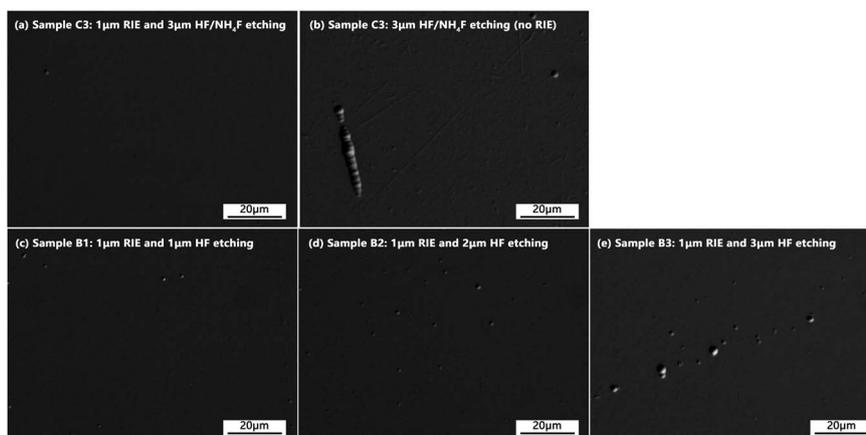
Fig. 5 Optical micrographs showing representative surface morphologies of the etched samples. (a) Sample C3 (exit surface): 1 μm RIE and 3 μm HF/NH₄F etching, (b) sample C3 (entrance surface): 3 μm HF/NH₄F etching, (c) sample B1: 1 μm RIE and 1 μm HF etching, (d) sample B2: 1 μm RIE and 2 μm HF etching, and (e) sample B3: 1 μm RIE and 3 μm HF etching.

Fig. 5 shows representative surface morphologies (undamaged locations) of the etched fused silica samples (samples C3, B1, B2, and B3). For sample C3, the morphologies of both the laser entrance (3 μm HF/NH₄F etching) and exit surfaces

(combined etching) are given. The morphology results of samples C1 and C2 are not given because there were no obvious differences among the three HF/ NH_4F -etched sample surfaces (at least for the observed results using $500\times$ optical microscopy, see ESI†). It can be seen from the figure that the morphologies of the surfaces treated with the combined processes are very similar to each other. All the treated surfaces were very smooth without visible scratches or micro-cracks except for several low-density micro-pits. On the contrary, the entrance surface treated with only $3\ \mu\text{m}$ HF/ NH_4F etching presents a large number of scratches, which had been passivated by the HF/ NH_4F solution, as shown in Fig. 5(b). The results suggested that the shallow combined etching process was very effective for tracelessly removing the fractured defects in the subsurface layer of the polished fused silica optics. However, the etched surfaces treated with RIE followed by HF etching exhibited slightly more micro-pits, which was indicative of the fact that this HF etching step might treat the subsurface fractured defects more isotropically. It is difficult to obtain the distribution of these isolated point defects; however, the SC imaging shown below can be used as an efficient tool for examining them.

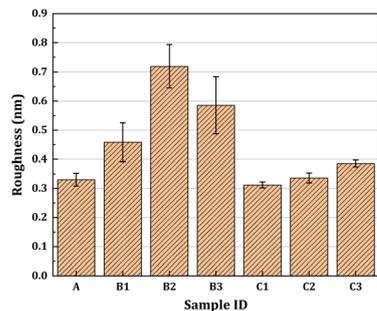
Fig. 6 Roughness R_q (at the sub-millimeter scale) of the as-polished surface and surfaces treated with RIE followed by HF or HF/ NH_4F wet etching with different etching depths. The error bars indicate the standard deviation of the measured R_q values.

We then compared the surface roughness of the two sets of treated fused silica samples after RIE followed by HF-based etching, as well as that of the as-polished sample. In Fig. 6, each bar represents the mean R_q value of all the measured points on each sample surface. The unetched sample surface had a relatively low roughness (0.33 nm). The surface roughnesses of the samples treated with RIE followed by HF etching increased significantly (from 0.46 nm to 0.72 nm) as the etching depth was increased to $2\ \mu\text{m}$, but decreased to 0.59 nm after $3\ \mu\text{m}$ etching. For the HF/ NH_4F etched surfaces, the surface roughness increased slightly with the etching depth, and the variations in the R_q value were less than 0.1 nm. The maximum R_q value was only 0.39 nm (sample C3).

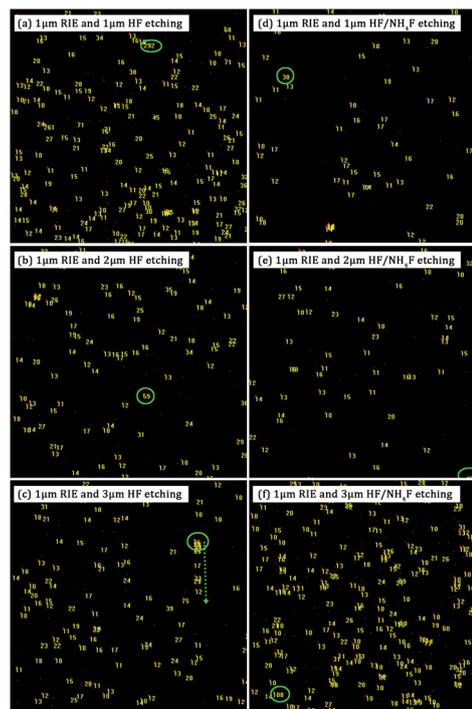
Fig. 7 SC images of the samples treated with RIE followed by HF-based etching. Left column (a–c): RIE and HF etching with removal amounts of $1\ \mu\text{m}$, $2\ \mu\text{m}$, and $3\ \mu\text{m}$. Right column (d–f): RIE and HF/ NH_4F etching with removal amounts of $1\ \mu\text{m}$, $2\ \mu\text{m}$, and $3\ \mu\text{m}$. Each image measures $3\ \text{mm}$ per side. Yellow numbers on each image indicate the sizes (number of pixels) of the SC objects. Only objects with a size larger than 10 pixels were marked. The largest-sized SC object on each sample surface is also circled in green.

High-resolution SC imaging was used to observe microscopic features on the HF-based etched fused silica surfaces that were pretreated using RIE, as shown in Fig. 7. We used the software Image-Pro to obtain the size of each SC object by calculating the pixels it comprised. The left column represents the samples treated with the RIE and HF etching process, while the right column represents the samples treated with the RIE and HF/

NH_4F etching process. It was noted that many point features were visible on all the observed sample surfaces, regardless of which HF-based etching process or removal amount was chosen. The point defects were probably due to the presence of embedded particles in the subsurface layer and even the silica matrix. Because HF acid solution has a higher etching rate toward these particles than toward the silica matrix, the particles were first detached from the surface, leaving typical traces of pits. An interesting phenomenon observed from the SC images was that the densities of the point defects on the different treated sample surfaces were different. It was noted that, for the left column, the sample surfaces treated with RIE followed by $1\ \mu\text{m}$ HF etching had the highest density of point defects. On the contrary, for the right column, the density of point defects on the surface treated with RIE followed by $3\ \mu\text{m}$ HF/ NH_4F etching was the highest. Except for samples B1 and C3, all others had a very similar density of point defects.

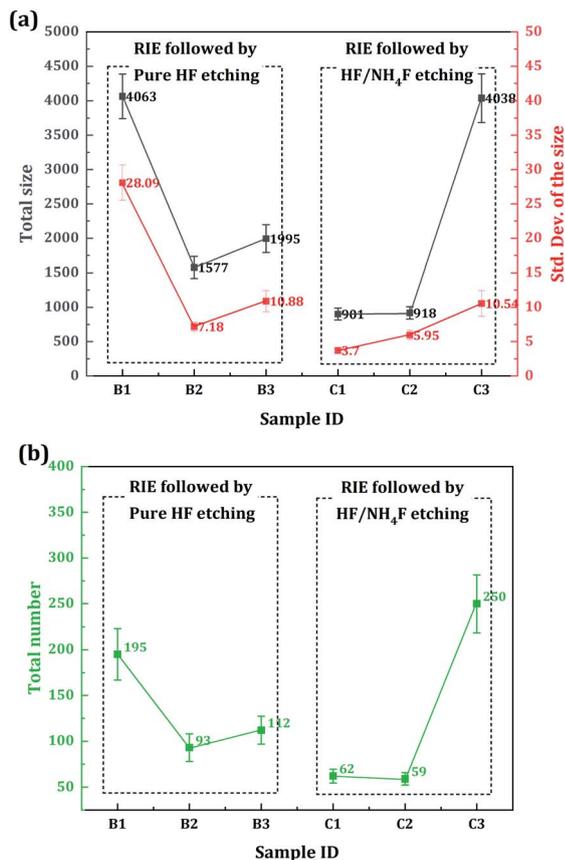
Fig. 8 Characteristics of the point defects on the etched sample surfaces. The gray, red, and green squares indicate the total size, standard deviation (std. dev.) of the size, and the total number of SC objects, respectively. The raw data and corresponding statistical data of the SC images can be seen in the ESI.†

To determine the characteristics of the point defects on the sample surfaces, we further extracted the total size, the standard deviation (std. dev.) of the size, and the total number of SC objects. As shown in Fig. 8, all the parameters presented similar trends for each of the HF-based etching processes. Additional information can be obtained through comparative analysis. First, samples B1 and C3 had the largest total sizes (nearly the same, ~ 4100 pixels) of point defects. Second, for the same

etching depth, the std. dev. of the sample surface treated with RIE followed by HF/NH₄F etching was lower than that of the surface treated with RIE followed by HF etching. Third, the total number of point defects on sample B1 was a little lower than that on sample C3. However, the other HF/NH₄F-etched samples (samples C1 and C2) had a relatively low total number of point defects compared to the other HF-etched samples (samples B2 and B3).

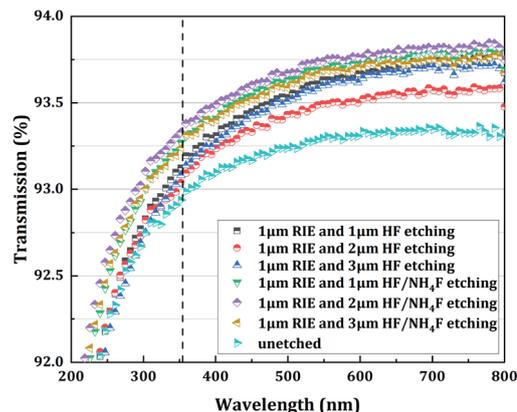
Fig. 9 Spectral transmission of the fused silica samples treated with RIE followed by HF-based etching. The spectral transmission of the unetched sample is used as a reference.

Fig. 9 shows the spectral transmission of the fused silica samples treated with RIE followed by HF-based etching. It was noted that all the combined-etched samples had a relatively high optical transmission compared to the unetched sample. It was also noted that the addition of NH₄F to the HF solution led to a slight increase in transmission, corresponding to a decrease in the absorption and scattering of the incident laser on the treated fused silica samples. This trend can be observed for all the samples treated with RIE followed by HF/NH₄F etching, but was most significant in the case of the 2 μm HF/NH₄F etching depth (sample C2). In the UV wavelength range (e.g., from the lowest measured wavelength, 190 nm, up to approximately 400 nm), this observed increase in transmission was more obvious. Additionally, it can also be noted that the

transmission of the sample treated with RIE followed by 2 μm HF etching (sample B2) decreased strongly, especially in the visible range. The decrease in the transmission might be due to the plasma-induced and chemical-etching-driven formation of chemical structure defects,²⁷ such as the ODCs mentioned in the Introduction.

(see Fig. 9). All these factors would lead to an increase in LID probability. Thus, the decrease in the surface roughness resulting from the addition of the NH₄F might be a key factor in enhancing the laser damage resistance of the etched fused silica. (2) The activation energy for the dissolution of fused silica in the HF/NH₄F solution is significantly higher than that in the HF solution.²⁸ A more stable SiO₂ network might exist after the HF/NH₄F etching. The FL spectra results give a clear insight into the way in which NH₄F affects the intensity of chemical structure defects such as ODC, O²⁻, and NBOHC during the HF-based wet etching of fused silica (see Fig. 10). The concentration of the chemical structure defects is shown to be one of the important factors influencing the creation of high LIDT surfaces of fused silica.

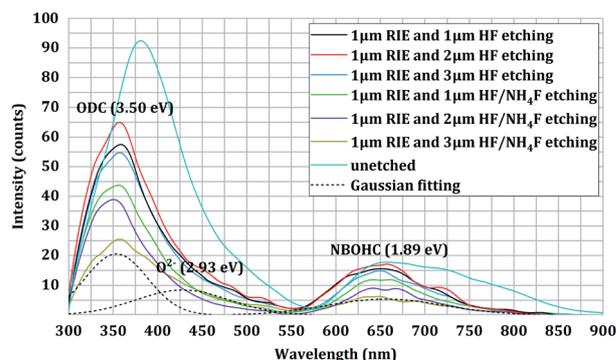
Fig. 10 Comparison of the FL spectra under 210 nm (5.9 eV) excitation for the combined-etched samples. The black dotted lines present the three Gaussian components of the spectrum deconvolution for the sample surfaces treated with 1 μm RIE and 3 μm HF/NH₄F etching. The FL spectrum of the unetched sample is used as a reference.

Finally, we performed FL spectra analysis for all the combined-etched samples as well as the unetched sample. It was noted that all the FL spectra had a very similar trend with the excitation wavelength. As expected, the unetched sample had the highest observed FL peak intensity. It can be also noted that the addition of NH₄F to the HF solution did not appear to cause a change in the FL defect type. Three main FL bands can be resolved from the measured emission spectra in the range of 300–800 nm. The 3.5 eV band is well known, and is attributed to ODC defects, while the 1.89 eV band is attributed to NBOHC defects. The other FL band centered at 2.93 eV is likely O²⁻. Compared to the first set of samples (samples B1, B2, and B3), the second set of samples (samples C1, C2, and C3) had a much lower fluorescence intensity. For the first set of samples, the HF etching depth had a weak effect on the peak intensity of all the FL bands. For the second set of samples, however, we found that the FL peak intensity was highly dependent on the HF/NH₄F etching depth. The intensities of the ODC and NBOHC defect peaks decreased with increasing HF/NH₄F etching depth. The results indicated that HF/NH₄F etching at a greater depth could cause a lower concentration of FL defects in the fused silica network.

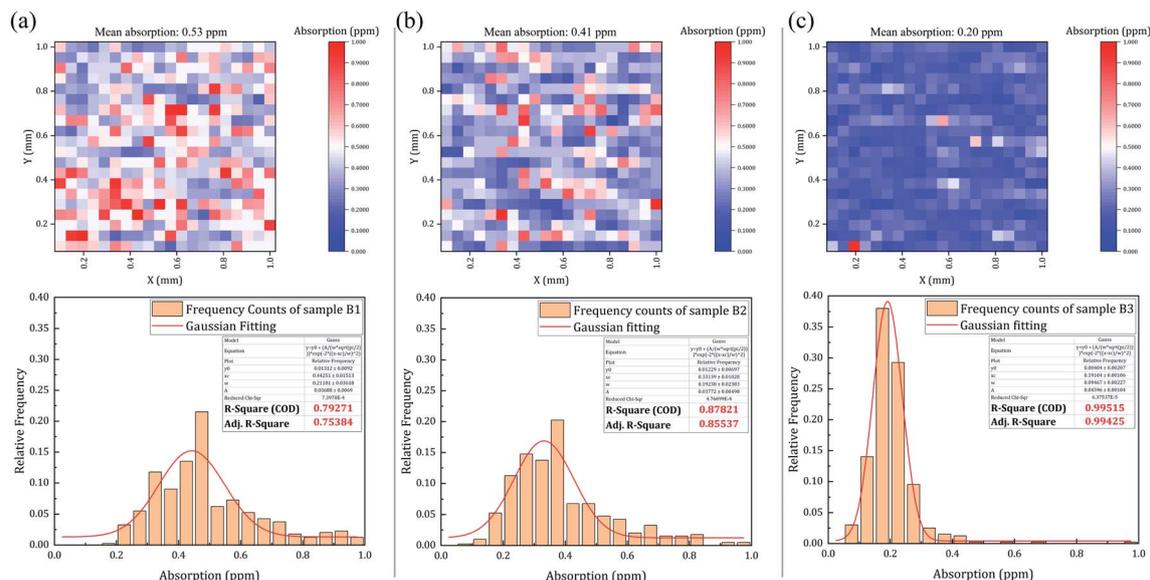
Fig. 11 Surface weak absorption mapping and corresponding statistical data (relative frequency) of the samples treated with RIE followed by HF etching (samples B1, B2, and B3). The measurements were conducted on 10 mm \times 10 mm scanning regions with a 0.05 mm step size for 400 testing points.

followed by NH_4F /HF etching. To further understand the effect of the HF etching depth on the optical performance of the combined-etched fused silica samples, we measured the weak absorption of the optical surfaces treated with RIE followed by HF etching (samples B1, B2, and B3), as shown in Fig. 11. The measurement was conducted using our self-developed photo-thermal deflection system based on a photo-thermal common-path interferometer. The pump beam was a 355 nm quasi-continuous laser with an output power of ~ 1.1 W. The beam spot was focused on the sample surface with a diameter ($1/e^2$) of ~ 20 μm . The probe beam was a modulated He-Ne laser that overlapped with the pump laser on the tested sample surface. A detailed description of the system can be found elsewhere.²⁹ 400 sites in a 10 mm \times 10 mm region on each sample surface were chosen for the measurement. It can be noted that the mean

absorption of the whole region trended to be a lower level when increasing the HF-etching depth. The relative frequencies of the absorption values were then analyzed and Gaussian-fitted. It was noted that the fitting relationship between the two variables became stronger as the HF-etching depth was increased (see the *R*-square coefficients). The results indicated that deep HF etching would make the fused silica surface more stable and uniform.

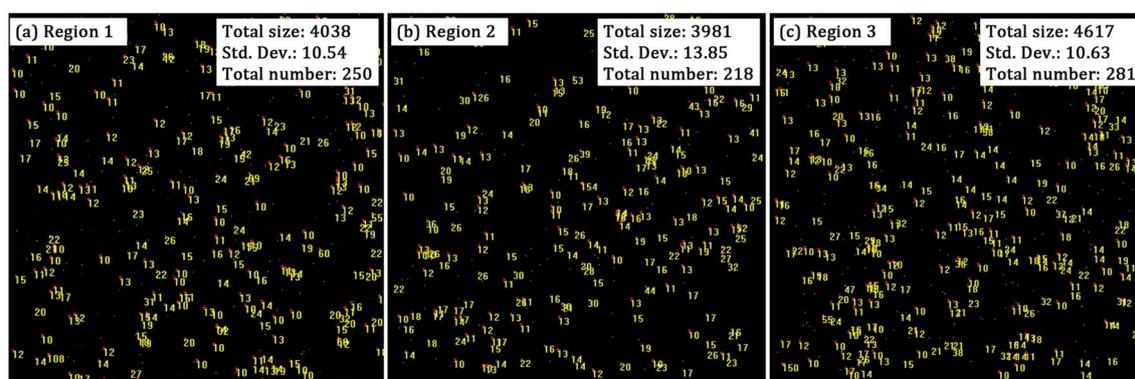
Fig. 12 SC images of three different regions of the sample treated with 1 μm RIE followed by 3 μm HF etching (sample C3). Yellow numbers on each image indicate the sizes (number of pixels) of the SC objects. Only objects with a size larger than 10 pixels were marked. The total size, the std. dev. of the sizes, and the total number of the SC objects for each region are also noted. Also, the raw data and the corresponding statistical data can be seen in the ESI.†

One issue not yet addressed is whether the difference in the point defect density is due to the inhomogeneity of the material. We thus chose another two regions on the surface of sample C3 to compare the SC results (regions 2 and 3) with those we had obtained before (region 1). As shown in Fig. 12, similar SC features were observed for the three regions on the same sample surface, suggesting that the material on the fused silica surface was relatively homogeneous. We would not associate this variation with the HF-based etching depth, because the surface treated with 1 μm RIE followed by 1 μm HF etching (sample B1) also had a high point defect density. More evidence, such as the SC results of a series of samples treated with the same combined etching process, will be obtained in future work.
