## Environmental and private property contamination following the Norfolk Southern chemical spill and chemical fires in Ohio<sup>†</sup>

In February 2023, a train derailment in Ohio caused a chemical spill and fires releasing contaminants into the air, soil, waterways, and buildings. The authors conducted a rapid response which included six field investigations and bench-scale experiments to understand the chemical identity, fate, and exposure pathways after the evacuation order was lifted. Multiple buildings were chemically contaminated and silicone wristband products inside a commercial building were found to have adsorbed derailment-related chemicals. The indoor air of this commercial building was found to be contaminated for 4.5 months after the derailment. Derailment chemicals were also found on building exteriors 5 weeks after the incident. Railcar chemicals were detected in the nearby creeks. Cleanup activities (sorbent pads, aerators) as well as creek hydraulic and environmental conditions influenced chemical fate in creeks. Creek mechanical aeration activities prompted VOC emission that contributed to human exposures and vapor intrusion. Atmospheric modeling revealed that

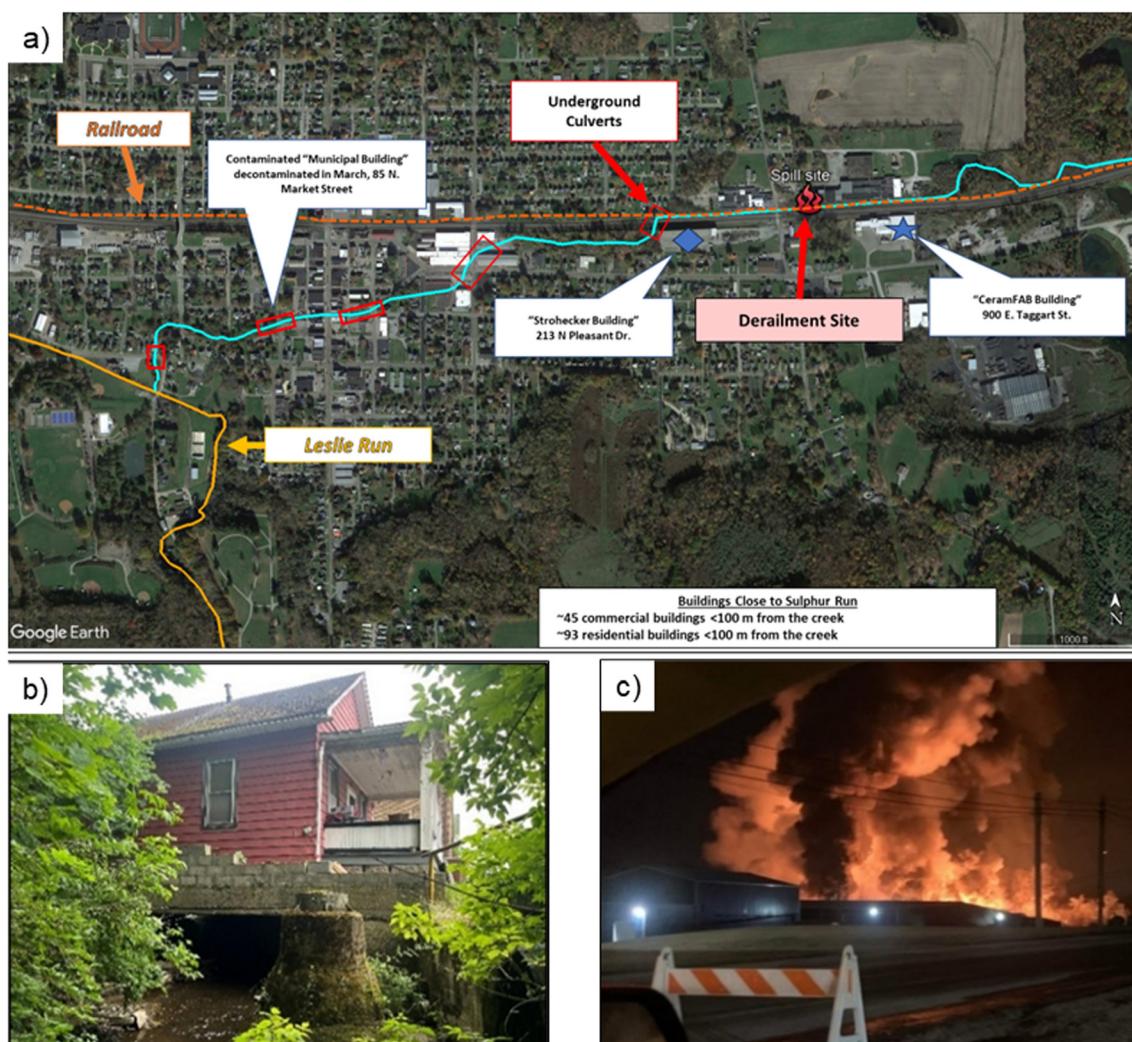
Fig. 1 a) Map showing the derailment site, culverts, and contaminated buildings near Sulphur Run, b) chemicals released from the derailment entered Sulphur Run and flowed into concrete culverts underneath residential, commercial, and municipal buildings, c) image of the chemical fire visible from East Taggart Street by the CeramFAB Building on February 3, 2023. This image was taken before the open burn was conducted February 6, 2023.

During the following months, concerns were raised about the fate of chemicals released as the derailment occurred on the Eastern side of East Palestine next to Sulphur Run creek (Fig. 1). Sulphur Run received spilled chemicals and runoff from the firefighting operations. Chemicals from the derailment site and roadways reached storm drains and Sulphur Run during the initial response (ESI-Context section†). Chemicals spilled into Sulphur Run flowed through East Palestine, as well as directly by and underneath more than 130 residential, commercial, and municipal buildings through concrete boxed and corrugated metal culverts, and under bridges. Doors and windows of some buildings were less than 5 feet from the creek. At East

Palestine City Park, Sulphur Run drained into Leslie Run Creek which flowed to the south. East Palestine's municipal drinking water wells were located 1.25 miles west of the derailment site. According to public records, the groundwater in the area was "highly susceptible to contamination" due to the lack of a surficial clay layer, and Leslie Run was adjacent to mineral mines.<sup>6,7</sup> Some households in the area relied on private drinking water wells adjacent to Leslie Run, some of which had a water elevation of 3 ft below ground surface.

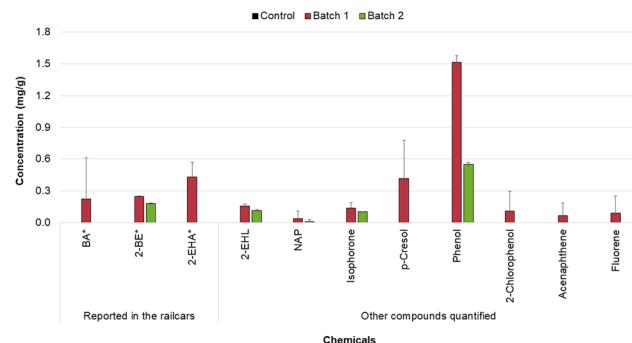
**Fig. 2** Contaminants from the derailment were found in silicone wristbands in an impacted commercial building. The business owner conducted their own testing in February and found that indoor air was contaminated with BA, 2-EHA, in addition to other chemicals. None of the chemicals were detected in unexposed control wristband samples. (\*) Chemicals were reported in the chemical manifest from Norfolk Southern (Table ESI-18†).

Of the buildings visited during the study, the authors identified only one commercial building with the distinct acrid chemical contamination odor that was also present in the contaminated creeks. The authors found that silicone wristbands inside the commercial building with the acrid odor were contaminated with chemicals from the derailment. This building was located directly above the concrete culvert that conveyed Sulphur Run through downtown and less than 0.1 mile from the derailment site. Wristbands removed from this building were found to contain several VOCs released from the railcars, including butyl acrylate (BA), 2-butoxyethanol (2-BE), and 2-ethylhexyl acrylate (2-EHA) (Fig. 2).<sup>26</sup> The contaminated wristbands also contained several VOCs that may be associated with incomplete combustion of petroleum products and other chemicals not listed in the chemical manifest for the railcars involved in the incident (2-chlorophenol, *p*-cresol, 2-ethylhexanol [2-EHL], isophorone, naphthalene [NAP], phenol).<sup>27,28</sup> SVOCs found in the wristbands may also be associated with the combustion of lube oil and petroleum-based fuels associated with the disaster (acenaphthene, fluorene).<sup>29</sup> 2-EHL was found in the surface water after the incident by RESP (as high as 580 ppb). The VOCs and SVOCs not previously identified by others found in the wristbands may be unidentified chemicals released or produced by the chemical spill and/or fires. None of the chemicals reported above were found in the new wristbands (control samples) obtained directly from the manufacturer. These control wristbands were never present at the contaminated building. While there are no specific exposure limits for chemicals in wristbands, general public and occupational airborne chemical exposure limits have been reported for some, but not all, of the chemicals (Table ESI-10†).

Separately, indoor air VOC sampling conducted by the business owner on February 14th corroborates the author's wristband finding that the building was contaminated with derailment chemicals. The business owner discovered the derailment chemicals BA (26 ppb) and 2-EHA (3 ppb) present in the air, as well as other VOCs, including benzene (0.6 ppb), toluene (0.6 ppb), *m*-, *p*-xylene (0.4 ppb), tetrachloroethene (0.6 ppb), 1-butanol (18 ppb), decane (4 ppb), carbon disulfide (0.4 ppb), and carbonyl sulfide (4 ppb).<sup>30</sup> The business owner also found ash and "soot" inside the building.<sup>30</sup> It is also noteworthy that the business's indoor air BA concentration 9 days after the incident was below the 2 week 50 ppb ATSDR screening level, but exceeded the >2 weeks to 1 y screening level (Table ESI-15†). In this building, the authors detected the acrid odor during the final sampling investigation, four and a half months after the derailment. Another business in the same building, sharing an adjacent space, was also found to have the acrid odor in their workspace during the same site visit.
