Cite this: *J. Mater. Chem. C*,
2024, 12, 9401

Infiltration issues in printed mesoporous carbon perovskite solar cells: a troubleshooting guide

Printed mesoscopic carbon perovskite solar cells (CPSCs) represent a potential frontrunner to perovskite commercialisation due to their inherent stability and easily scaled fabrication methods. Devices consist of three screen printed mesoporous layers of TiO₂, ZrO₂ and carbon, which are subsequently infiltrated with perovskite. It is well established that complete infiltration, or filling, of the base TiO₂ layer is key to achieving peak performance and reproducibility in both lab-scale devices and modules. A thorough understanding of the factors influencing infiltration is therefore essential for both lab-scale research and scale-up. TiO₂ infiltration is easily examined by optical microscopy through the glass substrate. This work identifies common characteristic infiltration defects at multiple scales, caused by specific issues in the manufacturing process such as mesh marking, printing issues, contaminant damage and environmental fluctuations. Likely causes and potential solutions are presented for each type of defect, to produce a troub

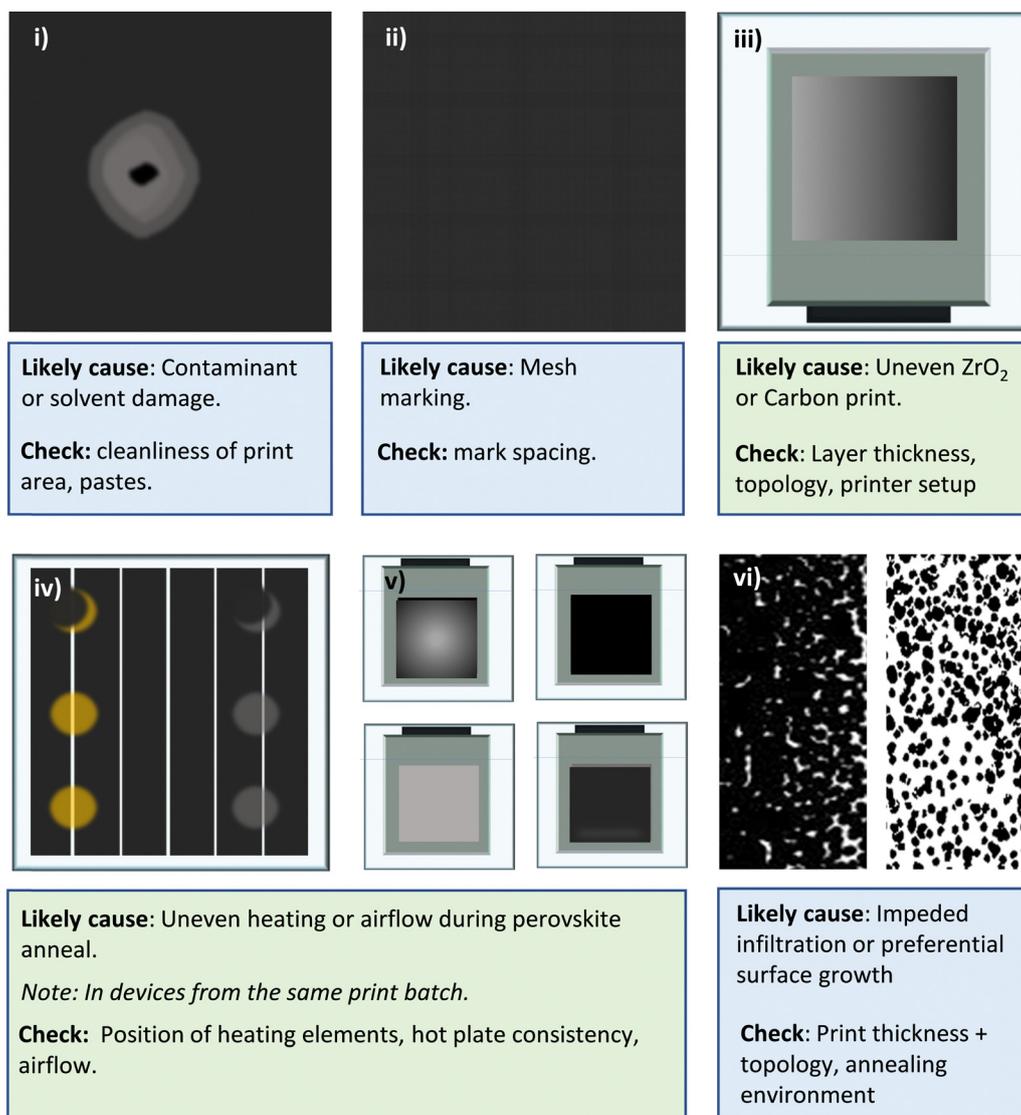
Fig. 1 Diagrams of common large (green text box, (iii)–(v)) and small-scale (blue text box, (i), (ii) and (vi)) infiltration issues in cells and modules, alongside likely causes and suggested checks. Each defect is discussed separately in the relevant numbered section below.

For quick identification of problems, Fig. 1 shows a diagrammatic representation of identified common, characteristic infiltration defects observed at the micro (blue) and macro (green) scale in CPSCs, alongside checks for potential causes. Each issue will be discussed in greater detail in a following subsection, with a final section covering causes of low performance in the absence of defects.

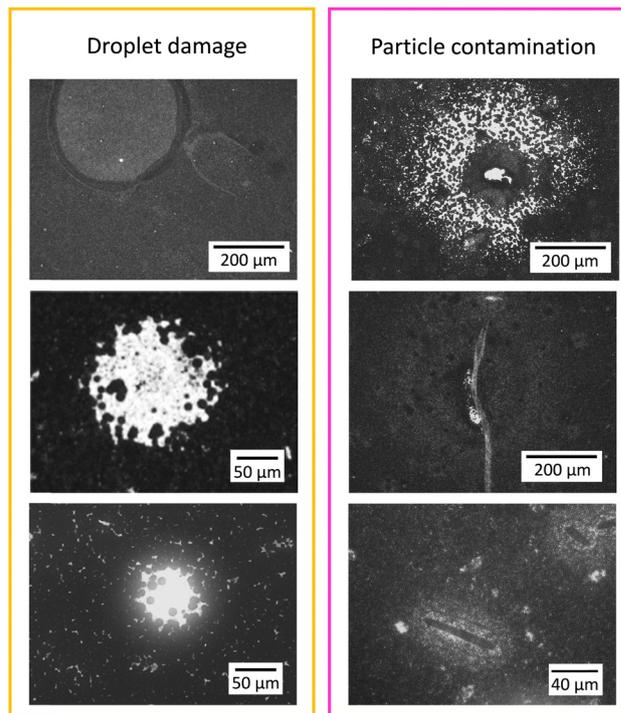
Fig. 2 Optical images of infiltration defects caused by solvent droplet damage and particle contamination.

Often (but not always) visible at the macro-scale, contaminants and solvent damage produce similar issues in completed devices, producing uneven defects of varied size, sometimes with a distinctive ‘halo’ or ringed surrounding pattern (Fig. 2). In the case of physical contaminants, a particle can be present at the defect centre, whereas solvent contamination issues are particle free. Particles will be visible through the glass substrate if the associated contamination is under, in, or on the TiO_2 print. Particle contamination of the ZrO_2 and carbon may also result in defects, but the given particle is unlikely to be visible through the glass substrate.

While solvent damage can be easily prevented through careful handling of liquids around printed stacks (especially when wet), physical contamination can be more persistent depending on the source. Wet and dry printed layers, screens and printing equipment should all be stored under covers to protect from dust and other airborne particulates. Placing wet films in areas of high airflow is not advised, as it can prevent film settling/slumping and increase the likelihood of particle contamination.

Upon observing these defects in cells or modules, pastes, screens, and printing equipment should be carefully inspected for particles or blockages. Blocked screens require cleaning, while contaminated pastes should be disposed of. If equipment and materials appear clean, the printing, film relaxation/slumping, annealing and storage areas should be wiped down to eliminate the source of particles, and storage procedures reviewed where necessary.

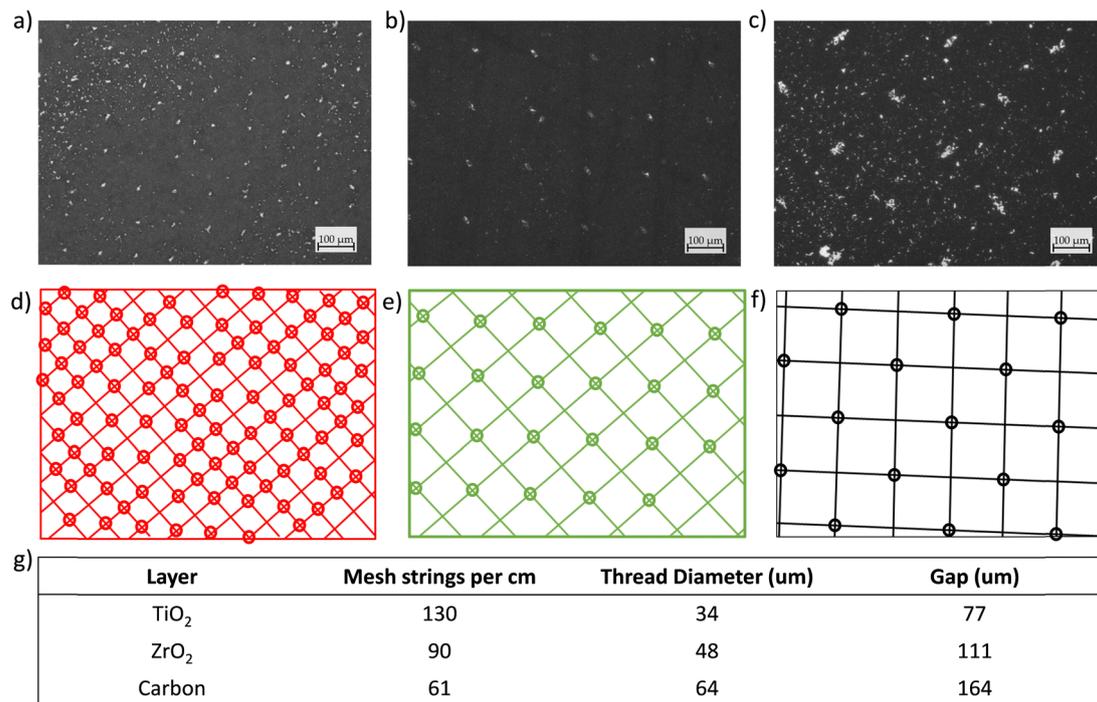
Fig. 3 Optical images of infiltrated TiO₂ in devices showing mesh mark defects from (a) TiO₂, (b) ZrO₂, and (c) carbon screens. (d)–(f) Show diagrams of mesh dimensions of TiO₂, ZrO₂ and carbon screens respectively, with circles representing cross sections where an infiltration issue is present in the device. (g) Shows mesh types and calculated gap size for each layer.

Perhaps the most characteristic defects are those caused by mesh marks; troughs or peaks at the surface of a screen printed layer. Mesh marks occur due to ink filaments forming at mesh crossover sections as the screen separates from the substrate during printing. This produces round, evenly spaced infiltration defects in the finished device. Usually present across a large area, these features are obvious when examining the infiltrated TiO_2 layer with an optical microscope (Fig. 3a–c). Critically, mesh marks in the ZrO_2 or carbon print can cause infiltration defects at the base of the TiO_2 . (Fig. 3a–c) shows optical microscopy images of infiltrated TiO_2 layers from three devices, which respectively show evidence of TiO_2 , ZrO_2 and carbon related mesh mark infiltration defects.

As presented in Fig. 3, observed infiltration defects will correspond with the mesh dimensions of the relevant screen. Therefore, if different screens have been used for TiO_2 , ZrO_2 and carbon, defect spacing can be measured to conclude in which layer the problematic marks reside. For example, the small defects in Fig. 3a must correspond with those from the TiO_2 layer, as this was the only deposition where a fine mesh was used (Fig. 3c). Note that defects may only appear (or be more severe) at alternate cross sections, as is the case in Fig. 3b and c. If similar mesh screens are used for different layers, the problematic layer can be identified using WLI (white light interferometry) of any remaining uninfiltrated devices single prints (Fig. 3b).

shown that slight increases in ZrO₂ roughness can cause severe increases in marking of the subsequent carbon print.²² Therefore, the topology of all layers (in an uninfilted sample) should be examined upon observing mesh marking to ascertain the root cause of the problem.

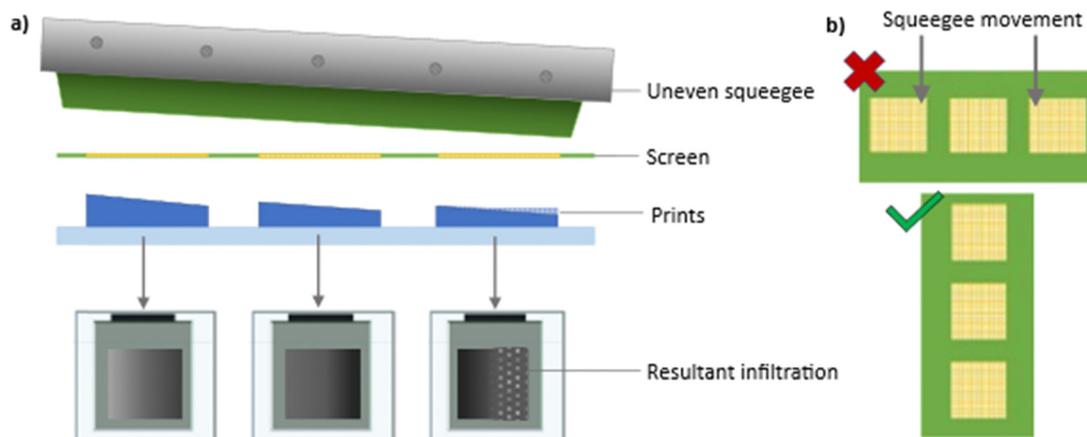
Fig. 4 (a) Diagrammatic representation of the consequences of uneven squeegee pressure and its resultant impact on device infiltration. Note that mesh marking defects in real samples will only be visible via optical microscopy. (b) Screen alignment to limit horizontal print variations.

Careful setup and pressure monitoring can help prevent squeegee related issues. Changing screen designs to limit the horizontal print width (depicted in Fig. 4b) can also improve uniformity and batch variation. In the case of glass warping, ramped heating and cooling steps for blocking layer spraying and each high temperature anneal can help minimise these issues.

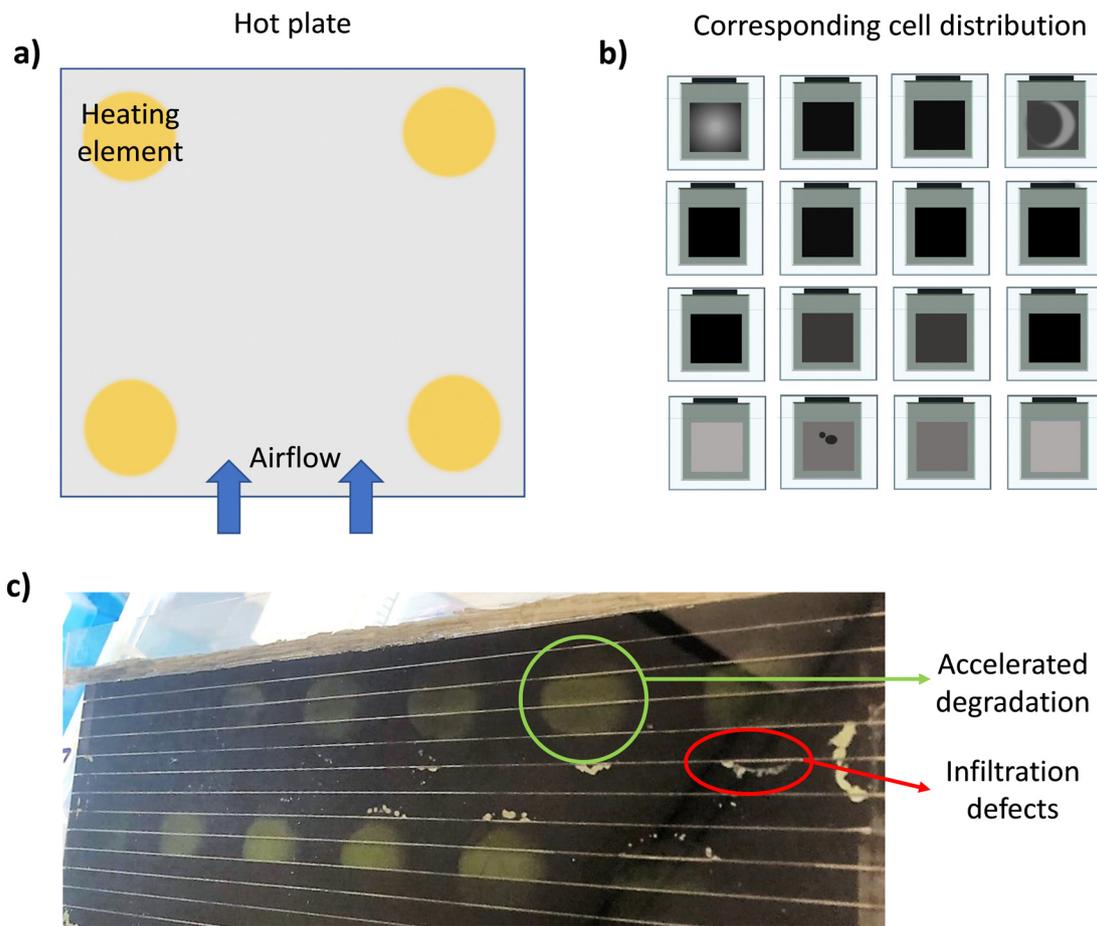
Fig. 5 Diagrammatic representation of (a) an unevenly heating hot plate and (b) resultant impact on device infiltration. Depicted in (c) is a photograph of damage on a $30 \times 30 \text{ cm}^2$ module caused by heating elements and airflow during perovskite annealing.

This issue can occur at multiple scales and using different equipment setup. For example, Fig. 5c shows a $30 \times 30 \text{ cm}^2$ module annealed on a conveyor dryer. Through the glass substrate, greyish white and yellow defects can be seen, impacting multiple cells. The grey or white perovskite free voids indicate an infiltration issue caused by fast crystallisation and high airflow, whereas the yellow areas show accelerated degradation due to uneven heating. On examination of equipment, the yellow defects corresponded with overhead heating elements in the dryer and the white and grey with areas of high airflow.

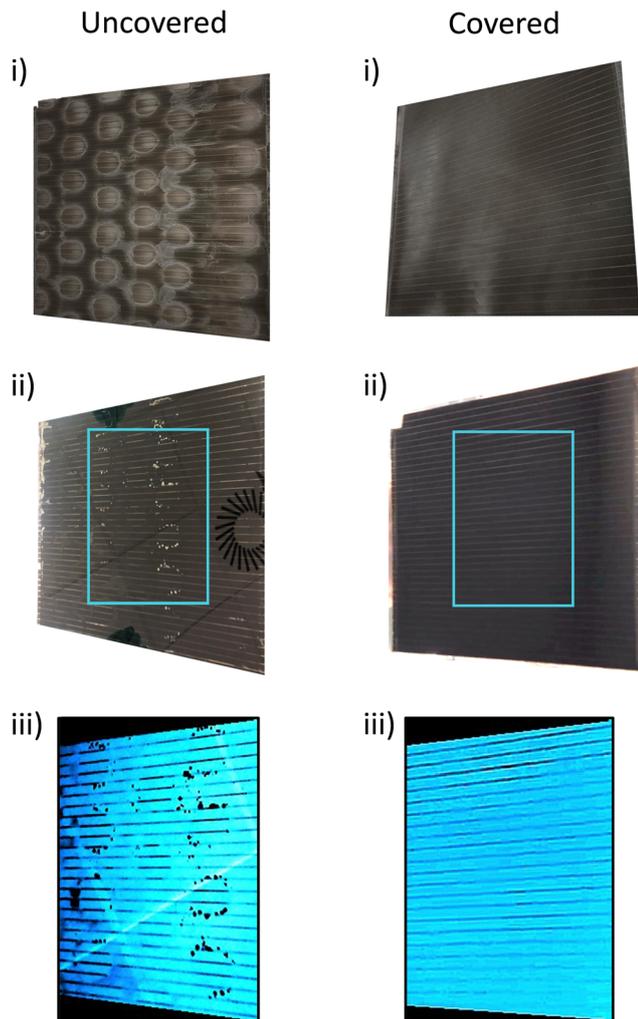
Fig. 6 Photographs of 519 cm² active area modules with (RHS) and without (LHS) a cover during perovskite annealing. (i) Back electrode, (ii) through glass substrate, (iii) magnified with applied colour filter to highlight infiltration problems.

A simple partial cover was thus applied, to protect the module surface while allowing sufficient solvent removal. This completely eliminated the defects, as shown in Fig. 6.

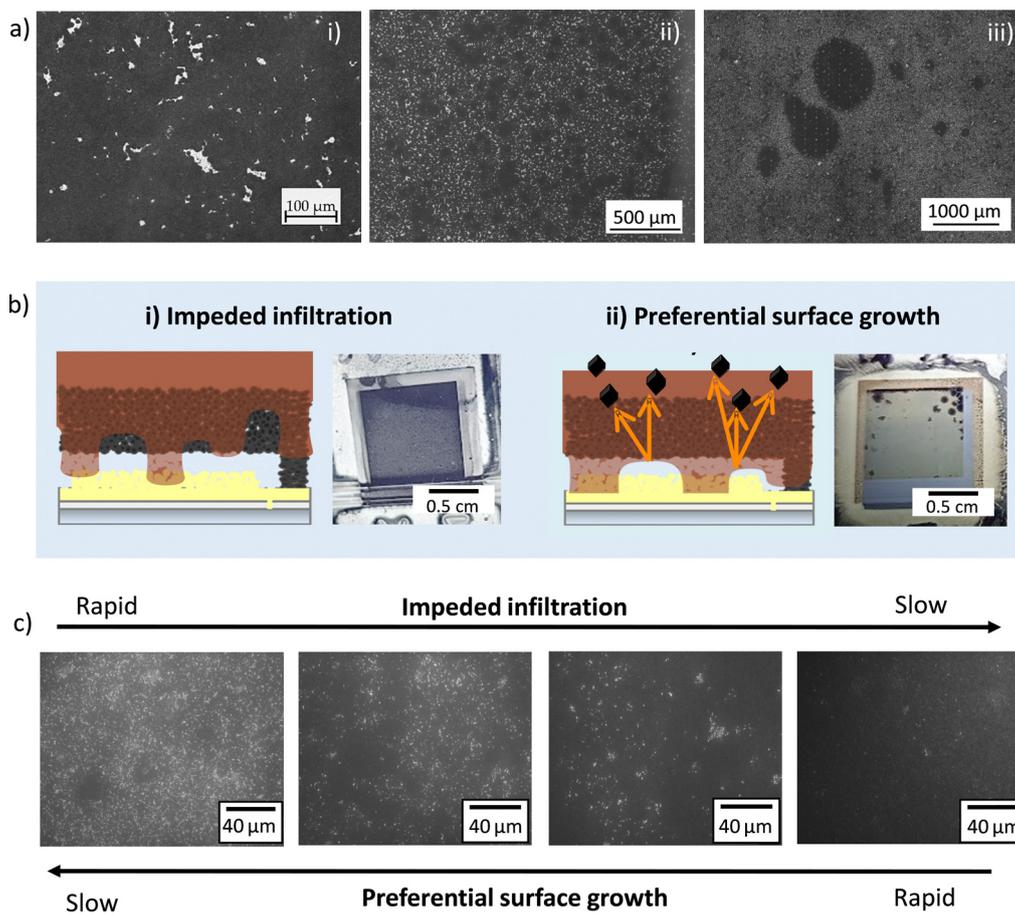
Fig. 7 (a) Optical microscopy images of randomly distributed infiltration defects at different scales. (b) Diagrammatic representation and example photograph of (i) impeded infiltration and (ii) preferential surface growth. (c) The impact of crystallisation speed with each mechanism.

Perhaps the most difficult to diagnose is when devices present with apparently random infiltration issues spread. As shown in Fig. 7a, this can appear at multiple scales with extreme variation in the shape and distribution of observed defects.

There exist two distinct mechanisms that can cause these problems, depicted in Fig. 7b. Impeded infiltration (Fig. 7b(i)) occurs when precursor cannot effectively reach the base of the stack, while preferential surface growth (Fig. 7b(ii)) is seen when nucleation and crystal growth occurs more favourably atop or within the carbon layer, reducing crystal formation in the small pores of the TiO_2 electrode. Both mechanisms can also occur concurrently: *e.g.* upon applying a new precursor formulation that favours surface crystal growth to a batch of cells with thick, rough carbon prints.

Example photographs of devices with particularly severe infiltration issues caused by each mechanism are shown in Fig. 7b. It should be noted that although the devices in the example look very different, they are not characteristic of the associated infiltration issue: without further examination or specific knowledge of the given sample, is not possible to tell visually which mechanism is present.

The causative mechanism can sometimes be identified through monitoring perovskite crystallisation speed across a batch and subsequently examining infiltration. To induce different crystallisation speeds, samples can be deliberately annealed at different temperatures. In the case of impeded infiltration, the best infiltration will be attained in devices that crystallised slowly, as the precursor had more time to percolate the stack. Conversely, with preferential surface growth the best infiltration will present in rapidly crystallised devices, as the infiltrated precursor rapidly forms small grains within the TiO_2 pores instead of slowly growing larger grains at the carbon

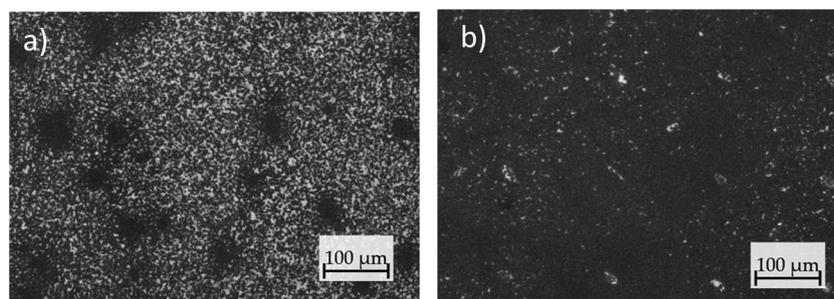
Fig. 8 Optical microscopy images of two devices with impeded infiltration, (a) annealed on an open hot plate and (b) under a partial cover. (b) Reveals mesh marks not observed.

Severe issues are usually caused by multiple concurrent problems acting in tandem. Fig. 8 shows images of TiO_2 infiltration from two devices from the same print batch, (a) annealed on the hot plate and (b) under a partial cover to limit surface airflow. Reducing surface airflow has produced better infiltration in sample b, revealing mesh marking defects that were not observable in the more sparsely filled sample a. Both issues (high surface airflow and mesh marking) therefore require resolving to ensure high-quality infiltration.
