Cite this: *J. Mater. Chem. C*,
2024, 12, 9401

Infiltration issues in printed mesoporous carbon perovskite solar cells: a troubleshooting guide

C. A. Worsley,^{id}* T. Dunlop,^{id} S. J. Potts,^{id} R. Bolton, E. Jewell and
T. M. Watson^{id}*

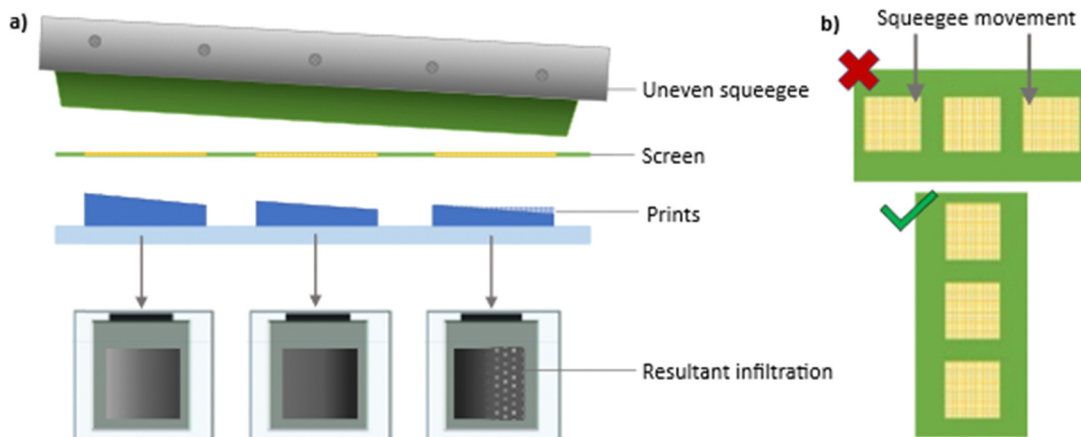
Fig. 4 (a) Diagrammatic representation of the consequences of uneven squeegee pressure and its resultant impact on device infiltration. Note that mesh marking defects in real samples will only be visible via optical microscopy. (b) Screen alignment to limit horizontal print variations.

Careful setup and pressure monitoring can help prevent squeegee related issues. Changing screen designs to limit the horizontal print width (depicted in Fig. 4b) can also improve uniformity and batch variation. In the case of glass warping, ramped heating and cooling steps for blocking layer spraying and each high temperature anneal can help minimise these issues.

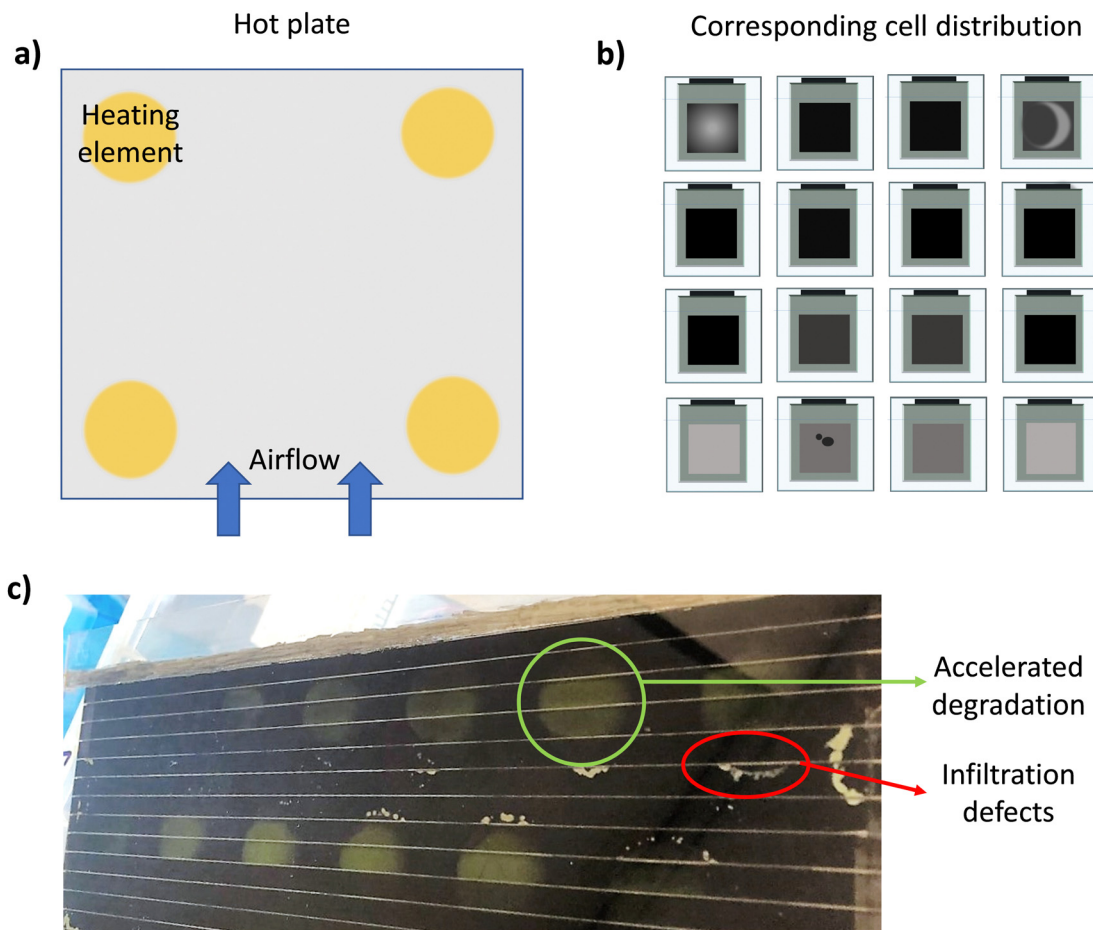
Fig. 5 Diagrammatic representation of (a) an unevenly heating hot plate and (b) resultant impact on device infiltration. Depicted in (c) is a photograph of damage on a $30 \times 30 \text{ cm}^2$ module caused by heating elements and airflow during perovskite annealing.

This issue can occur at multiple scales and using different equipment setup. For example, Fig. 5c shows a $30 \times 30 \text{ cm}^2$ module annealed on a conveyor dryer. Through the glass substrate, greyish white and yellow defects can be seen, impacting multiple cells. The grey or white perovskite free voids indicate an infiltration issue caused by fast crystallisation and high airflow, whereas the yellow areas show accelerated degradation due to uneven heating. On examination of equipment, the yellow defects corresponded with overhead heating elements in the dryer and the white and grey with areas of high airflow.

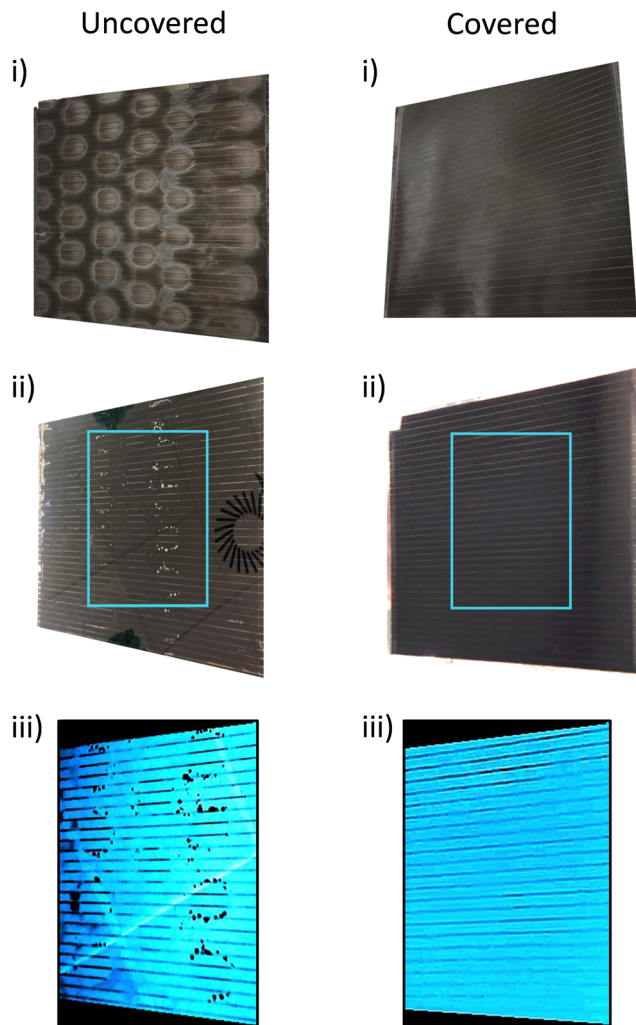
Fig. 6 Photographs of 519 cm² active area modules with (RHS) and without (LHS) a cover during perovskite annealing. (i) Back electrode, (ii) through glass substrate, (iii) magnified with applied colour filter to highlight infiltration problems.

A simple partial cover was thus applied, to protect the module surface while allowing sufficient solvent removal. This completely eliminated the defects, as shown in Fig. 6.

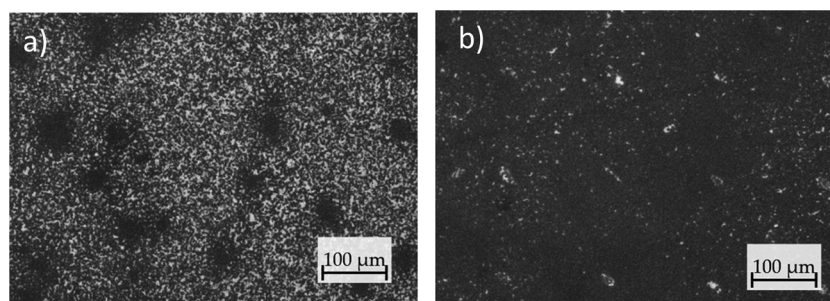
Fig. 8 Optical microscopy images of two devices with impeded infiltration, (a) annealed on an open hot plate and (b) under a partial cover. (b) Reveals mesh marks not observed.

Severe issues are usually caused by multiple concurrent problems acting in tandem. Fig. 8 shows images of TiO_2 infiltration from two devices from the same print batch, (a) annealed on the hot plate and (b) under a partial cover to limit surface airflow. Reducing surface airflow has produced better infiltration in sample b, revealing mesh marking defects that were not observable in the more sparsely filled sample a. Both issues (high surface airflow and mesh marking) therefore require resolving to ensure high-quality infiltration.
