Infiltration issues in printed mesoporous carbon perovskite solar cells: a troubleshooting guide

Printed mesoscopic carbon perovskite solar cells (CPSCs) represent a potential frontrunner to perovskite commercialisation due to their inherent stability and easily scaled fabrication methods. Devices consist of three screen printed mesoporous layers of TiO₂, ZrO₂ and carbon, which are subsequently infiltrated with perovskite. It is well established that complete infiltration, or filling, of the base TiO₂ layer is key to achieving peak performance and reproducibility in both lab-scale devices and modules. A thorough understanding of the factors influencing infiltration is therefore essential for both lab-scale research and scale-up. TiO₂ infiltration is easily examined by optical microscopy through the glass substrate. This work identifies common characteristic infiltration defects at multiple scales, caused by specific issues in the manufacturing process such as mesh marking, printing issues, contaminant damage and environmental fluctuations. Likely causes and potential solutions are presented for each type of defect, to produce a troubleshooting reference resource for tackling this

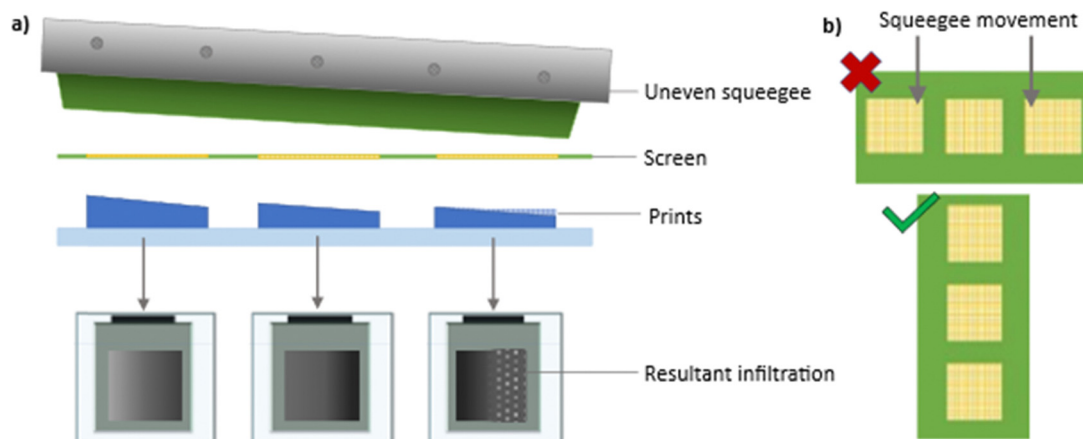
Fig. 4 (a) Diagrammatic representation of the consequences of uneven squeegee pressure and its resultant impact on device infiltration. Note that mesh marking defects in real samples will only be visible via optical microscopy. (b) Screen alignment to limit horizontal print variations.

Sub-optimal printer setup is usually the cause of these issues, although glass warping can also cause similar problems. Consequently, it may be a more prevalent issue in more manual screen-printing equipment, as advanced machines will be able to detect screen, squeegee or substrate misalignment. As shown in Fig. 4a, uneven squeegee or flow coat setup can produce thickness variation across the print. In extreme cases, one side of the print will be extremely thick (limiting infiltration), and the other thin with pronounced mesh marking (as depicted in Fig. 4a). Note that small inconsistencies in the ZrO₂ can cause large problems in the subsequent carbon print, so sub-optimal inhomogeneous carbon prints may not be a consequence of printer setup during carbon deposition.²²

In the case of glass warping, observed infiltration gradients will align with the substrate warp, with areas further from the screen usually producing thicker prints, and areas closer to the screen producing thinner ones (sometimes accompanied by mesh marking).

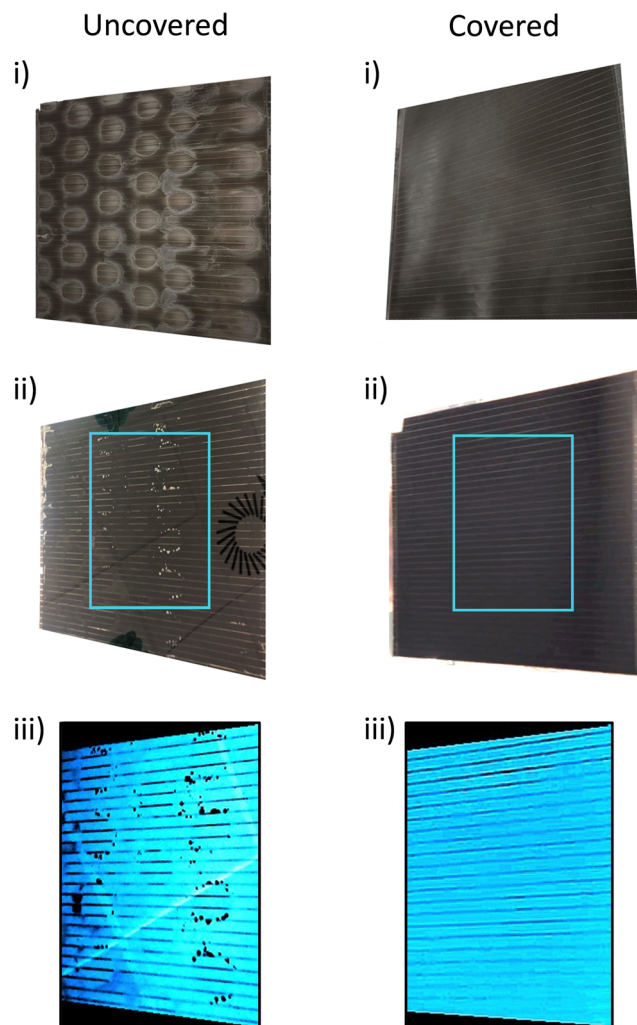
Fig. 6 Photographs of 519 cm² active area modules with (RHS) and without (LHS) a cover during perovskite annealing. (i) Back electrode, (ii) through glass substrate, (iii) magnified with applied colour filter to highlight infiltration problems.

A simple partial cover was thus applied, to protect the module surface while allowing sufficient solvent removal. This completely eliminated the defects, as shown in Fig. 6.

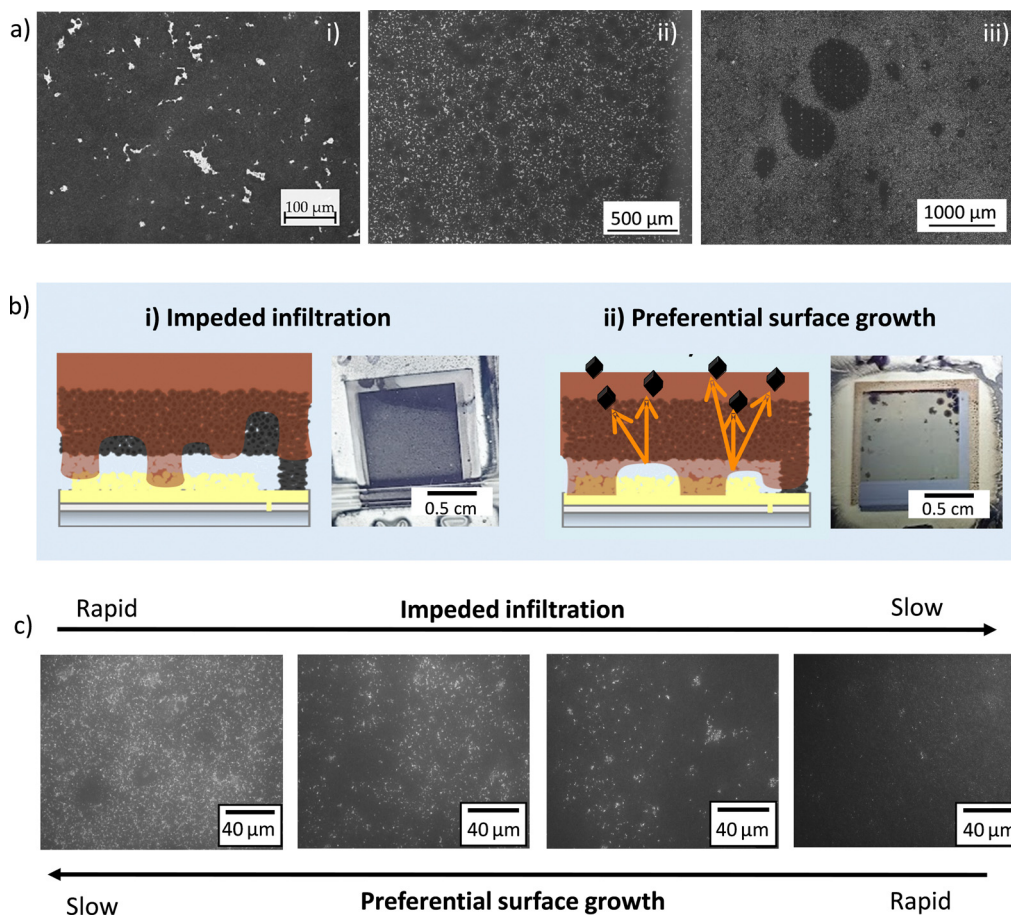
Fig. 7 (a) Optical microscopy images of randomly distributed infiltration defects at different scales. (b) Diagrammatic representation and example photograph of (i) impeded infiltration and (ii) preferential surface growth. (c) The impact of crystallisation speed with each mechanism.

Perhaps the most difficult to diagnose is when devices present with apparently random infiltration issues spread. As shown in Fig. 7a, this can appear at multiple scales with extreme variation in the shape and distribution of observed defects.

There exist two distinct mechanisms that can cause these problems, depicted in Fig. 7b. Impeded infiltration (Fig. 7b(i)) occurs when precursor cannot effectively reach the base of the stack, while preferential surface growth (Fig. 7b(ii)) is seen when nucleation and crystal growth occurs more favourably atop or within the carbon layer, reducing crystal formation in the small pores of the TiO_2 electrode. Both mechanisms can also occur concurrently: *e.g.* upon applying a new precursor formulation that favours surface crystal growth to a batch of cells with thick, rough carbon prints.

Example photographs of devices with particularly severe infiltration issues caused by each mechanism are shown in Fig. 7b. It should be noted that although the devices in the example look very different, they are not characteristic of the associated infiltration issue: without further examination or specific knowledge of the given sample, is not possible to tell visually which mechanism is present.
