Cite this: *J. Mater. Chem. C*,
2024, 12, 9401

Infiltration issues in printed mesoporous carbon perovskite solar cells: a troubleshooting guide

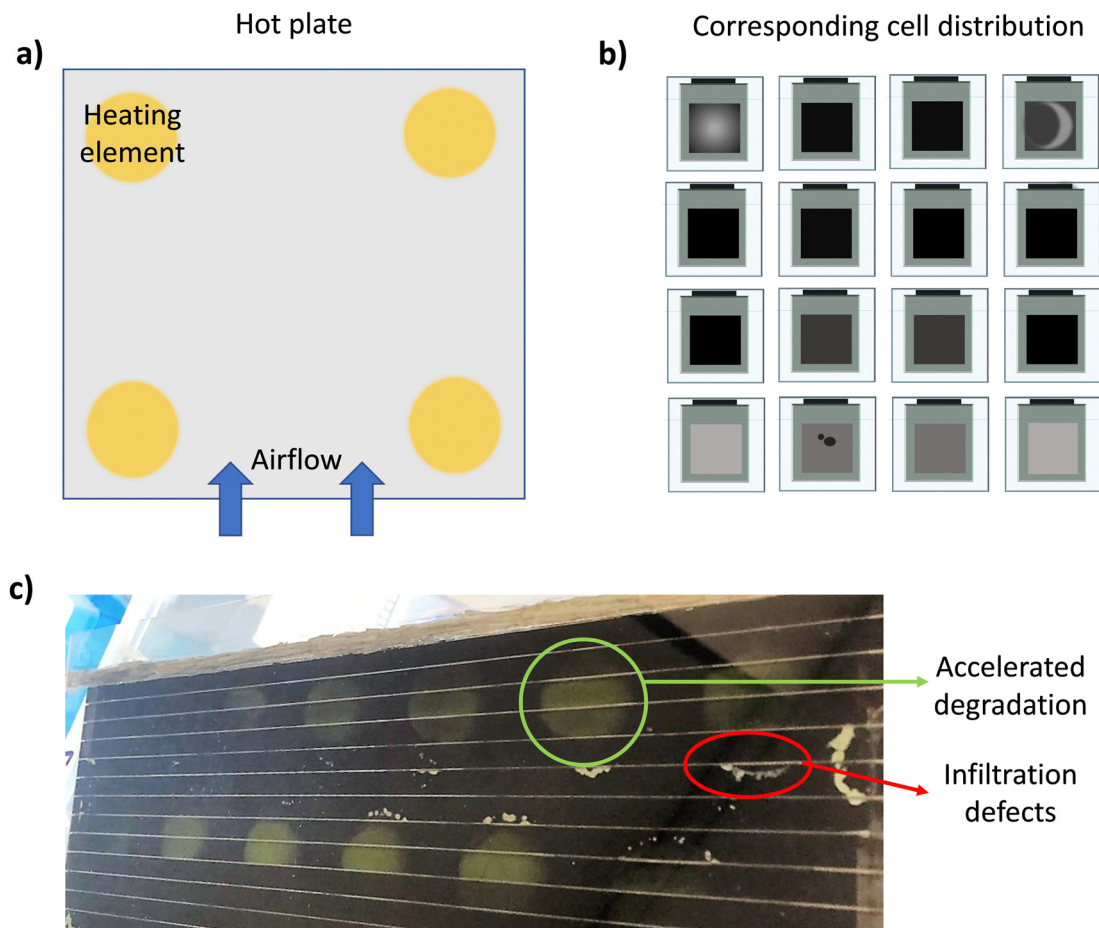
Fig. 5 Diagrammatic representation of (a) an unevenly heating hot plate and (b) resultant impact on device infiltration. Depicted in (c) is a photograph of damage on a $30 \times 30 \text{ cm}^2$ module caused by heating elements and airflow during perovskite annealing.

This issue can occur at multiple scales and using different equipment setup. For example, Fig. 5c shows a $30 \times 30 \text{ cm}^2$ module annealed on a conveyor dryer. Through the glass substrate, greyish white and yellow defects can be seen, impacting multiple cells. The grey or white perovskite free voids indicate an infiltration issue caused by fast crystallisation and high airflow, whereas the yellow areas show accelerated degradation due to uneven heating. On examination of equipment, the yellow defects corresponded with overhead heating elements in the dryer and the white and grey with areas of high airflow.
