Cite this: *J. Mater. Chem. C*,
2024, 12, 9401

Infiltration issues in printed mesoporous carbon perovskite solar cells: a troubleshooting guide

Printed mesoscopic carbon perovskite solar cells (CPSCs) represent a potential frontrunner to perovskite commercialisation due to their inherent stability and easily scaled fabrication methods. Devices consist of three screen printed mesoporous layers of TiO₂, ZrO₂ and carbon, which are subsequently infiltrated with perovskite. It is well established that complete infiltration, or filling, of the base TiO₂ layer is key to achieving peak performance and reproducibility in both lab-scale devices and modules. A thorough understanding of the factors influencing infiltration is therefore essential for both lab-scale research and scale-up. TiO₂ infiltration is easily examined by optical microscopy through the glass substrate. This work identifies common characteristic infiltration defects at multiple scales, caused by specific issues in the manufacturing process such as mesh marking, printing issues, contaminant damage and environmental fluctuations. Likely causes and potential solutions are presented for each type of defect, to produce a troub

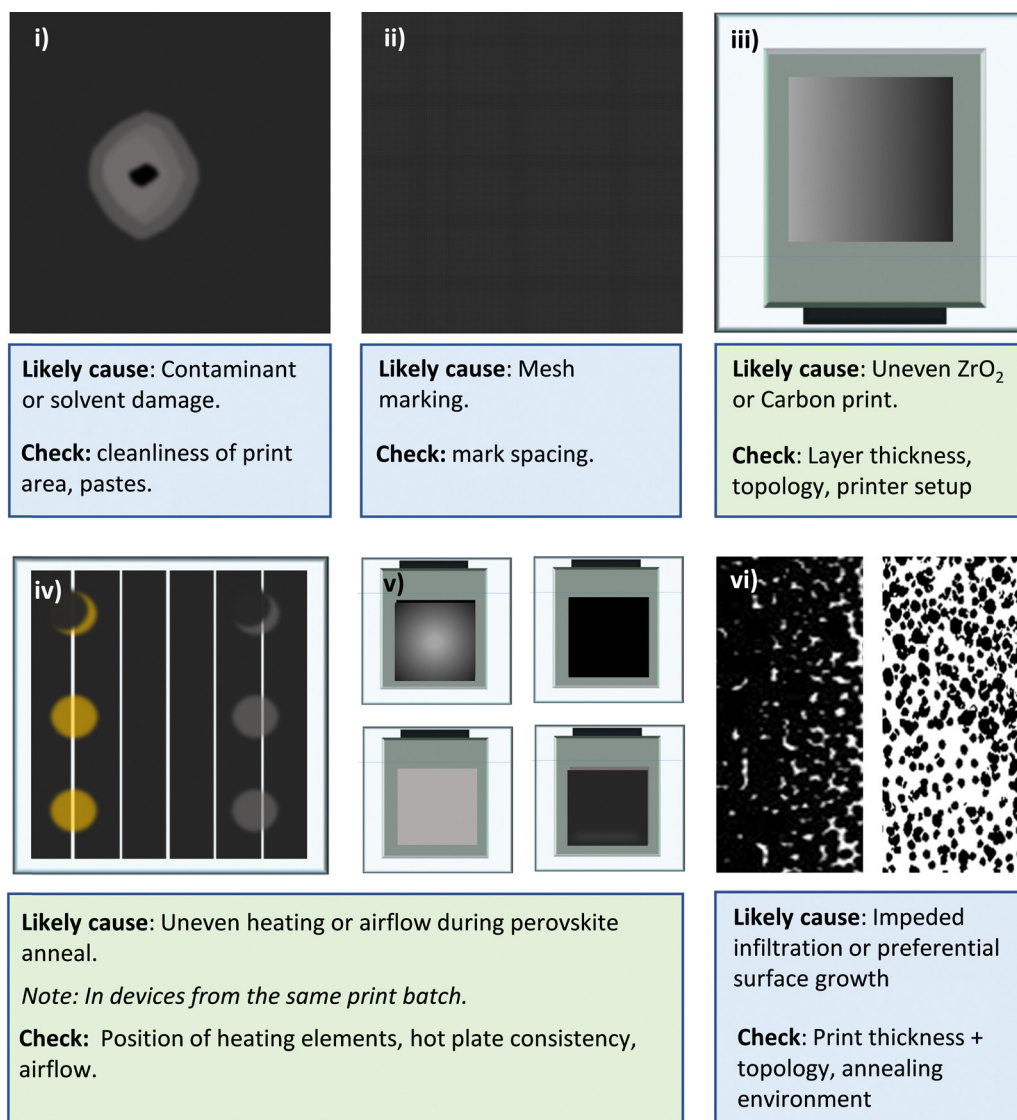
Fig. 1 Diagrams of common large (green text box, (iii)–(v)) and small-scale (blue text box, (i), (ii) and (vi)) infiltration issues in cells and modules, alongside likely causes and suggested checks. Each defect is discussed separately in the relevant numbered section below.

For quick identification of problems, Fig. 1 shows a diagrammatic representation of identified common, characteristic infiltration defects observed at the micro (blue) and macro (green) scale in CPSCs, alongside checks for potential causes. Each issue will be discussed in greater detail in a following subsection, with a final section covering causes of low performance in the absence of defects.

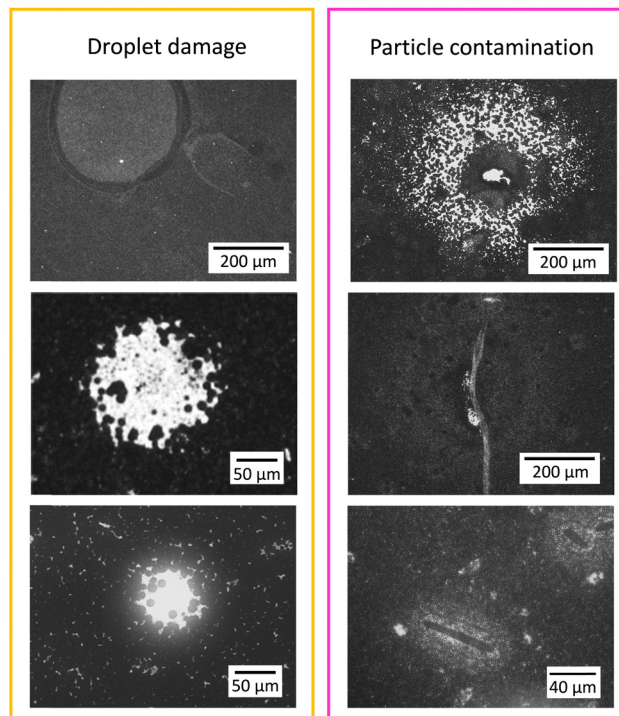
Fig. 2 Optical images of infiltration defects caused by solvent droplet damage and particle contamination.

Often (but not always) visible at the macro-scale, contaminants and solvent damage produce similar issues in completed devices, producing uneven defects of varied size, sometimes with a distinctive ‘halo’ or ringed surrounding pattern (Fig. 2). In the case of physical contaminants, a particle can be present at the defect centre, whereas solvent contamination issues are particle free. Particles will be visible through the glass substrate if the associated contamination is under, in, or on the TiO_2 print. Particle contamination of the ZrO_2 and carbon may also result in defects, but the given particle is unlikely to be visible through the glass substrate.

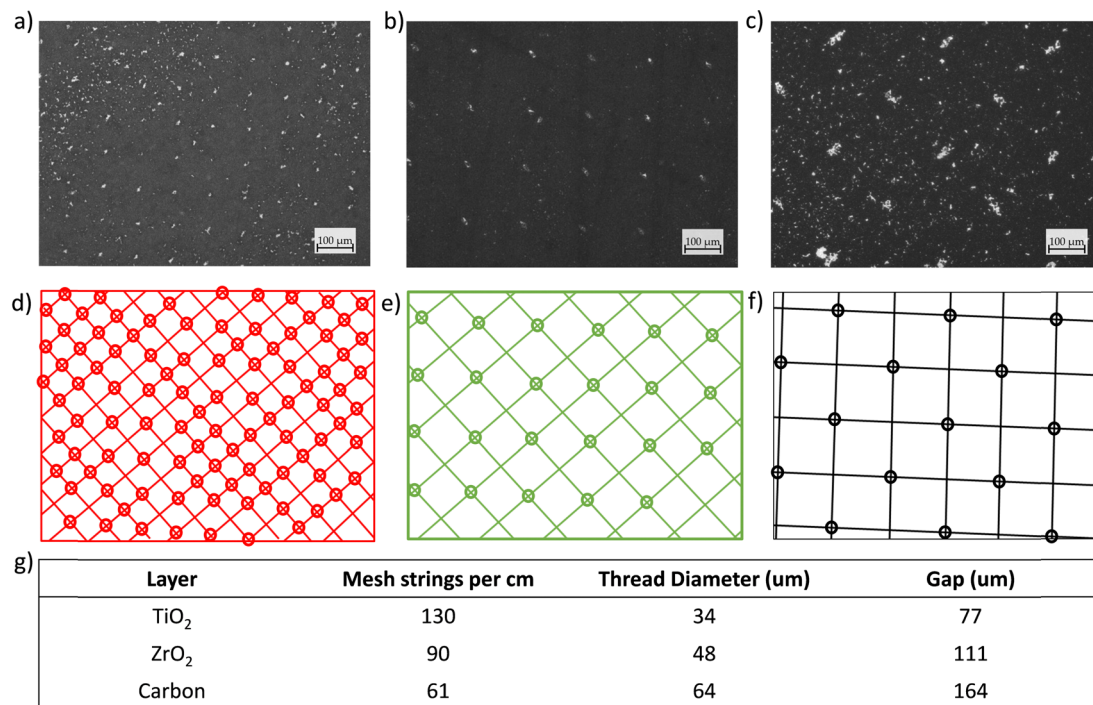
Fig. 3 Optical images of infiltrated TiO₂ in devices showing mesh mark defects from (a) TiO₂, (b) ZrO₂, and (c) carbon screens. (d)–(f) Show diagrams of mesh dimensions of TiO₂, ZrO₂ and carbon screens respectively, with circles representing cross sections where an infiltration issue is present in the device. (g) Shows mesh types and calculated gap size for each layer.

Perhaps the most characteristic defects are those caused by mesh marks; troughs or peaks at the surface of a screen printed layer. Mesh marks occur due to ink filaments forming at mesh crossover sections as the screen separates from the substrate during printing. This produces round, evenly spaced infiltration defects in the finished device. Usually present across a large area, these features are obvious when examining the infiltrated TiO_2 layer with an optical microscope (Fig. 3a–c). Critically, mesh marks in the ZrO_2 or carbon print can cause infiltration defects at the base of the TiO_2 . (Fig. 3a–c) shows optical microscopy images of infiltrated TiO_2 layers from three devices, which respectively show evidence of TiO_2 , ZrO_2 and carbon related mesh mark infiltration defects.

As presented in Fig. 3, observed infiltration defects will correspond with the mesh dimensions of the relevant screen. Therefore, if different screens have been used for TiO_2 , ZrO_2 and carbon, defect spacing can be measured to conclude in which layer the problematic marks reside. For example, the small defects in Fig. 3a must correspond with those from the TiO_2 layer, as this was the only deposition where a fine mesh was used (Fig. 3c). Note that defects may only appear (or be more severe) at alternate cross sections, as is the case in Fig. 3b and c. If similar mesh screens are used for different layers, the problematic layer can be identified using WLI (white light interferometry) of any remaining uninfiltrated devices single prints (Fig. 3b).

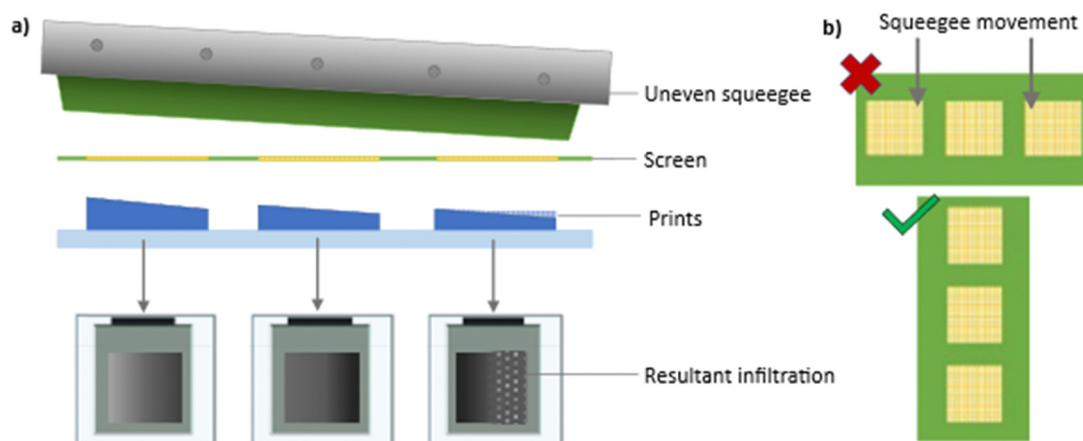
Fig. 4 (a) Diagrammatic representation of the consequences of uneven squeegee pressure and its resultant impact on device infiltration. Note that mesh marking defects in real samples will only be visible via optical microscopy. (b) Screen alignment to limit horizontal print variations.

Careful setup and pressure monitoring can help prevent squeegee related issues. Changing screen designs to limit the horizontal print width (depicted in Fig. 4b) can also improve uniformity and batch variation. In the case of glass warping, ramped heating and cooling steps for blocking layer spraying and each high temperature anneal can help minimise these issues.

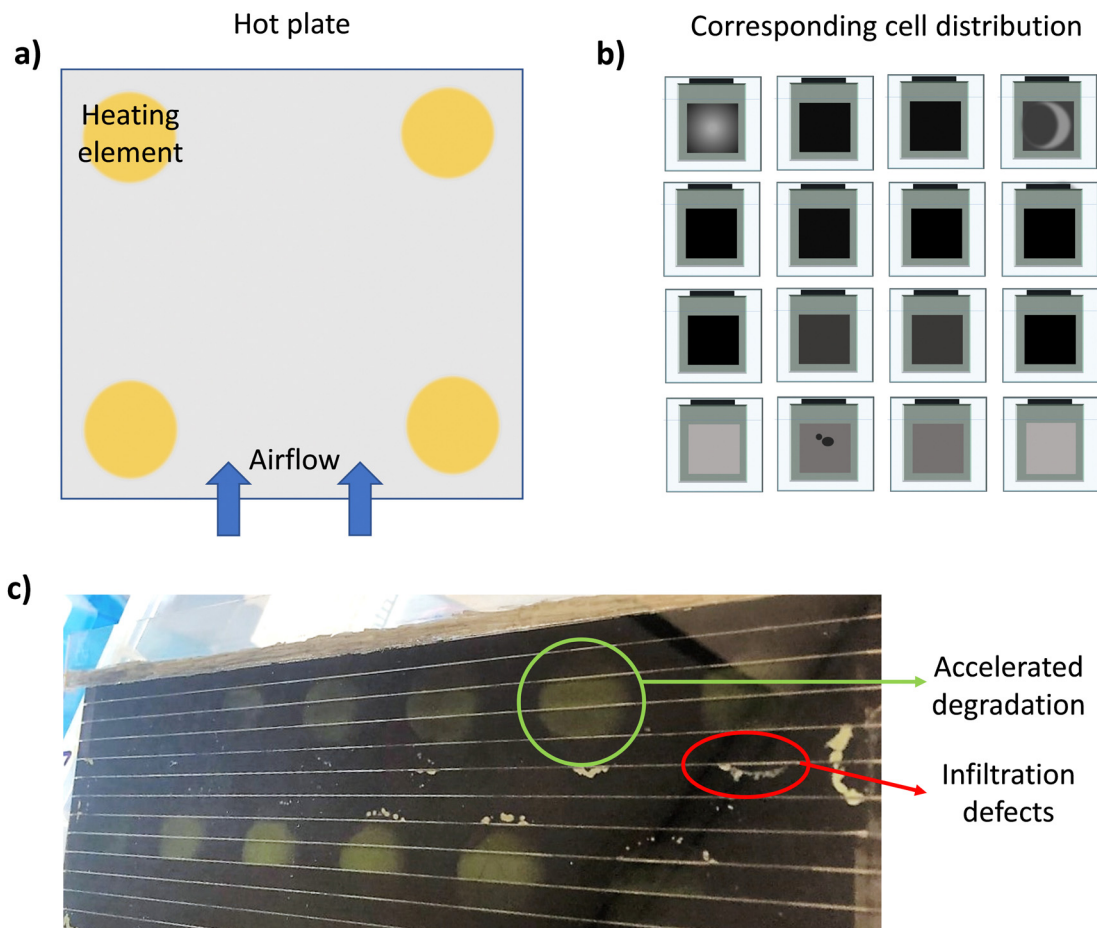
Fig. 5 Diagrammatic representation of (a) an unevenly heating hot plate and (b) resultant impact on device infiltration. Depicted in (c) is a photograph of damage on a $30 \times 30 \text{ cm}^2$ module caused by heating elements and airflow during perovskite annealing.

This issue can occur at multiple scales and using different equipment setup. For example, Fig. 5c shows a $30 \times 30 \text{ cm}^2$ module annealed on a conveyor dryer. Through the glass substrate, greyish white and yellow defects can be seen, impacting multiple cells. The grey or white perovskite free voids indicate an infiltration issue caused by fast crystallisation and high airflow, whereas the yellow areas show accelerated degradation due to uneven heating. On examination of equipment, the yellow defects corresponded with overhead heating elements in the dryer and the white and grey with areas of high airflow.

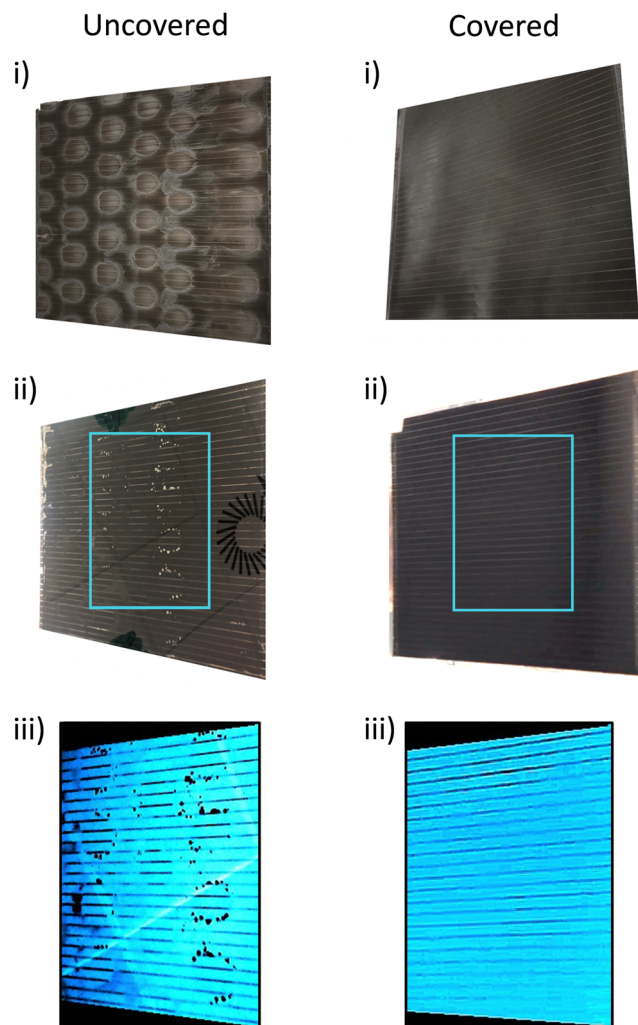
Fig. 6 Photographs of 519 cm² active area modules with (RHS) and without (LHS) a cover during perovskite annealing. (i) Back electrode, (ii) through glass substrate, (iii) magnified with applied colour filter to highlight infiltration problems.

A simple partial cover was thus applied, to protect the module surface while allowing sufficient solvent removal. This completely eliminated the defects, as shown in Fig. 6.

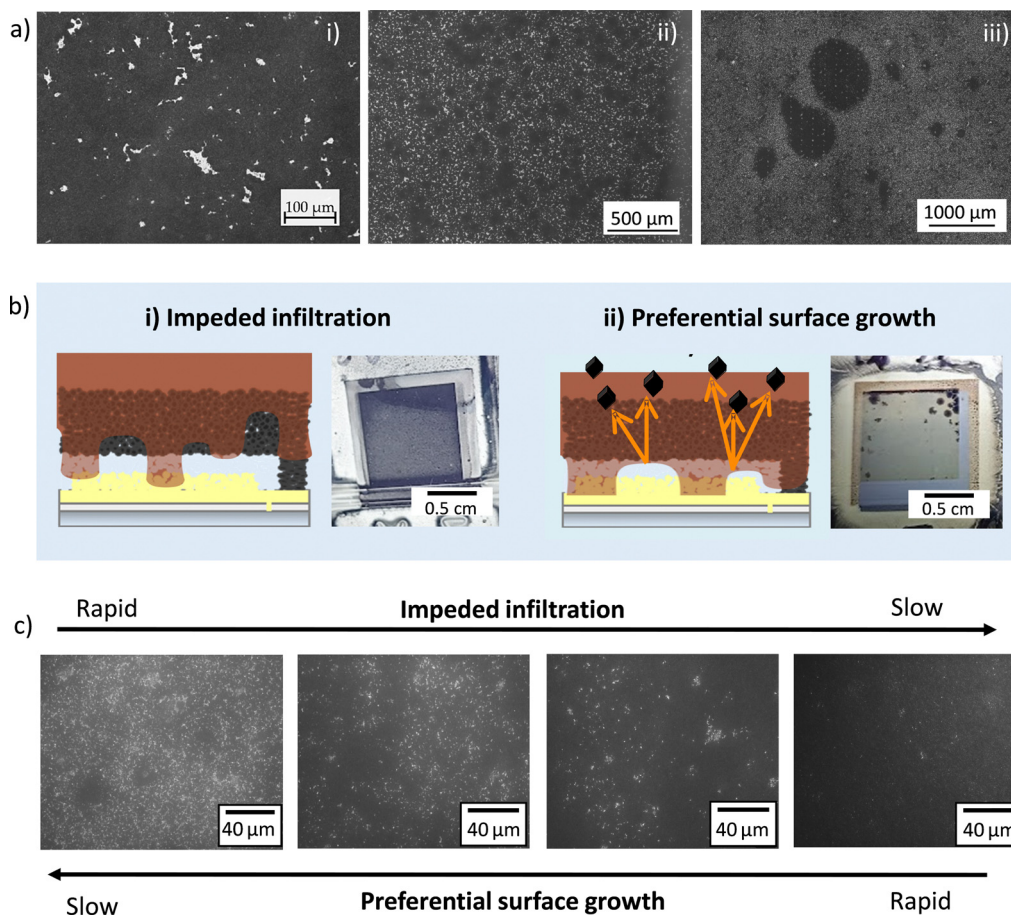
Fig. 7 (a) Optical microscopy images of randomly distributed infiltration defects at different scales. (b) Diagrammatic representation and example photograph of (i) impeded infiltration and (ii) preferential surface growth. (c) The impact of crystallisation speed with each mechanism.

Perhaps the most difficult to diagnose is when devices present with apparently random infiltration issues spread. As shown in Fig. 7a, this can appear at multiple scales with extreme variation in the shape and distribution of observed defects.

There exist two distinct mechanisms that can cause these problems, depicted in Fig. 7b. Impeded infiltration (Fig. 7b(i)) occurs when precursor cannot effectively reach the base of the stack, while preferential surface growth (Fig. 7b(ii)) is seen when nucleation and crystal growth occurs more favourably atop or within the carbon layer, reducing crystal formation in the small pores of the TiO_2 electrode. Both mechanisms can also occur concurrently: *e.g.* upon applying a new precursor formulation that favours surface crystal growth to a batch of cells with thick, rough carbon prints.

Example photographs of devices with particularly severe infiltration issues caused by each mechanism are shown in Fig. 7b. It should be noted that although the devices in the example look very different, they are not characteristic of the associated infiltration issue: without further examination or specific knowledge of the given sample, is not possible to tell visually which mechanism is present.

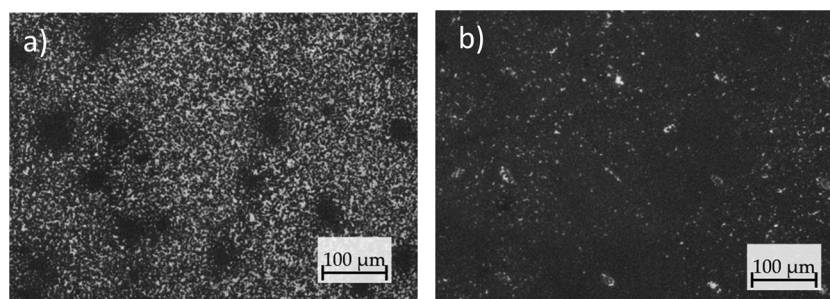
Fig. 8 Optical microscopy images of two devices with impeded infiltration, (a) annealed on an open hot plate and (b) under a partial cover. (b) Reveals mesh marks not observed.

Severe issues are usually caused by multiple concurrent problems acting in tandem. Fig. 8 shows images of TiO_2 infiltration from two devices from the same print batch, (a) annealed on the hot plate and (b) under a partial cover to limit surface airflow. Reducing surface airflow has produced better infiltration in sample b, revealing mesh marking defects that were not observable in the more sparsely filled sample a. Both issues (high surface airflow and mesh marking) therefore require resolving to ensure high-quality infiltration.
