CRITICAL REVIEW

Ongoing legacy contamination from a military radar station in Iceland: a case study

María J. Gunnarsdottir

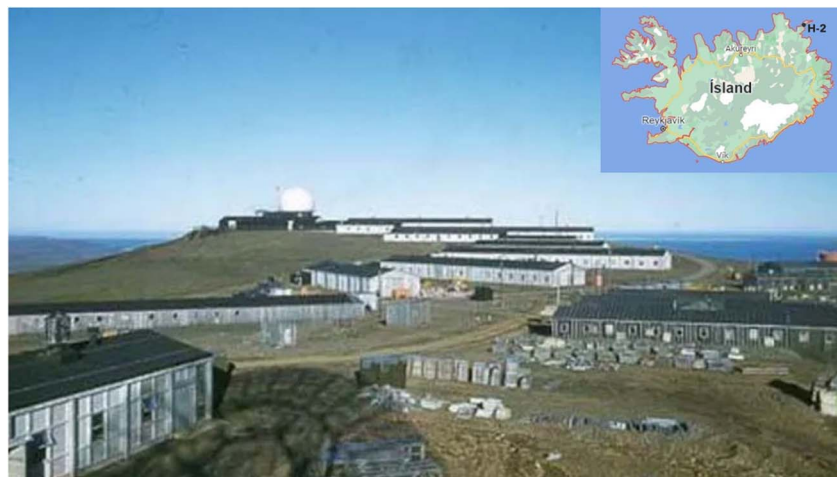
Fig. 1 The DEW line radar station at Heiðarfjall in 1958 (<https://www.radomes.org/museum/acwgrnland.php>).
