Cite this: *Environ. Sci.: Adv.*, 2024, **3**, 972

Ongoing legacy contamination from a military radar station in Iceland: a case study

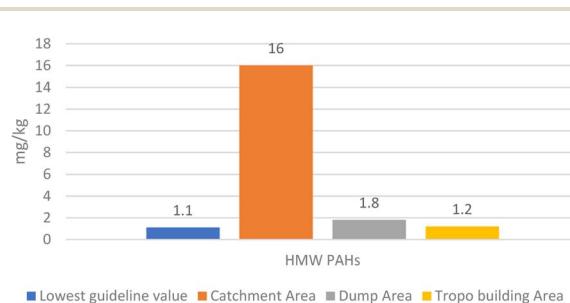
Fig. 7 HMW PAHs (mg kg^{-1}) tested in five areas with the content exceeding the lowest guideline value (1.1 mg kg^{-1}) in three areas. The highest values detected in the three areas are shown.

PAHs are released during incomplete combustion of petroleum products or from petroleum spill. They are persistent in the environment and several have multiple adverse health effects.²⁷ PAHs were summarized in two categories, low molecular weight PAHs (LMW PAHs) and high molecular weight PAHs (HMW PAHs), with the latter being more toxic and carcinogenic.⁵¹ Fifteen PAHs were tested (5 LMW and 10 HMW) in nine samples from five areas (Dump, Tropo, Sewage outfall, Powerhouse and Catchment), see Table 1, and found to exceed the lowest guideline value at three areas: Catchment, Dump and Tropo areas. The highest values in both categories (LMW and HMW) were found at the Catchment area (Table 2). See Fig. 7 for results for HMW PAHs.
