## Ongoing legacy contamination from a military radar station in Iceland: a case study

María J. Gunnarsdottir

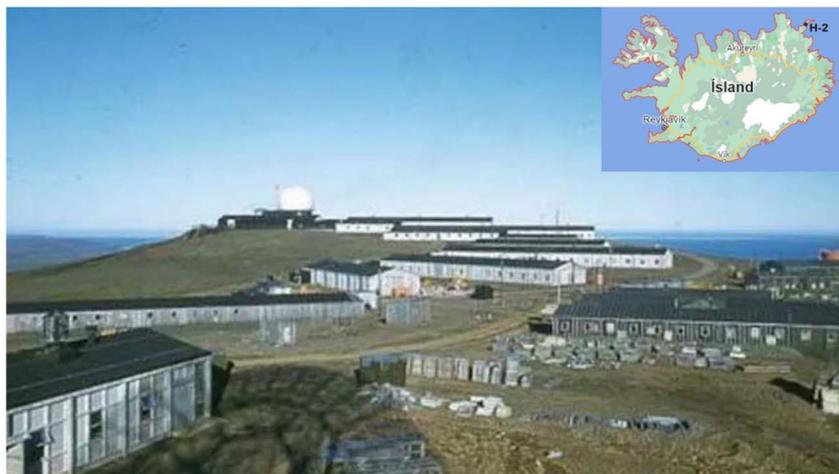
Fig. 1 The DEW line radar station at Heiðarfjall in 1958 (<https://www.radomes.org/museum/acwgrnland.php>).

The H-2 radar station at Heiðarfjall (66°16'42"N 14°59'32"W) was operated from 1957 until 1970, by the US Air Force until 1961 and after that by the US Navy watching submarine traffic until 1970 when the station was closed down and later demolished. The radar station was built on the top of Heiðarfjall mountain, approximately 260 metres above sea level. The mountain is part of the land of Eiði farm, which was leased by the Icelandic government in 1953 and handed over to the US

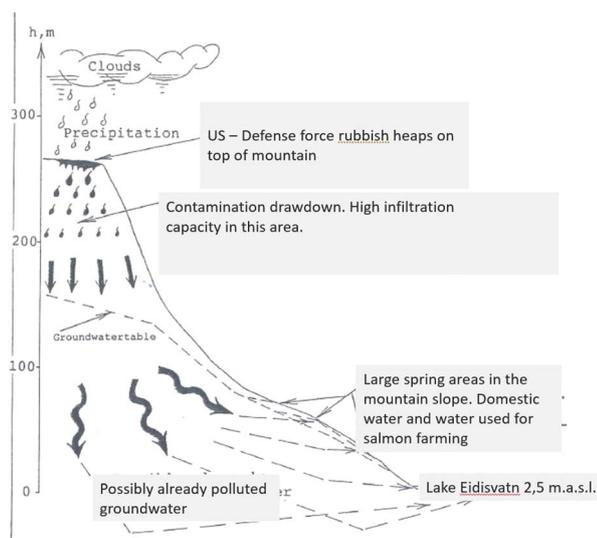
Fig. 2 Transport model of pollution spread at Heiðarfjall.<sup>42</sup>

The engineering consultant's conclusion was that groundwater pollution would mostly spread southwards towards the farm, the estuary lake Eiðisvatn and the sea as shown in Fig. 2. Calculations of the pollution infiltration flow from the top of the mountain indicate that it would take at least 30 years to reach the springs on the south side of the mountain flowing to Eiðisvatn.

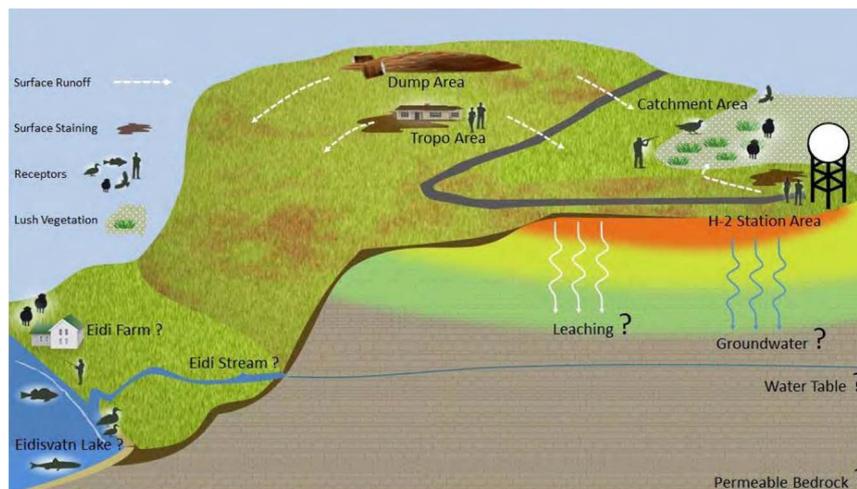
Fig. 3 Schematic picture of Heiðarfjall and the sites investigated by the ESG in 2017.<sup>10</sup> Water source for Eidi farm is at the Eidi stream.

The sites chosen for sampling by the ESG, see Fig. 3, were: (1) the Dump area (*ca.*  $18.000 \text{ m}^2$ ) where debris, both during operating and later during clean-up, had been buried; (2) the Tropo area, with a communication building (still standing), and where two tropospheric communication dishes once stood; (3) the Sewage Outfall area; (4) the POL (petroleum oil and lubricant) Tank area, where a large fuel storage tank used to be situated. Sites 3 and 4 were on the southern edge of the summit area, directly above the Eiði farm; (5) the Garage area; (6) the Barracks area; (7) the Powerhouse area, and (8) Radome area (sites 5, 6, 7, and 8 are all situated at the Station area); (9) the lower-lying Catchment area, where a concrete drainage pipe was observed leading to a small pond; and (10) the Eiði stream area. Fig. 4 shows a recent picture of the Station area.

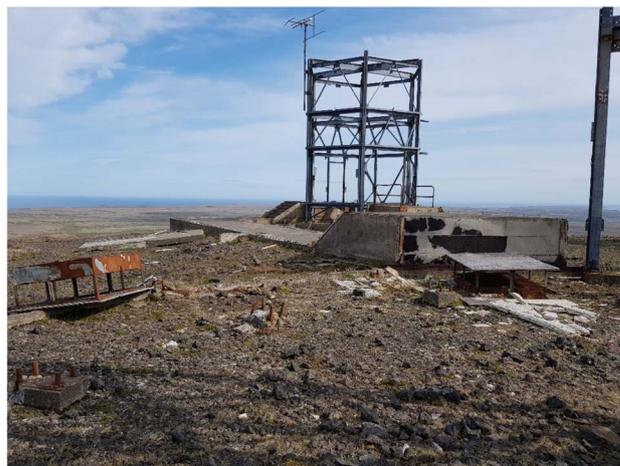
Fig. 4 The H-2 Station Radome area at Heiðarfjall, 26. 7. 2021 (M. J. Gunnarsdottir).

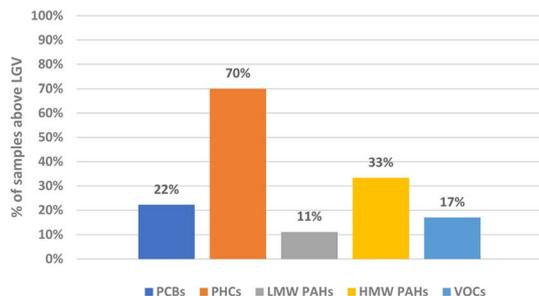
Fig. 5 Non-compliance of POPs with the LGV (lowest guideline value) in samples.<sup>10</sup>

POPs are non-compliant to the lowest guideline value, as shown in Fig. 5, from 11% for low molecular weight PAHs to

70% for PHCs. However, this is not representative as sampling is not evenly distributed and several sites are not tested for some POPs as shown in Table 1.

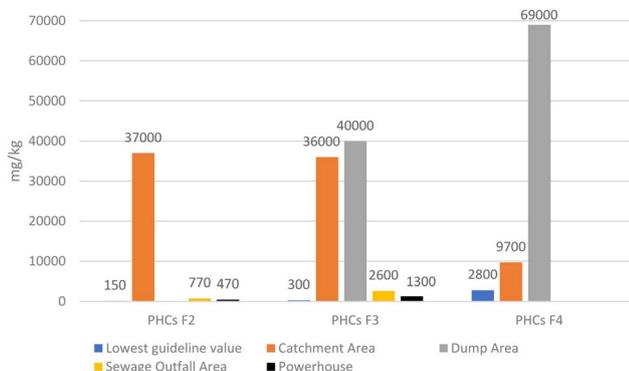
Fig. 6 PHCs (mg kg<sup>-1</sup>) detected above the lowest guideline value for F2, F3 and F4 (150, 300, and 2800, respectively) at four areas. The highest value in each area of the four is shown in the figure.

PHCs, used as fuels and lubricants, consist of a large number of hydrocarbon compounds, some of which can cause severe health issues. The ESG observed considerable remains of oil barrels, some of which were stained black, and some black tar like chunks around the Dump area and around the Powerhouse area. Oil barrels were also observed by the MHR in 1993, as mentioned previously.<sup>43</sup> PHCs are arranged into four categories (F1, F2, F3, F4) depending on the number of carbons, and their volatility decreases and persistence increases in the environment with a rising number of carbons. PHCs in F1 were not detected over the lowest guideline values whereas this was the case with the other three, to varying degrees. PHCs were tested at six areas and detected over the lowest standard at four areas: the Dump, Sewage outfall, Powerhouse and Catchment areas (Table 2 and Fig. 6). The highest concentration of PHCs ranged from 40 000 mg kg<sup>-1</sup> to 69 000 mg kg<sup>-1</sup> at the Dump area and was 9700 to 37 000 mg kg<sup>-1</sup> at the Catchment area. A similar case was at the DEW line site at Utqiagvik in Alaska where areas around the powerhouse site showed significant petroleum-derived contamination as mentioned earlier.<sup>5</sup>

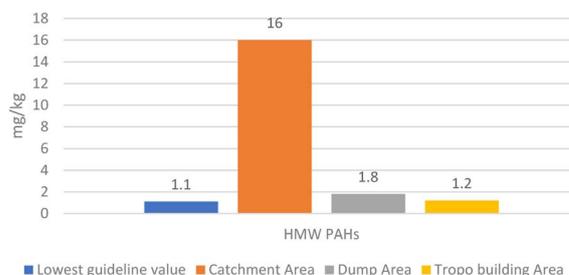
Fig. 7 HMW PAHs (mg kg<sup>-1</sup>) tested in five areas with the content exceeding the lowest guideline value (1.1 mg kg<sup>-1</sup>) in three areas. The highest values detected in the three areas are shown.

PAHs are released during incomplete combustion of petroleum products or from petroleum spill. They are persistent in the environment and several have multiple adverse health effects.<sup>27</sup> PAHs were summarized in two categories, low molecular weight PAHs (LMW PAHs) and high molecular weight PAHs (HMW PAHs), with the latter being more toxic and carcinogenic.<sup>51</sup> Fifteen PAHs were tested (5 LMW and 10 HMW) in nine samples from five areas (Dump, Trope, Sewage outfall, Powerhouse and Catchment), see Table 1, and found to exceed the lowest guideline value at three areas: Catchment, Dump and Trope areas. The highest values in both categories (LMW and HMW) were found at the Catchment area (Table 2). See Fig. 7 for results for HMW PAHs.

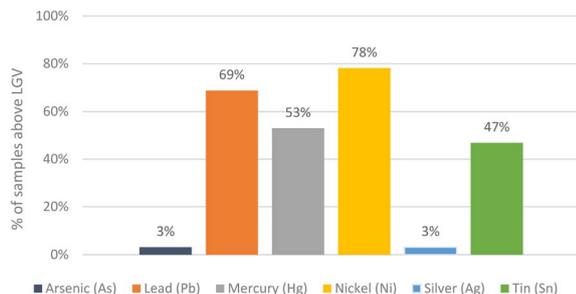
Fig. 8 Non-compliance with the lowest guideline value in samples of 6 primary trace elements, measured in 32 samples from the 10 areas chosen by the ESG for investigation at the H-2 area.<sup>10</sup>

Thirty-two samples were tested for 30 inorganic elements: four of the six primary trace elements were elevated at the sites: Pb, Hg, Ni, and Sn, with 47% to 78% of the samples exceeding the lowest guideline values, whereas silver and arsenic have less exceedance (3%). The five most impacted areas are the Catchment, Garage, Dump, Radome and Sewage outfall areas. The highest value for lead is at the Dump area (1700-fold), and lead is also high at the Radome and Garage areas (118-fold and 55-fold respectively), and Hg and Sn at the Catchment area (530-fold and 48-fold respectively). Many other inorganic elements were also above the lowest guideline values; for example

aluminium, antimony, cobalt, copper, iron, manganese, vanadium, and zinc were frequently above the guideline values. None of the six primary inorganic elements were above the guideline values at the Eiði farm area. However, ten other inorganic elements (not shown here) exceeded the lowest guidelines at the Eiði farm area, especially vanadium and antimony which were 50 and 20-fold higher than the lowest guideline values. Others were aluminium, chromium, cobalt, copper, iron, manganese, sulphur, and zinc, ranging from 2 to 7-fold higher (Fig. 8).
