Cite this: *Energy Environ. Sci.*,  
2025, 18, 264

## Removal of residual contaminants by minute-level washing facilitates the direct regeneration of spent cathodes from retired EV Li-ion batteries†

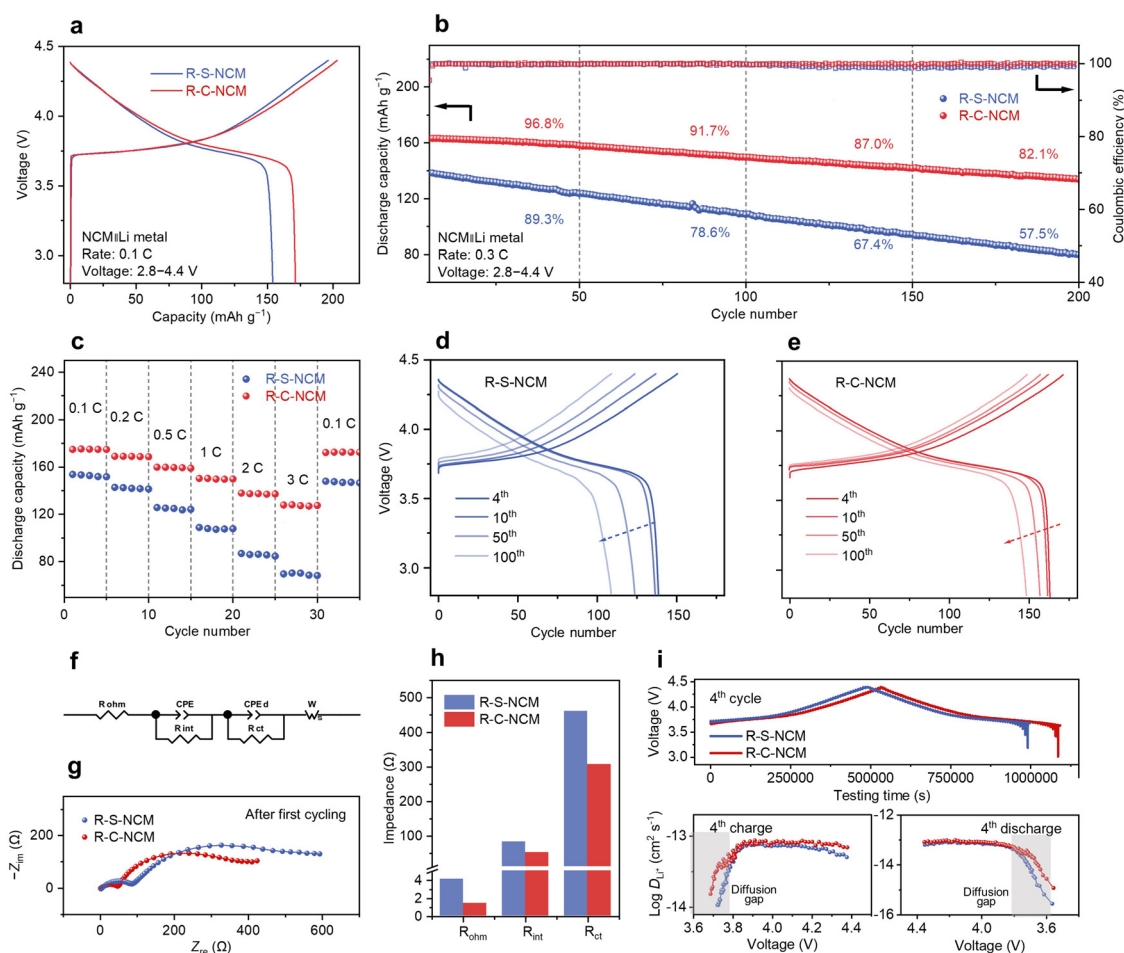
Fig. 4 Electrochemical deterioration for the regenerated NCM cathodes with impurity residue. (a) Initial galvanostatic charge–discharge curves of R-S-NCM and R-C-NCM at 0.1C (1C = 150 mA h g<sup>-1</sup>) and (b) long cycling test and capacity retention in a half-cell. (c) Rate capabilities of R-S-NCM and R-C-NCM. Charge–discharge curves of (d) R-S-NCM, (e) R-C-NCM in the voltage range of 2.8–4.4 V (vs. Li/Li<sup>+</sup>) at different cycles. (f) Equivalent circuit applied in the EIS measurements. Nyquist plots of (g) R-S-NCM and R-C-NCM and (h) fitting results showing the Ohmic resistance ( $R_{ohm}$ ), interface resistance ( $R_{int}$ ), and charge-transfer resistance ( $R_{ct}$ ). (i) GITT curves and the calculated Li<sup>+</sup>-diffusion rate of R-S-NCM and R-C-NCM for the 4th cycle number after activation in the same charge–discharge period. The shadow area indicates low Li<sup>+</sup> diffusion in a certain voltage range.

As shown in Fig. 4a and Fig. S30 (ESI<sup>†</sup>), the initial discharge capacity increased from  $154.1 \text{ mA h g}^{-1}$  for R-S-NCM to  $171.4 \text{ mA h g}^{-1}$  for R-C-NCM after the purifying treatment, although this was slightly lower than for P-NCM. In Fig. 4b and Fig. S31 (ESI<sup>†</sup>), the R-C-NCM cathode exhibit 91.7% and 82.1% capacity retention after 100 cycles and 200 cycles, respectively, compared with 91.6% and 78.3% for P-NCM, and 78.6% and

57.5% for R-S-NCM, indicating the R-C-NCM cathode had better cycling stability, even compared to the pristine one. As for the rate performance, the R-C-NCM cathode demonstrated a better high-rate capability (Fig. 4c and Fig. S30, ESI†) at 3C ( $127.8 \text{ mA h g}^{-1}$ ) compared to R-S-NCM ( $69.8 \text{ mA h g}^{-1}$ ) and P-NCM ( $108.9 \text{ mA h g}^{-1}$ ), which was commonly observed on the regenerated NCM cathodes and may be attributed to appropriate F element doping.<sup>12,47</sup> The plateau at  $\sim 3.6 \text{ V}$  in the voltage profiles (Fig. 4d and e and Fig. S30, ESI†) for R-S-NCM nearly disappears after 100 cycles, suggesting that R-S-NCM had a rising polarization after long-term cycling. Based on the cyclic voltammetry curves at different scan rates and calculations (Fig. S31 and Table S12, ESI†), the fitting line slope for R-S-NCM was found to be the lowest among all the samples. According to the equivalent circuit (Fig. 4f), the calculated impedance values ( $R_{\text{ohm}}$ ,  $R_{\text{int}}$ , and  $R_{\text{ct}}$ ) of R-C-NCM (Fig. 4g and h) were 1.4, 51.1, and  $307.1 \Omega$ , respectively, and were smaller than that of R-S-NCM. These results indicate the deteriorated kinetics of  $\text{Li}^+$  transportation due to the residual impurities, especially on the surfaces of the regenerated cathodes. According to the chemical state of the electrode surface (Fig. S32, ESI†), R-C-NCM exposed less inorganic fluoride and more lattice oxide, leading to the suppressed interfacial resistance growing during the long-term cycling. Furthermore, the galvanostatic intermittent titration technique (GITT) test also revealed the kinetic characteristics of the solid phase. The current pulse profile and calculated Li-ion diffusion coefficient ( $D_{\text{Li}^+}$ ) after activation are shown in Fig. 4i. The average  $D_{\text{Li}^+}$  values of R-C-NCM and R-S-NCM were calculated to be  $5.78 \times 10^{-14}$  and  $2.99 \times 10^{-14}$  for the charge process (and  $4.56 \times 10^{-14}$  and  $4.29 \times 10^{-14}$  for the discharge process), suggesting that residual impurities penetrating the interior bulk after regeneration hamper  $\text{Li}^+$  hopping within the lattice of the NCM cathode, as supported by the observed F element (Fig. 3c and Fig. S27, ESI†).
