Cite this: *Energy Environ. Sci.*,
2025, 18, 264

Removal of residual contaminants by minute-level washing facilitates the direct regeneration of spent cathodes from retired EV Li-ion batteries†

DOI: 10.1039/d4ee03021d

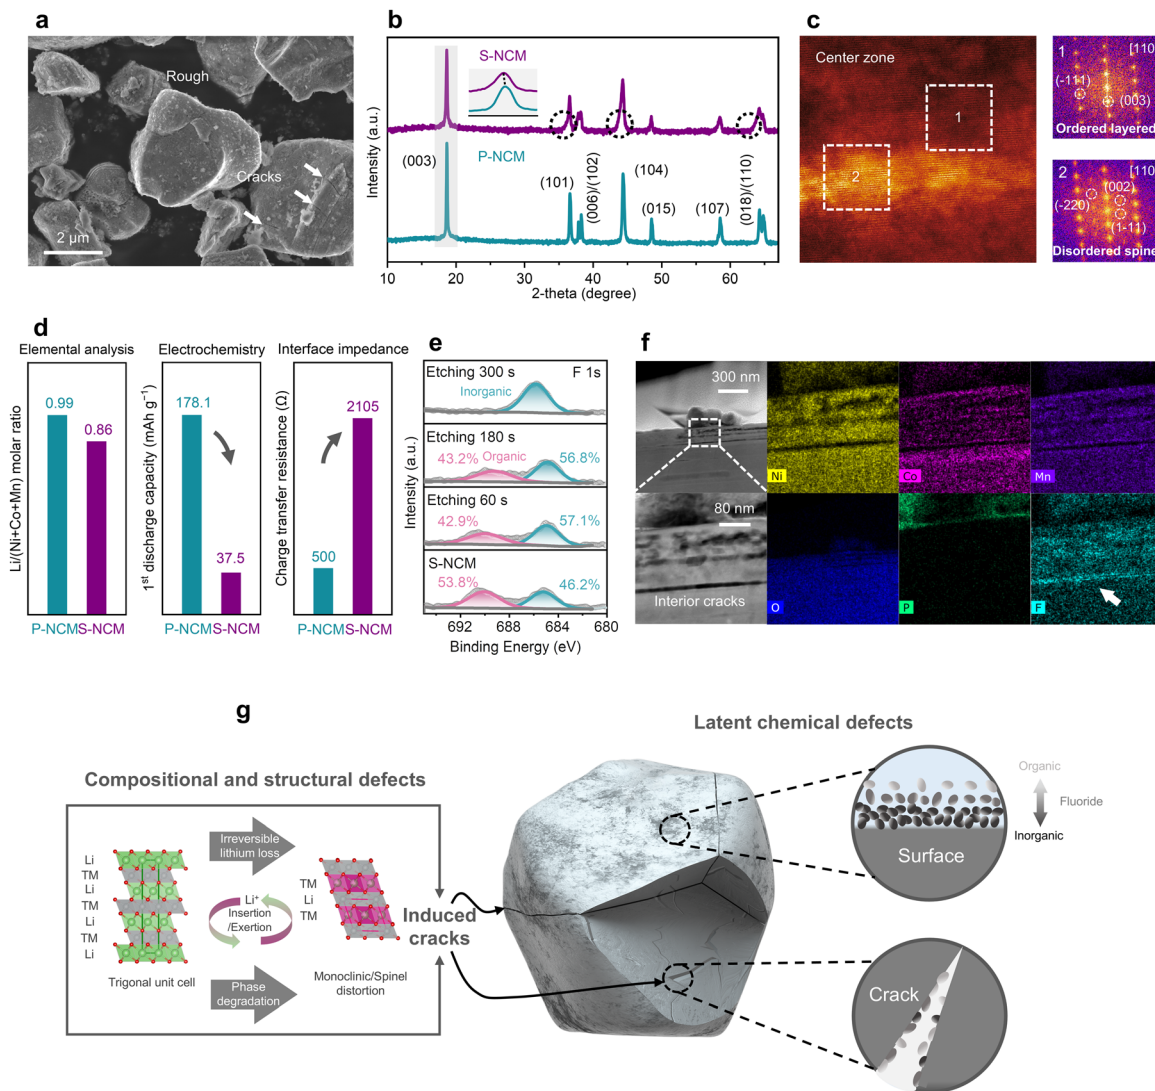
Fig. 1 Neglected chemical residuals on the 250k-miles-serviced cathode. (a) SEM image and (b) XRD pattern of the degraded S-NCM. The black dotted circle accentuates the subtle peaks that do not belong to the layered structure; (c) high-resolution HAADF-STEM images on the central area of the S-NCM particle and the FFT patterns of the selected dark and bright regions; (d) comprehensive comparison of lithium loss in degraded powders measured by ICP-OES, electrochemical capacity, and charge-transfer resistance analyses in the half-cell using S-NCM and P-NCM powders as cathode active materials; (e) F 1s XPS patterns of S-NCM powders for different sputtering times using an ion-beam. Based on the calculated integral area, the proportional values of the organics and inorganics in fluoride are presented in the patterns; (f) HAADF-STEM images based on focused ion beam cutting and an enlarged view displaying the interior microcracks. Corresponding EDS mapping analysis indicates the presence of F element along these microcracks pointed out by a white arrow. (g) Deficiencies of S-NCM addressed before direct regeneration, including the compositional and structural aspects (e.g., irreversible lithium-ionic loss, phase degradation, internal and external cracks) and latent chemical defects (e.g., surface and crack-edge impurities enriching the F element).

To understand the surface state of the spent cathode, energy-dispersive spectroscopy (EDS) element mapping and X-ray photoelectron spectroscopy (XPS) were conducted. As shown in Fig. S7–S9, and Tables S5, S6 (ESI[†]), the S-NCM cathode surface residuals consisted of C, O, F, and P elements, and displayed a surface-rich gradient distribution, as revealed

by XPS with etching. The F 1s XPS peaks with etching for S-NCM are shown in Fig. 1e, where two F 1s peaks could be observed before sputtering, with the major peak centered at 685.5 eV, which was attributed to inorganic fluorides and the minor F 1s peak centered at 690.4 eV, which could be assigned to organic fluorides, with the ratio of 53.8% for organic fluorides.²⁹ However, the organic-related F peak declined significantly after sputtering, and completely disappeared after 300 s Ar^+ sputtering. The surface-rich distribution of organic fluoride was consistent with the cathode electrolyte interphase (CEI) composition previously reported.^{29,30}

To further reveal the microscopic distribution of those F-rich residuals, SEM combined with time-of-flight secondary ion mass spectrometry (SEM-ToF-SIMS) characterization was conducted for the cycled cathode. The results are shown in Fig. S10 and Videos S1, S2 (ESI[†]). Based on the spatial distribution of F⁻ secondary ion fragments, it was confirmed that fluoride impurities were primarily deposited on the particle surface. Moreover, during the long-time battery service, it could be observed from the HAADF-STEM image and corresponding element mapping (see Fig. 1f) that, in the S-NCM cathode, the fluorides could spread into the interior of the cathode along the intragranular cracks. Coincidentally, from the selected FFT figure shown in Fig. S4 (ESI[†]), the existence of an amorphous ring was observed along the intragranular cracking, which may be related to the fluorides also observed in the bulk. To sum up, the collected S-NCM exhibited limited structural and compositional degradation, while preserving the fluoride-containing impurities aggregated on the surface and along the intragranular cracks, as illustrated in Fig. 1g.

Furthermore, it was previously widely accepted that the source of F-rich impurities in the spent cathode was due to decomposition of the PVDF binder during the heat delamination process at around 350 °C;^{11,23–25,31} however, during the thermal decomposition of PVDF, most the fluoride-containing products were gas species (*i.e.*, HF) and fragments (–CF– and –CH–CF–),^{32–34} which are subject to ejection instead of propagating along the cathode intragranular cracks. To confirm the source of those observed residual impurities, four kinds of cathodes with varying cycling conditions were collected and examined, namely cathode laminates with/without electrolyte filling, and laminates from 125k and 250k miles-serviced batteries, as listed in Table S7 (ESI[†]). The SEM images and electrochemical performance are shown in Fig. S11 and S12 (ESI[†]). Compared with the pristine one (sample A), the other spent cathodes from battery formation and cycling exhibited a rough surface and limited discharge capacity. Notably, the laminate from formation only but with no cycling (sample B), which it was believed would retain the full lithium inventory and show negligible structural degradation since it had not undergone charge/discharge cycling, showed a poor discharge capacity, which was the same as the other long-cycled ones. Moreover, the heat exfoliation used to pyrolyze the adhesive binders deteriorated the original CEI layer on the spent cathodes and generated more harmful byproducts (*e.g.*, Li₂CO₃, Li₃PO₄, LiF). This, combined with electrolyte decomposition during electrochemical cycling, exacerbates chemical degradation, resulting in a significant capacity decline. Therefore, the above comparison revealed that the cathode residual impurities should originate from the electrolyte components (such as LiPF₆, DMC, ethylene carbonate (EC)) decomposition during battery formation, cycling, and common heat exfoliation, leading to severe capacity loss in spent cathodes (Fig. 1d).
