Energy & Environmental Science

DOI: 10.1039/d4ee03021d

Removal of residual contaminants by minute-level washing facilitates the direct regeneration of spent cathodes from retired EV Li-ion batteries†

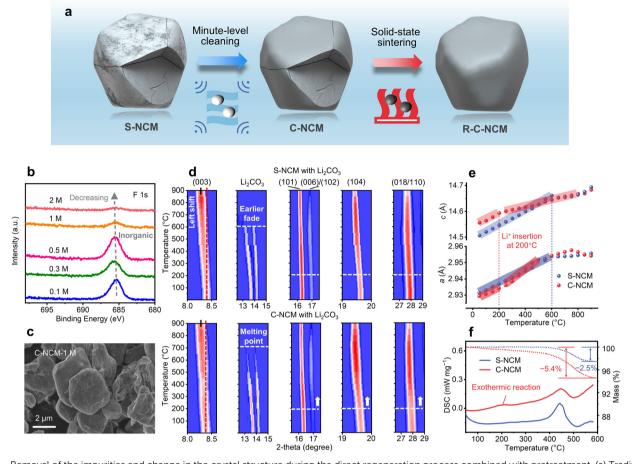
Fig. 2 Removal of the impurities and change in the crystal structure during the direct regeneration process combined with pretreatment. (a) Traditional direct regeneration path using solid-state sintering and the minute-level pretreatment introduced in an advanced path targeted to the critical obstacles within degraded cathode materials; (b) F 1s XPS fine patterns of C-NCM undergoing ultrasonic stirring in solutions with different concentrations; (c) SEM image of C-NCM obtained by soaking S-NCM in 1 M HNO₃ solution; (d) partial in situ XRD patterns of S-NCM and C-NCM mixed with a Li resource, keeping a constant heating rate (20 °C min⁻¹) and holding the temperature for diffraction at 50 °C intervals; (e) evolution of the unit cell parameters a and c for S-NCM (blue symbols) and C-NCM (red symbols) mixed with Li slate through Rietveld refinement. The earlier Li⁺ insertion at 200 °C changed the variation tendency of the unit parameters for the sample after cleaning. (f) Heat generation measured by DSC from mixtures.

morphology of the cathode remained unchanged, which may be related to the Li⁺/H⁺ exchange mechanism with the stabilizing lattice structure. 40,41 Moreover, as shown in Fig. 2b and Fig. S22 (ESI†), based on the charge/discharge efficiency, we further optimized the solution concentration as 1 M in the following investigations.

To reveal the effect of the residuals during the direct regeneration of the recycled cathode, in situ XRD characterizations were compared following the regeneration of S-NCM and C-NCM. During the heating, the unit cell lattice first nearly linearly expanded until there was a differentiation of the expansion ratio caused by the lithium insertion. As shown in Fig. 2d, the shift of the (003) peak of C-NCM was less pronounced than that of S-NCM when heating to 900 °C, indicating its unit cell lattice c was not expanded as much as for the S-NCM due to its more efficient lithium insertion. Therefore, more lithium insertion was observed for the C-NCM cathode. Correspondingly, the Li₂CO₃ in the mixture of S-NCM and C-NCM also performed differently, whereby the Li₂CO₃ in the

C-NCM cathode was consumed gradually until it disappeared at its melting point around 730 °C, while the Li₂CO₃ in the S-NCM cathode completely vanished at around only 600 °C, and this earlier consumption of the lithium source may be attributed to the reaction between Li₂CO₃ and the residual impurities (such as LiF, LiOH, and Li₃PO₄) by co-melting, vaporizing, and replenishing in S-NCM.42 Equivalently, the high angle reflection peak intensity spanning from (006) to (110), representing the layered structure, significantly increased starting from around 200 °C for the C-NCM cathode after the purifying treatment compared to there being no obvious enhancement for S-NCM, indicting the better repair of the layered structure during heating. To further unveil the underlying mechanism, Rietveld refinement of each XRD pattern was conducted, which can depict the continuous change of the unit cell parameters during regeneration. Generally, the unit cell parameter c decreases and a increases with the insertion of Li ions into a layered structure, similar to in the discharge process.²⁸ As shown in Fig. 2e, the lattice evolution of the S- and C-NCM

cathodes were compared. For C-NCM, the lattice c expansion slope became obviously flatter at 200 $^{\circ}$ C, denoting a lattice cshrinkage at this temperature induced by the Li-ion insertion and repairing. However, for the S-NCM without undergoing purifying treatment for the residuals, the lattice expanded still nearly linearly with no obvious lithium insertion until 600 °C. Concurrently, the lattice a expansion slope became steeper at 200 °C for C-NCM. Last but not least, Differential scanning calorimetry (DSC) characterization was also conducted during the regeneration process to confirm the lithium insertion pattern for the S- and C-NCM cathodes, which can trace the lithium replenishment associated with the exothermic reaction as reported by others. 43 As shown in Fig. 2f, the characteristic exothermic reaction at around 200 °C was only observed for C-NCM, confirmed the earlier lithium insertion after the purifying treatment. The earlier lithium insertion was also supported by the CO₂ gas release observed during Li₂CO₃ decomposition to supply the lithium source for the C-NCM cathode, as shown Fig. S23 (ESI†). Moreover, from the thermogravimetric results shown in Fig. 2f, the weight loss of C-NCM was 5.4%, which was significantly larger than that of S-NCM of 2.5%, indicating that more Li₂CO₃ was activated and decomposed to provide the lithium source for C-NCM. 43,44 To sum up, through multiple in situ and ex situ characterizations, we proved that, with a purifying pretreatment, the direct regeneration could be facilitated to start at a lower temperature of 200 °C from the spent cathode.

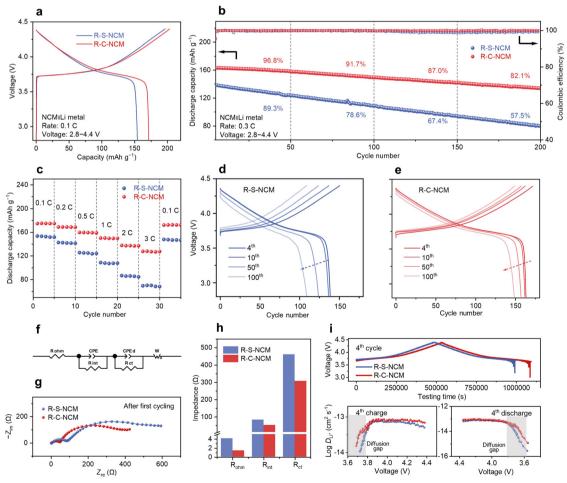
Fig. 4 Electrochemical deterioration for the regenerated NCM cathodes with impurity residue. (a) Initial galvanostatic charge-discharge curves of R-S-NCM and R-C-NCM at 0.1C (1C = 150 mA h g^{-1}) and (b) long cycling test and capacity retention in a half-cell. (c) Rate capabilities of R-S-NCM and R-C-NCM. Charge-discharge curves of (d) R-S-NCM, (e) R-C-NCM in the voltage range of 2.8-4.4 V (vs. Li/Li⁺) at different cycles. (f) Equivalent circuit applied in the EIS measurements. Nyquist plots of (g) R-S-NCM and R-C-NCM and (h) fitting results showing the Ohmic resistance (Rohm), interface resistance (R_{int}), and charge-transfer resistance (R_{Ct}). (i) GITT curves and the calculated Li⁺-diffusion rate of R-S-NCM and R-C-NCM for the 4th cycle number after activation in the same charge-discharge period. The shadow area indicates low Li⁺ diffusion in a certain voltage range.

As shown in Fig. 4a and Fig. S30 (ESI†), the initial discharge capacity increased from 154.1 mA h g⁻¹ for R-S-NCM to 171.4 mA h g^{-1} for R-C-NCM after the purifying treatment, although this was slightly lower than for P-NCM. In Fig. 4b and Fig. S31 (ESI†), the R-C-NCM cathode exhibit 91.7% and 82.1% capacity retention after 100 cycles and 200 cycles, respectively, compared with 91.6% and 78.3% for P-NCM, and 78.6% and

57.5% for R-S-NCM, indicating the R-C-NCM cathode had better cycling stability, even compared to the pristine one. As for the rate performance, the R-C-NCM cathode demonstrated a better high-rate capability (Fig. 4c and Fig. S30, ESI†) at 3C (127.8 mA h g^{-1}) compared to R-S-NCM (69.8 mA h g^{-1}) and P-NCM (108.9 mA h g⁻¹), which was commonly observed on the regenerated NCM cathodes and may be attributed to appropriate F element doping. 12,47 The plateau at ~ 3.6 V in the voltage profiles (Fig. 4d and e and Fig. S30, ESI†) for R-S-NCM nearly disappears after 100 cycles, suggesting that R-S-NCM had a rising polarization after long-term cycling. Based on the cyclic voltammetry curves at different scan rates and calculations (Fig. S31 and Table S12, ESI†), the fitting line slope for R-S-NCM was found to be the lowest among all the samples. According to the equivalent circuit (Fig. 4f), the calculated impedance values ($R_{\rm ohm}$, $R_{\rm int}$, and $R_{\rm ct}$) of R-C-NCM (Fig. 4g and h) were 1.4, 51.1, and 307.1 Ω , respectively, and were smaller than that of R-S-NCM. These results indicate the deteriorated kinetics of Li⁺ transportation due to the residual impurities, especially on the surfaces of the regenerated cathodes. According to the chemical state of the electrode surface (Fig. S32, ESI†), R-C-NCM exposed less inorganic fluoride and more lattice oxide, leading to the suppressed interfacial resistance growing during the long-term cycling. Furthermore, the galvanostatic intermittent titration technique (GITT) test also revealed the kinetic characteristics of the solid phase. The current pulse profile and calculated Li-ion diffusion coefficient (D_{Li^+}) after activation are shown in Fig. 4i. The average D_{Li^+} values of R-C-NCM and R-S-NCM were calculated to be 5.78 \times 10^{-14} and 2.99×10^{-14} for the charge process (and 4.56×10^{-14} and 4.29×10^{-14} for the discharge process), suggesting that residual impurities penetrating the interior bulk after regeneration hamper Li⁺ hopping within the lattice of the NCM cathode, as supported by the observed F element (Fig. 3c and Fig. S27, ESI†).

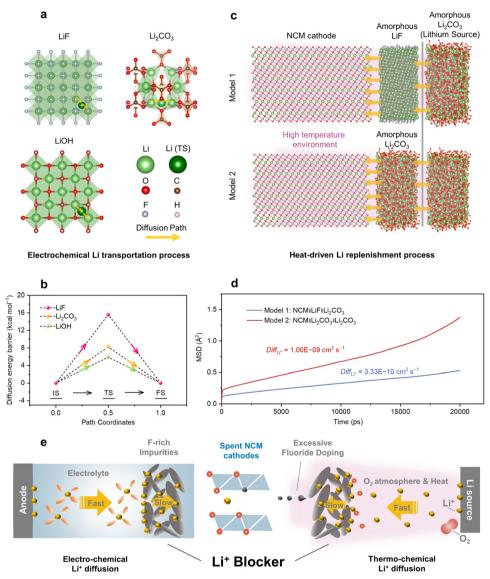
Fig. 5 Role of the F-rich impurities as a blocker in electrochemical and thermochemical Li⁺ diffusion as ascertained from thermodynamic and kinetic simulations. (a) Illustrations of the selected migration pathways with a similar distance for Li⁺ inside the crystal lattice of three common components. The initial state, transition state, and final state of Li⁺ transportation are denoted as IS, TS, and FS, respectively. (b) Calculated energy diffusion barrier for Li ions in selected phases. (c) Two models for stimulating the kinetics of Li transportation in direct regeneration. Model 1 consists of the NCM cathode substrate, the amorphous LiF layer, and Li_2CO_3 as a lithium source in direct regeneration, which is denoted as $\text{NCM} \| \text{Li}_F \| \text{Li}_2\text{CO}_3$. In Model 2 ($\text{NCM} \| \text{Li}_2\text{CO}_3 \| \text{Li}_$ short), the middle LiF layer is replaced by a common residual alkali (Li₂CO₃), which is used to simulate the regeneration of NCM cathodes after cleaning pretreatment. Each shape symbol is the same as for Fig. 5a. (d) MSD of the Li atoms in 20 ns and calculated Li⁺ diffusivity based on the above model. "E – $9^{\prime\prime}$ means 10^{-9} . (e) Mechanism diagram for preventing the NCM cathodes from reusing and directly regenerating under the influence of impurities.

According to the above results (Fig. 1d, Fig. S6, S16 (ESI†), and Fig. 4h, i), the migration rate of lithium ions was significantly influenced by the residual impurities; therefore it was crucial to theoretically investigate their influence on capacity delivery in the reuse case and during direct regeneration. Considering the impurities were mostly concentrated at the surface before and after regeneration, and that F-rich residuals could be observed, as shown in Fig. S9 and S10 (ESI†) and Fig. 3c, we chose three representative inorganic components (LiF, Li2CO3, and LiOH) in the CEI layer⁴⁸ or residual alkali⁴⁹ to calculate the Li⁺ diffusion from a thermodynamic perspective, and their structures are shown in Fig. 5a. By maintaining a similar distance and concentration of mobile Li-ions, the diffusion energy barrier of lithium ions (ΔE_{Li^+}) during the cycling of spent cathodes within the different crystal structures (Fig. 5b) allowed valid comparisons. We found that the ΔE_{Li^+} of the LiF phase, as a common inorganic component from CEI, was about 2 and 3 times higher than that of the LiOH and Li₂CO₃ phases from

Fig. 5b. Therefore, this result confirmed that the presence of fluoride-rich impurity residuals on the cathode surface significantly increased the diffusion resistance of Li ions when cycling, ultimately exacerbating the cell impedance and interfacial parasitic reactions (Fig. 1d). To comprehend the largerscale kinetic characteristics and understand the effect of impurity coatings during heating for regeneration of the spent cathodes, two molecular dynamics models were established for simulating Li⁺ transportation at 1000 K over 20 ns. Specifically, Model 1 was devised to include an impurity barrier consisting of a LiF layer (Fig. 5c and Fig. S33, ESI†). Through computing the mean square displacement (MSD) of Li atoms and fitting curves (Fig. 5d), we determined that the Li diffusivity (Diff_{Li}+) of Model 1 was 3.33×10^{-10} , which was an order of magnitude lower than that of Model 2 (1.00 \times 10⁻⁹). The differences in molecular dynamics models under practical conditions suggest that fluoride-rich impurity coatings increase the resistance to Li-ion diffusion into spent cathodes with Li deficiencies during thermo-driven regeneration, leading to inadequate compositional and structural recovery.

As illustrated in Fig. 5e, the impurity phase containing the F element served as an electro- and thermo-diffusion blocker of Li ions hindering the reuse and direct regeneration of the spent cathode. In the spent cathodes collected by physical pretreatment and collection from used lithium-ion batteries, the ubiquitous electrolyte was decomposed to form an ion barrier with slow ion diffusivity. However, these impurities have long been overlooked in most studies (Table S2, ESI†), mainly due to the use of lab-scale degraded cathodes and fine manual separation pretreatment. In previous studies, 12-16,42 the latent impact of the residual impurities on direct regeneration remains untouched because impurities are easily converted into other inconspicuous matter in extreme physical or chemical regeneration environments. Looking ahead, the direct regeneration of nextgeneration sensitive cathode materials, such as Li-rich Mnbased, Co-free, and ultra-high-Ni cathode materials, faces serious challenges from these latent impurities if they enter the recycling circle. From another perspective, establishing the controlling law for the inherent impurities doping within the closed-loop material flow could instructively enhance the performance of such recycled materials in the future. Moreover, only by revealing the effect of the overlooked impurities or by getting rid of impurities, can evolving technologies and mechanisms for direct regeneration and upcycling be reasonably evaluated.50
