# Epoxy–glass fibre composite splash ring suppresses metal-derived lubricant contamination in splash lubrication systems

Metallic components used in splash-lubricated mechanical systems can generate wear debris that accelerates lubricant degradation and contaminates the oil. In this work, a fibre-reinforced epoxy–glass composite splash ring was developed as a nonmetallic alternative to a conventional brass component. The composite ring was fabricated and evaluated in a laboratory lubrication rig operating at 3000 rpm for long-duration tests up to 1000 h. Oil samples were analysed using atomic absorption spectrometry, total acid number measurements, and gravimetric wear analysis, while surface morphology was examined by scanning electron microscopy. The composite component eliminated detectable Cu and Zn contamination in the lubricant and reduced oil oxidation, while increasing oil flow rate by approximately 66% compared with the brass reference component. The improved performance is attributed to the chemical inertness and favourable tribological behaviour of the epoxy–glass composite, which suppresses metal-catalysed oxidation reactions and reduces the generation of wear particle

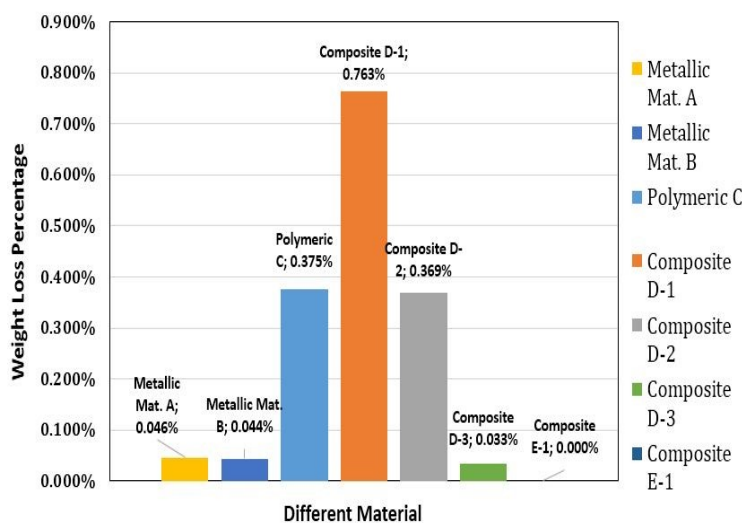
Figure 2: Comparative gravimetric mass loss (% relative to initial ring mass) of epoxy–glass composite (E1), copper alloy (CuZn30), and HDPE rings after 500 h of continuous operation at 3000 rpm in ISO VG 68 mineral oil. Error bars represent ±1 SD (n = 3 independent runs). The composite ring showed no statistically significant mass loss above the analytical balance detection limit (0.0001 g).

below the detection limit of the analytical balance, as opposed to the copper alloy ring, which lost 0.763±0.012% of its initial mass (n = 3), whereas the composite ring showed mass loss below the 0.0001 g detection limit. (Fig. 2)<sup>49,50</sup>. The reported concentrations are above the method LOQ for all elements and are based on a validated AAS procedure for this oil matrix, as detailed in Section 2. Prior to each new test, the rig was cleaned using the decontamination protocol described in Section 2.2.1, and residual Cu, Zn and Fe levels in the final flushing oil were below 10 ppm, confirming that the measured differences between ring materials are not due to cross-contamination from previous runs.

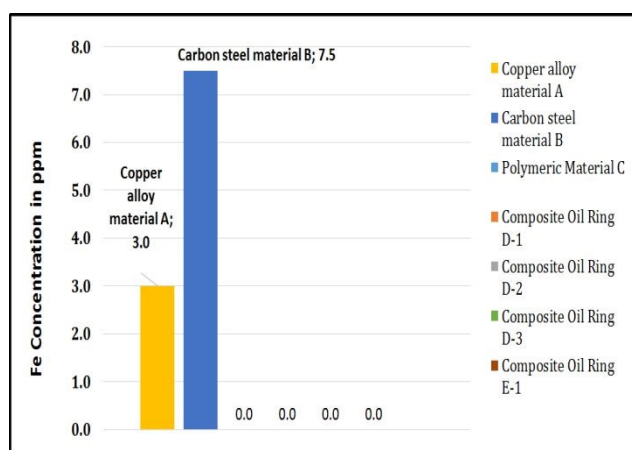
Figure 3: Iron (Fe) concentration (ppm) in ISO VG 68 mineral oil after 500 h of operation at 3000 rpm with copper alloy (CuZn30) and epoxy-glass composite (E1) rings, determined by GF-AAS. Values are mean  $\pm$  SD ( $n = 3$ ). The dashed line indicates the method limit of quantification (LOQ = 0.15 ppm). Corresponding Cu and Zn data are presented in Table 3.

These results correlate directly with the analysis of the lubricant. The oil used with the copper ring was found heavily loaded with metallic particulate: AAS detected 241.3±10.2 ppm and 567.7±22.4 ppm with the copper ring, whereas all metallic species remained below the detection limit (0.1 ppm) with the composite (n = 3) (Table 3). To fully appreciate the drastic differences in the TAN results, the specific chemical mechanism of metal-catalysed oil oxidation must be considered. Mineral oil degradation is fundamentally a self-accelerating autoxidation process driven by free-radical chain reactions<sup>51</sup>. Under normal operational thermal stress, the hydrocarbon base oil naturally forms hydroperoxides as primary oxidation intermediates<sup>52</sup>. Transition metals, such as copper and zinc, released by the mechanical wear of the brass ring, act as highly active catalysts that artificially accelerate the decomposition of these hydroperoxides. Through continuous electron

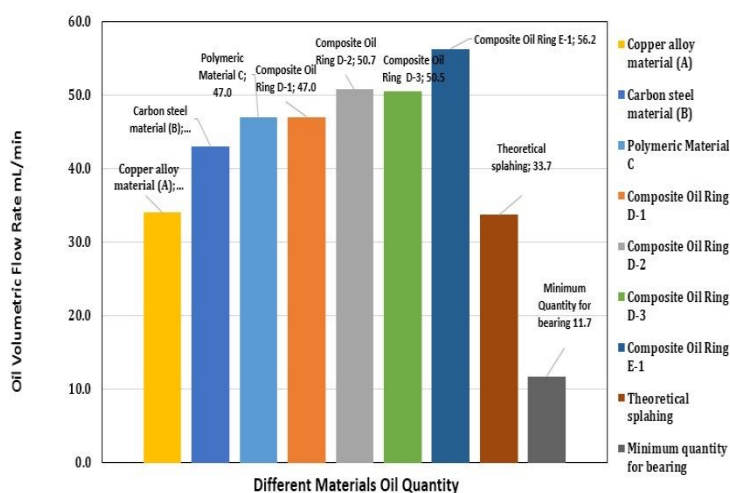
Figure 6: Average oil flow rate delivered to the bearings by copper alloy and epoxy–glass composite rings at 3000 rpm, showing a 66% increase for the composite ring.

The most crucial aspect of performance improvement is a significant increase in oil delivery. On this basis, TAN was selected as a primary indicator of lubricant health to compare the impact of the composite and copper-alloy splash rings. In Table 3, the composite ring increased the mean oil flow rate from  $35 \pm 2$  to  $58 \pm 3$  ( $n = 5$ ,  $p < 0.01$ ) (Fig. 6)<sup>6</sup>. This performance can be attributed directly to the material's fundamental properties and the system's governing dynamics. At only 12.20 g, the composite ring has a mass reduction of 89% compared to the copper ring's 107.75 g. As per the principles of rotational dynamics, a body with lower inertia can be accelerated more easily and will

respond more readily to driving forces. In this system, the lighter composite ring is able to maintain a higher average angular velocity ( $Nr$ ) as it is carried by the shaft, experiencing less slippage and erratic motion. From what the theoretical equation for oil splash quantity ( $Q$ ) shows, the splashed oil quantity has a direct relationship with the peripheral speed ( $U$ ) of the ring, which is dependent on the factor  $Nr$ . This indicates that higher rotational speeds of the light, ring-like component can lift greater quantities of oil and splash it onto the bearings. An increased lubricant flow allows the use of convective heat transfer to remove heat from the bearings, resulting in a lower operating temperature.

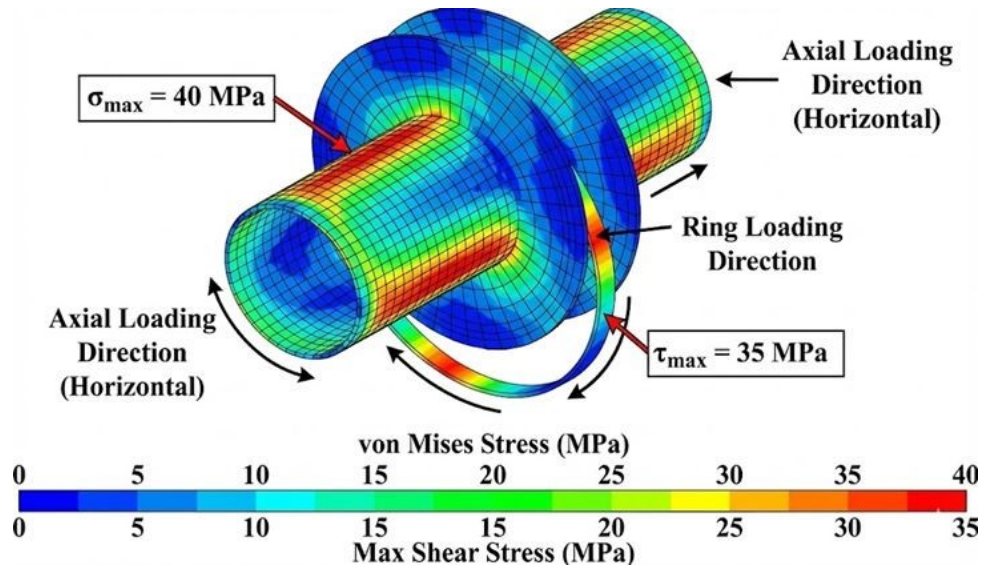
Figure 8: Finite element analysis (FEA, GT STRUDEL) stress distribution on the shaft and epoxy–glass composite oil splash ring ( $E = 7.2$  GPa,  $\nu = 0.32$ ) under combined loading: radial load 17 kN and axial load 45 kN. Colour contours show von Mises stress (MPa): maximum of 40 MPa on the shaft surface and maximum shear stress of 35 MPa within the ring body. Peak stress occurs at the inner-diameter fillet (stress concentration factor  $K_t = 1.95$ ). The material compressive strength is 155 MPa, giving a structural safety factor of 1.67.

The structural soundness of the design was confirmed using Finite Element Analysis (FEA). Maximum expected radial and axial loads were applied to the computational model, predicting a maximum shear stress of 30 MPa within the composite ring<sup>64</sup>. This value is comfortably below the maximum allowable stress, already established at 50 MPa for the material, yielding a safety factor of approximately 1.67 and ensuring the ring is designed to withstand operational forces without risk of structural failure (Figs. 8 and 9).

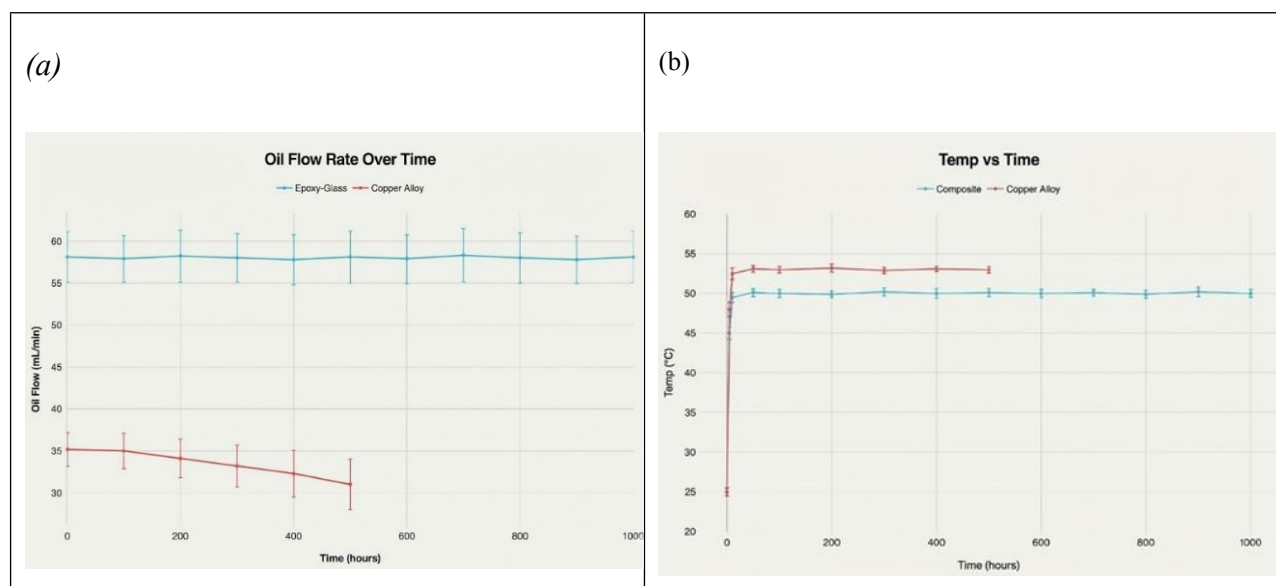
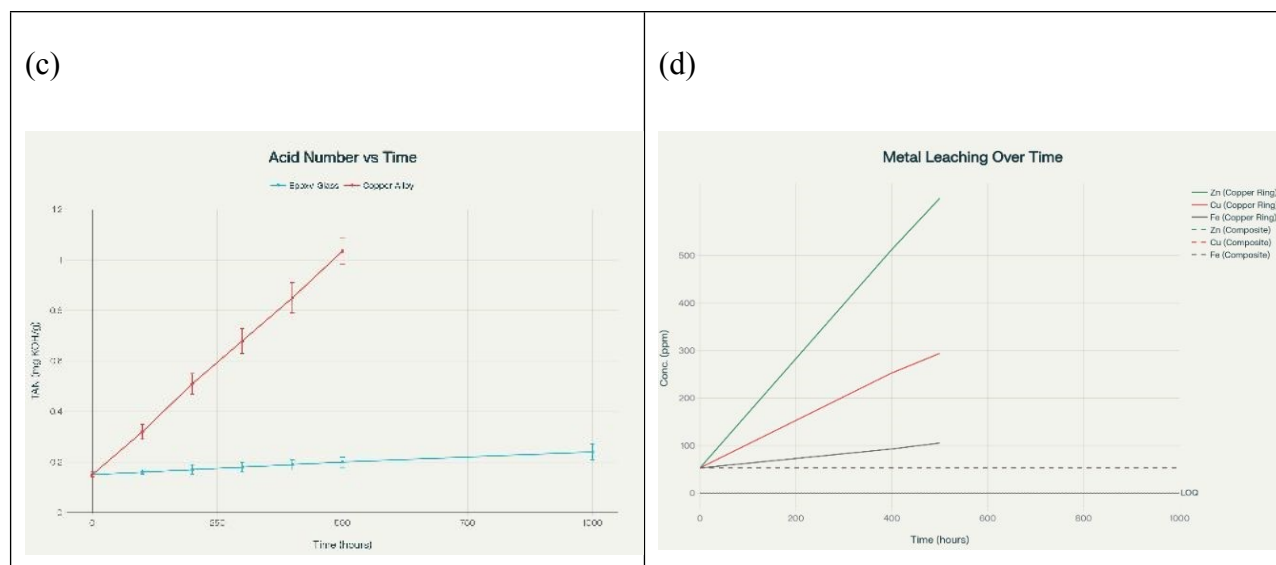
Figure 11: Long-term performance metrics for copper alloy (CuZn30, filled symbols) and epoxy-glass composite (E1, open symbols) oil splash rings operating at 3000 rpm in ISO VG 68 mineral oil. All data are mean  $\pm$  1 SD ( $n = 3$  independent runs). (a) Oil flow rate (mL/min) delivered to bearings versus test duration (h). Composite ring: stable at  $58 \pm 3$  mL/min; copper ring: declining from  $\sim 35$  to 31 mL/min. (b) Bearing housing temperature ( $^{\circ}\text{C}$ ) versus time (h). Composite ring stabilises at  $50.0 \pm 0.5^{\circ}\text{C}$ ; copper ring at  $53.0 \pm 0.4^{\circ}\text{C}$  ( $p < 0.01$ , two-sample t-test). (c) Total Acid Number (TAN, mg KOH/g) of ISO VG 68 lubricant versus time. Fresh oil baseline: 0.15 mg KOH/g. Composite ring: TAN = 0.24 mg KOH/g at 1000 h; copper ring: TAN = 1.035 mg KOH/g at 500 h, exceeding the typical condemnation limit ( $\sim 1.0$  mg KOH/g). (d) Dissolved metallic wear element concentrations (ppm) versus time determined by GFAAS: Cu (circles), Zn (squares), and Fe (triangles). Composite ring: all elements below LOQ (0.1 ppm) at all time points; copper ring: Cu = 241.3 ppm, Zn = 567.7 ppm, Fe = 52.5 ppm at 500 h

Figure 11a illustrates the evolution of oil flow rate delivered by the splash rings over the test duration. For the composite ring, the oil flow rate remained essentially constant at  $58 \pm 3$  mL/min over 0–1000 h, with no statistically significant linear trend (slope not different from zero at  $\alpha = 0.05$ ). In contrast, the copper ring showed a gradual decline from approximately  $35 \pm 2$  mL/min at 100 h to  $31 \pm 3$  mL/min at 500 h, consistent with progressive wear and reduction in ring width. This stable performance of the composite ring over the extended 1000-hour period confirms its superior long-term lubrication reliability compared to the metallic benchmark.

Figure 11c tracks the chemical degradation of the lubricant over time. For the composite ring, TAN remained almost unchanged from its initial value ( $\approx 0.15$  mg KOH/g) up to 500 h and increased only slightly to  $\approx 0.24$  mg KOH/g by 1000 h, remaining well below typical condemnation limits. In contrast, the copper alloy ring induced a rapid increase in TAN to  $\approx 1.035$  mg KOH/g by 500 h, indicating accelerated oxidation and acid formation. These trends show that, over 500–1000 h, the composite ring does not cause noticeable additional oil degradation beyond the baseline ageing of the lubricant, effectively preventing the catalytic oxidation cycle associated with metallic wear debris.

Figure 11d compares the accumulation of metallic wear debris in the lubricant. With the copper ring, Cu and Zn concentrations increased approximately linearly with time, reaching several hundred ppm (567.7 ppm Zn, 241.3 ppm Cu) by 500 h, while Fe also rose to  $\approx 52.5$  ppm due to shaft and bearing wear. For the composite ring, all three metals remained below the method LOQ ( $< 0.1$  ppm) at all time points, indicating that no detectable metallic wear debris accumulated even during extended operation. This confirms that replacing the metallic ring eliminates the primary source of catalytic metals in the oil.

Beyond the absence of measurable metallic contamination, a complete assessment of lubricant cleanliness requires consideration of whether the composite ring itself releases nonmetallic particulates, specifically, epoxy matrix fragments and E-glass fibre splinters, into the oil during long-term operation. Three categories of nonmetallic debris are physically possible from the E1 ring system: (i) epoxy matrix flakes, produced by adhesive and fatigue wear at the ring–shaft contact zone and liberated as low-density, irregularly shaped fragments with Vickers hardness of ~15–25 HV; (ii) E-glass fibre end-fragments, produced by fibre pull-out at individual asperity contacts and potentially angularly shaped with hardness ~500–600 HV; and (iii) nanoscale silane sizing residue, detached from fibre surfaces at sub-LOQ concentrations during interfacial micro-sliding events. The gravimetric wear data provide a direct upper-bound estimate of the total nonmetallic debris dose: the composite ring lost 0.73 mg over 1000 h into a 2.5 L oil sump, corresponding to a maximum theoretical debris concentration of 0.29 ppm by mass, assuming conservatively that the entire wear mass exists as discrete suspended particles rather than surface transfer films. This concentration is three to four orders of magnitude below the metallic contamination levels measured in the brass ring oil samples (Cu: 412 ppm, Zn: 387 ppm at 1000 h) (Fig. 11d), and is negligible relative to any established particulate cleanliness threshold for rolling element bearing lubrication systems. At this concentration, even if all composite debris particles were at the coarsest end of the wear-generated size spectrum (~100  $\mu\text{m}$  glass fibre fragments), the total particle number in the oil sump would be insufficient to populate a measurable count in an ISO 4406 particle counter, an inference that is consistent with the stable bearing housing temperature and oil flow rate recorded throughout the 1000 h test, both of which are sensitive indicators of progressive lubricant contamination (Fig. 11a, b).
