Analytical Methods

Analytical study to evaluate the origin and severity of damage caused by salt weathering in a Historical Palace House: The attack of infiltration waterOlivia Gómez-Laserna,*^a Nagore Prieto-Taboada,^a Héctor Morillas,^a Iker Arrizabalaga,^a M^a Angeles Olazabal,^a Gorka Arana^a and Juan Manuel Madariaga^a*Received (in XXX, XXX) Xth XXXXXXXXX 20XX, Accepted Xth XXXXXXXXX 20XX*

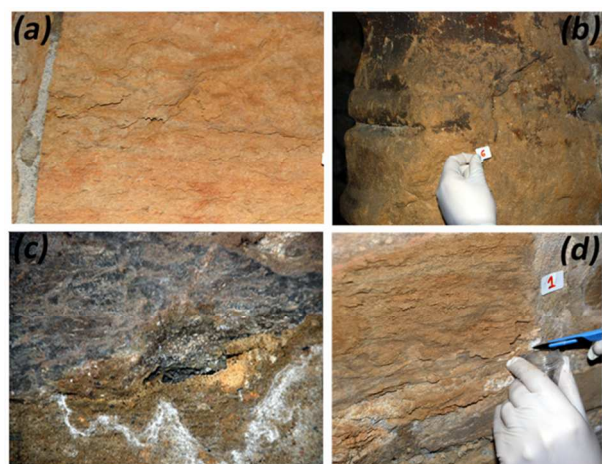
Fig. 2 Photographs of the deterioration observed in the Palace House; (a) Details of flaking over sandstone of the central courtyard, (b) Sandstone structural column details of the central courtyard, (c) Enlargement of the salts front with an important material loss, in the first instance, (d) Details of efflorescences and subefflorescences over sandstone of the central courtyard.

In samples visibly affected by salts (Fig. 2a, 2b) the total content of salt shows percentages above 35%. However, values less than 35% were found in samples that apparently did not showed efflorescences or visible damage, exceeding the limit of 10% considered as gravely polluted according to the UNI standard²⁴. These high percentages, similar to values observed in Venice²⁴, could be caused by dissolution of the main component, in this case calcite. An acid pH is required for this to happen, which in this case is easily reachable by the acid infiltration water of the area, whose pH values were between 5.7 and 6.4 during the samplings carried out.

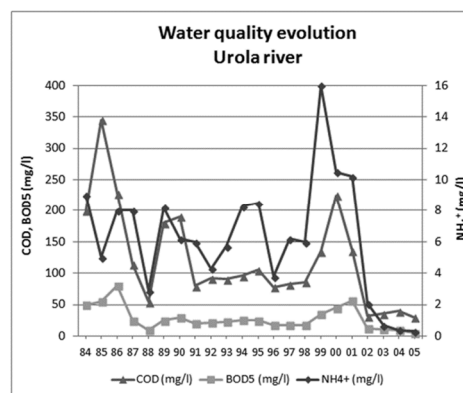
Fig.3 Historic values of ammonium, Chemical and Biochemical oxygen demand (COD and BOD₅, respectively) observed in the Urola River. Information extracted from the report of Gipuzkoa County Council, Department for Sustainable Development, Directorate General of Hydraulic Works¹⁴.

observed (Fig.3), probably derived from industry and agricultural activities¹⁴. Therefore, the ground water that could infiltrate in the building constructed close to the water table is probably rich in nitrates as consequence of the rural activity. Besides, its salt content could be increased by ground leachate or even by dragged from other building materials.

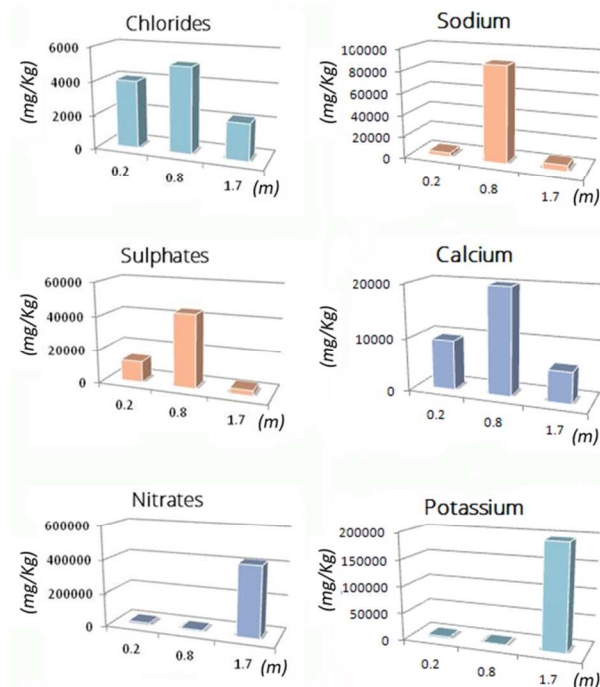
Fig.4 Average of ion content determined by ion chromatography at different heights in the walls at the test site.

According to the discussion of the results, its origin appears to be related to the acid infiltration water action over limestone and mortar materials. Therefore, as source of potassium, the hydrolysis of the aluminum silicate was studied first (Fig 6a). The mass fraction diagram of potassium shows that its hydrolysis starts at pH values lower than 8, which are easily reached by common infiltration waters. In addition, given the presence of a high concentration of ammonium in the waters of this region, the release of potassium is evident (Fig 4).

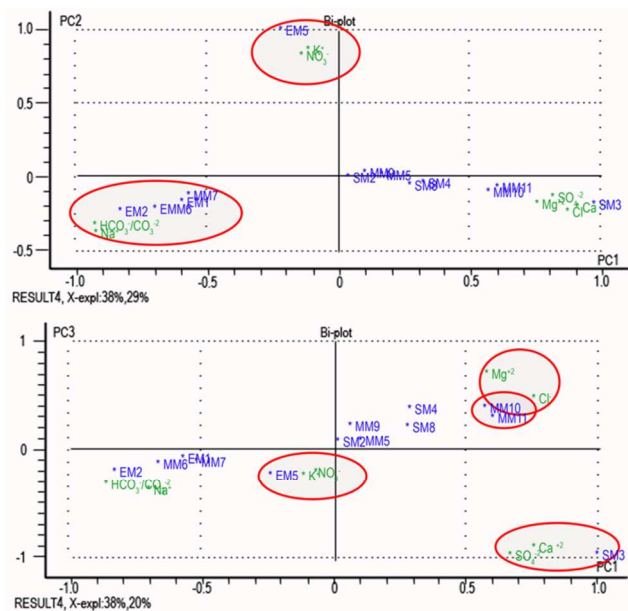
Fig.5 PCAs carried out by Unscrambler . a) Representation of PC1 vs PCA2 of the results obtained by ion chromatographic b) PC1 vs PCA3. Representation of groups formed according to the main three principal components are highlighted: carbonate, nitrates, sulphates and chloride.

The obtained Principal Component Analysis (PCA) explained 87% of the variance, using 3 PCAs to simplify the system. As can be seen in Figure 5, some salts formation is suggested with the grouping of three clusters; sodium and carbonate, potassium and nitrate and magnesium and chloride.

Potassium is only correlated with nitrate ($r = 0.999$) and, the proximity of EM5 (Fig 5), efflorescence of the front salt, indicates its main composition. The origin of potassium could be related to two different sources, salt content of the infiltration water and/or it could correspond to an original compound of mortar and limestone. Therefore, this formation mechanism will be studied later in depth.
