**Testing methods for new pit latrine designs in rural and peri-urban areas of Malawi where conventional testing is difficult to employ**

Journal:	<i>Environmental Science: Water Research &amp; Technology</i>
Manuscript ID	EW-ART-10-2015-000246.R3
Article Type:	Paper
Date Submitted by the Author:	20-Apr-2016
Complete List of Authors:	Chidya, Russel; Mzuzu University Holm, Rochelle; Mzuzu University Tembo, Mavuto; Mzuzu University Cole, Ben; Murdoch University Workneh, Paulos ; UNICEF Malawi Kanyama, John ; UNICEF Malawi

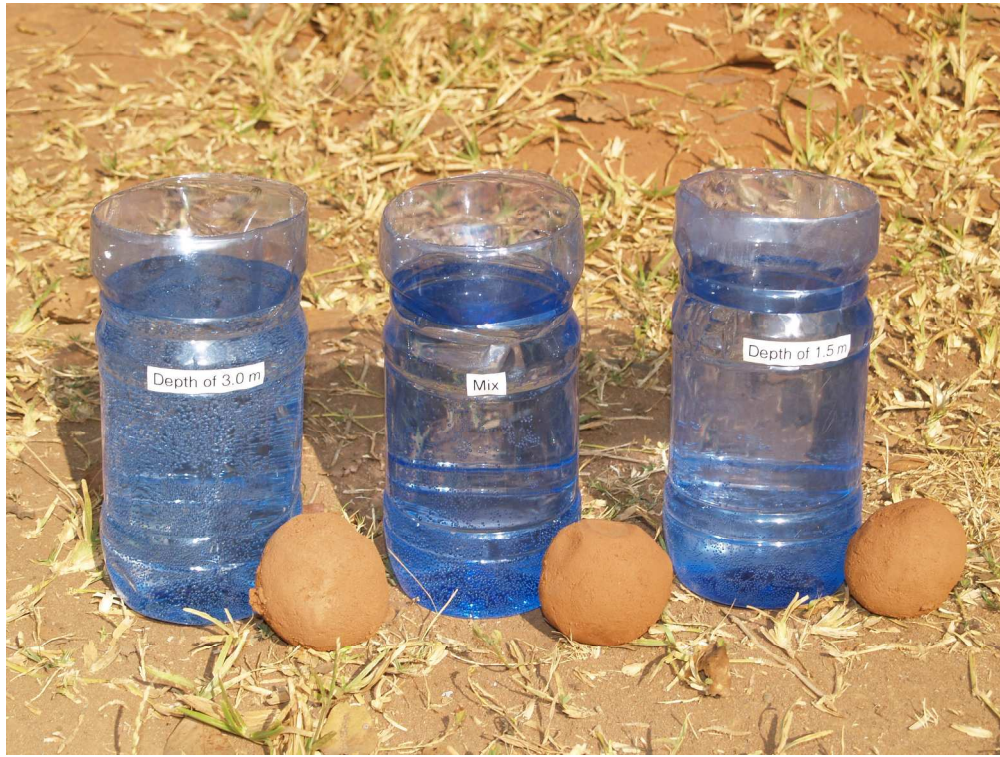
Figure 4 Containers filled with water to test the "tennis ball" shape

Containers filled with water to test the 'tennis ball' shape  
197x148mm (300 x 300 DPI)

**Mud-mortar selection:** The following field, or on-site, mud-mortar testing method was developed to assist

rural masons in identifying suitable types of soil and mixture ratios for the mortar to be used in bonding the bricks in place for the dome. In the event of unsuitable mortar being used, the corbelled latrine may collapse. During construction, soil samples (approximately 200 g) were collected from midway (1.5 m) and at the bottom of the pit (3.0 m depth). Three 2-L containers were filled with water and labeled 'Depth 1.5 m,' 'Depth 3.0 m' and 'Mix' (Figure 4). Soil samples from each depth were shaped into a "tennis ball" and placed in an appropriately labelled container filled with water. The 'Mix' contained one handful of soil each from a depth of 1.5 m and 3.0 m. The balls in the three containers were submerged in water for 24 hours. After the soaking period, the balls were then evaluated for their "tennis ball" shape, which indicated the suitability of the soils for construction of a corbelled latrine. The mud that held its shape the best after soaking in water was the most suitable mortar material for the corbelled latrine substructure. If the balls in all three containers lost their "tennis ball" shape, the mortar at the construction site was not suitable for building a corbelled latrine on its own. In such cases, another method was formulated in which equal portions of sand and clay were mixed and formed into the "tennis ball" shape (1:1 ratio). If this withstood the mud-mortar selection test, then the mortar was determined to be acceptable for construction use. If the retest was unsuccessful, then the latrine was not recommended for construction at that location or there was a need to transport suitable soil from a nearby location for construction.
