Cite this: *Environ. Sci.: Water Res. Technol.*, 2021, 7, 274

Drinking water contamination from the thermal degradation of plastics: implications for wildfire and structure fire response†

Kristofer P. Isaacson,^a Caitlin R. Proctor,^b Q. Erica Wang,^a Ethan Y. Edwards,^c Yoorae Noh,^c Amisha D. Shah^b and Andrew J. Whelton^b

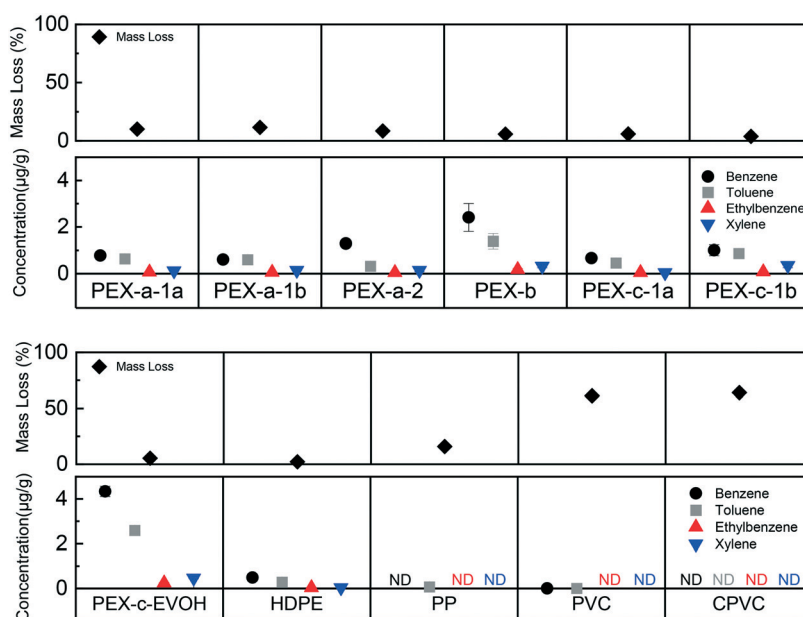
Fig. 2 Average amount of benzene, toluene, ethylbenzene, and xylene leaching observed after burning each material at 400 °C and extracting in water for 7 days. The error bars reflect the standard deviation of the measurements ($n = 3$). If no error bars are visible, this indicates the error bars are smaller than the symbol size. ND indicates the compound was not detected above the MDL.

Results showed that plastic pipe thermal exposure can generate BTEX, which can then leach from cooled plastics into water. BTEX was not found from new and non-thermally degraded plastics in water, while 10 of 11 thermally degraded plastic pipes leached at least one BTEX component (Fig. 2). The chemical leaching differences between products is likely attributed to differences between plastic characteristics and experimental conditions. PE materials lost less mass due to isothermal heating (5 wt% to 10 wt%) compared to the PVC and CPVC samples (61 wt% and 64 wt%, respectively) (Fig. 2). A detectable, but significantly lower amount of benzene and toluene was observed for the PVC pipe, and no BTEX was found for the CPVC pipe (Fig. 2). Additionally, there was a general trend of compound concentration leaching across the plastics where benzene > toluene > ethylbenzene ≈ xylene (Fig. 2). This trend could be attributed to several factors including compound production, water solubility, air volatilization, polymer solubility parameters, and/or partitioning into the aqueous phase. Octanol-water coefficients and solubility values mirror the trend of concentrations observed (Table S4[†]), indicating that benzene would most readily partition into the aqueous phase.
