## Survey of green building water systems reveals elevated water age and water quality concerns†

William J. Rhoads,\* Amy Pruden and Marc A. Edwards

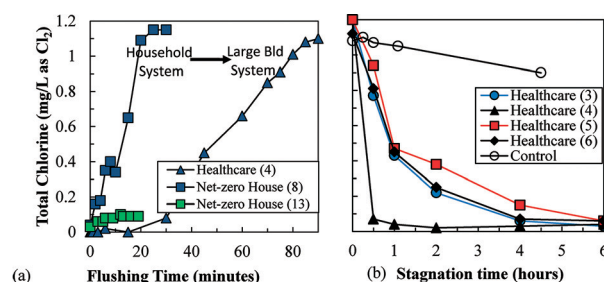
Note: Sampling locations indicated in parenthesis in the figure legends correspond to sample locations depicted in Figure 1.

**Fig. 2** Total chlorine residual concentrations (a) as a function of stagnation in one room at the healthcare suite (large building system above), a tap near the head of the building at the net-zero house (household system above), and during three showering events at net-zero house, and (b) as a function of stagnation in several rooms at FS#1 (control represents identical water placed in a glass container with no head space).

minutes of flushing was necessary to establish a chloramine residual similar to that present in the main distribution system (Fig. 2a). Taps at these locations are typically used for 15–30 seconds at a time; therefore, it is unlikely that a chloramine residual is ever present in portions of this plumbing system. Approximately 30 minutes of flushing was required at the net-zero energy house to establish a residual in the cold water system during the first site visit. In contrast, the conventional home had a residual of 0.71 mg L<sup>-1</sup> chlorine as Cl<sub>2</sub> in stagnant cold water. The water heaters at the net-zero house had <0.15 mg L<sup>-1</sup> chlorine as Cl<sub>2</sub> during a 20 minute flush due to the added storage volume and water age associated with the solar heater (Fig. 1c).

The healthcare suite also showed evidence of very rapid disinfectant residual decay. In all four exam rooms monitored, the first-order decay rate of chloramine in the plumbing was 20–144 times greater than in well-flushed (>80 minutes) water collected from the same tap and placed into a glass container with no headspace (*i.e.*, “control,” Fig. 2b). The highest rate of decay (sample location 4) was observed in
