# **Environmental** Science Water Research & Technology

# Drinking water contamination from the thermal degradation of plastics: implications for wildfire and structure fire response†

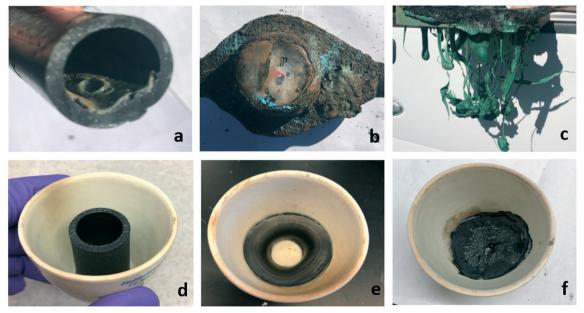
Fig. 1 Images of fire-damaged water system components including (a) a HDPE plastic pipe, (b) a water meter, and (c) a water meter cover following the Camp Fire. Thermally degraded pipe samples in laboratory experiments include the (d) PEX-c pipe degraded at 300 °C, (e) HDPE pipe degraded at 300 °C, and (f) HDPE pipe degraded at 400 °C.

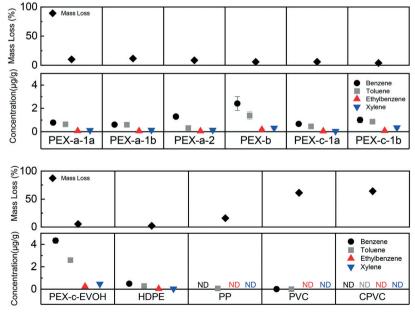
Fig. 2 Average amount of benzene, toluene, ethylbenzene, and xylene leaching observed after burning each material at 400 °C and extracting in water for 7 days. The error bars reflect the standard deviation of the measurements (n = 3). If no error bars are visible, this indicates the error bars are smaller than the symbol size. ND indicates the compound was not detected above the MDL.

Results showed that plastic pipe thermal exposure can generate BTEX, which can then leach from cooled plastics into water. BTEX was not found from new and non-thermally degraded plastics in water, while 10 of 11 thermally degraded plastic pipes leached at least one BTEX component (Fig. 2). The chemical leaching differences between products is likely attributed to differences between plastic characteristics and experimental conditions. PE materials lost less mass due to isothermal heating (5 wt% to 10 wt%) compared to the PVC and CPVC samples (61 wt% and 64 wt%, respectively) (Fig. 2). A detectable, but significantly lower amount of benzene and toluene was observed for the PVC pipe, and no BTEX was found for the CPVC pipe (Fig. 2). Additionally, there was a general trend of compound concentration leaching across the plastics where benzene > toluene > ethylbenzene  $\approx$  xylene (Fig. 2). This trend could be attributed to several factors including compound production, water solubility, air volatilization, polymer solubility parameters, and/or partitioning into the aqueous phase. Octanol-water coefficients and solubility values mirror the trend of concentrations observed (Table S4†), indicating that benzene would most readily partition into the aqueous phase.

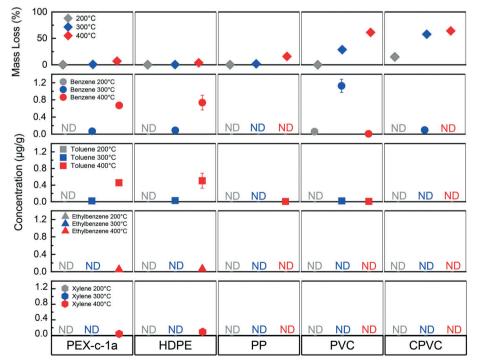
Fig. 3 Mean BTEX concentration after extracting each burned material at 200 °C, 300 °C, and 400 °C in water. The error bars reflect the standard deviation of the measurements (n = 3). If no error bars are visible, it indicates they were smaller than the symbol size. ND indicates the compound was not detected.

Different concentrations of BTEX were found in water after changing the isothermal heating temperature, such that two patterns emerged (Fig. 3). For the HDPE and PEX pipes, the amount of BTEX that leached into the water increased as the plastic degradation temperature increased from 200 °C to 400 °C (Fig. 3). Conversely, the greatest benzene concentration was found for the PVC pipe when exposed to 300 °C, with relatively less concentrations at 200 °C and 400 °C (Fig. 3). The CPVC pipe showed a similar pattern for benzene as the PVC pipe, however, at much lower concentrations (Fig. 3). This spike phenomenon for vinyl materials can potentially be explained by the lower amount of mass loss, where not all benzene produced during degradation volatilized out of the solid. The 300 °C exposure temperature was greater than the onset degradation temperature (Table 1) where dehydrochlorination would occur. However, the PVC pipe mass loss was only 23 wt% as opposed to 61 wt% at the 400 °C condition resulting in a more structurally intact plastic after degradation (Fig. S2†).

Compared to vinyl pipes, greater BTEX concentrations were found as the degradation temperature increased for the HDPE and PEX materials (Fig. 3). The onset degradation temperature for both of these materials exceeds 430 °C (Table 1) which can explain why little to no BTEX leaching was observed at 200 °C and 300 °C. The increase in leaching between 300 °C and 400 °C can be attributed to the plastic pipes beginning to degrade and generating BTEX and other compounds. Elevated temperatures lead to the polymer chain undergoing chain scission resulting in the formation of alkenes. 32 As the pipe is exposed to greater temperatures, the amount of polymer chain scission that occurs also increases. The increase in scission results in more alkene fragments that may subsequently undergo aromatization. A similar pattern was observed in a study of HDPE combustion by others, in which the benzene concentration in the air increased as the combustion temperatures increased from 500 °C to 800 °C. 51 However, the increase in potential BTEX formation does not necessarily indicate that this trend of increased leaching as a function of temperature will

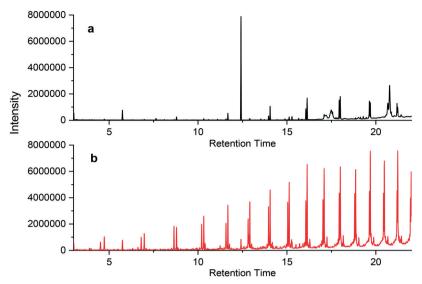
Fig. 4 Chromatographs of PEX-c-1a when (a) unburned and (b) burned at 400 °C, where samples were extracted in n-hexane. The internal standard is the peak at 5.8 minutes.

Leaching promoted by hexane extraction. As expected, a greater number of peaks were observed in the n-hexane extracts (32 to 134) compared to the water extracts (3 to 22) for all plastics (see example for PEX-c-1a in Fig. 4 and all other pipe types in Fig. S17-S26†). For the degraded PEX, HDPE, and PP pipes, between 100 to 134 unique compounds were leached into n-hexane, whereas for the degraded PVC and CPVC pipes between 30 to 41 compounds were leached (Fig. 4 and S17-S26†). While most compounds extracted from the new pipes were either straight chain or branched alkanes of varying lengths (Table S3†), thermal exposure led alkenes to represent the majority of compounds detected in the leachate (Table S5†). These aliphatic hydrocarbons are products of alkane hydrocarbon chain scission and are not typical drinking water contaminants. They have low aqueous solubility, which is why they were only detected in the hexane extracts and are generally less toxic than their cyclical or aromatic counterparts. 56,57

Generally, both the magnitude of the peak and the number of compounds increased after burning the materials. However, one notable exception occurred for the PEX-c pipes; one peak (retention time of 12.5 min) for the unburned pipe was significantly larger than that of any of the burned peaks (Fig. 4 and S21†). This peak likely represented the compound, di-tert-butylbenzene, which has been shown to be an ultraviolet light or radiolysis degradation product of the antioxidant Irgafos 168®.58,59 This compound was only observed in the leachate of the PEX-c materials, in which the crosslinking occurs using beta irradiation. This may explain why the magnitude of this degradation product was so large.60 This peak decreased substantially in the burned plastic extract (Fig. 4 and S21†), indicating it may have been thermally decomposed.
