## Environmental and private property contamination following the Norfolk Southern chemical spill and chemical fires in Ohio†

In February 2023, a train derailment in Ohio caused a chemical spill and fires releasing contaminants into the air, soil, waterways, and buildings. The authors conducted a rapid response which included six field investigations and bench-scale experiments to understand the chemical identity, fate, and exposure pathways after the evacuation order was lifted. Multiple buildings were chemically contaminated and silicone wristband products inside a commercial building were found to have adsorbed derailment-related chemicals. The indoor air of this commercial building was found to be contaminated for 4.5 months after the derailment. Derailment chemicals were also found on building exteriors 5 weeks after the incident. Railcar chemicals were detected in the nearby creeks. Cleanup activities (sorbent pads, aerators) as well as creek hydraulic and environmental conditions influenced chemical fate in creeks. Creek mechanical aeration activities prompted VOC emission that contributed to human exposures and vapor intrusion. Atmospheric modeling revealed that the chemic

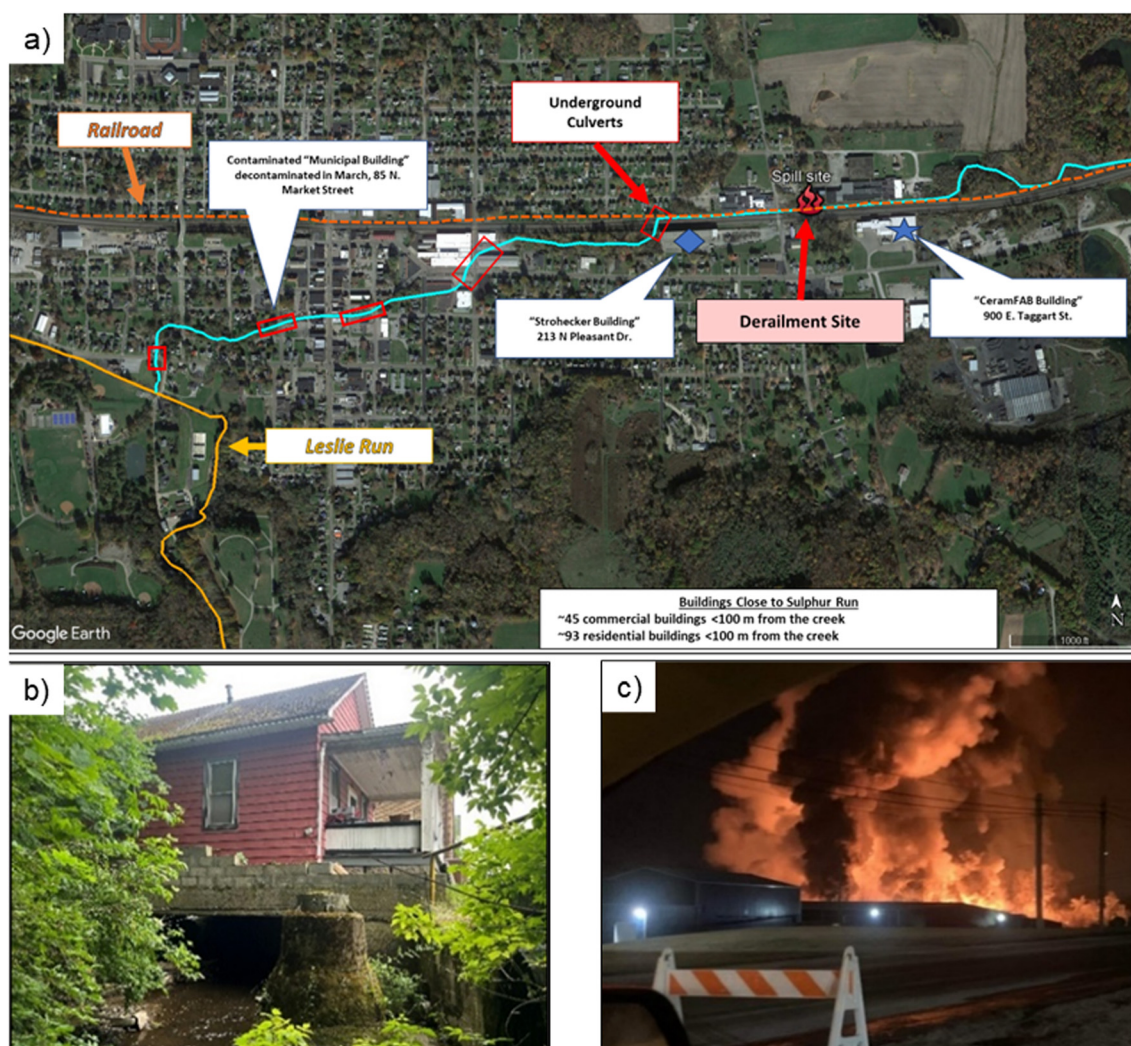
**Fig. 1** a) Map showing the derailment site, culverts, and contaminated buildings near Sulphur Run, b) chemicals released from the derailment entered Sulphur Run and flowed into concrete culverts underneath residential, commercial, and municipal buildings, c) image of the chemical fire visible from East Taggart Street by the CeramFAB Building on February 3, 2023. This image was taken before the open burn was conducted February 6, 2023.

During the following months, concerns were raised about the fate of chemicals released as the derailment occurred on the Eastern side of East Palestine next to Sulphur Run creek (Fig. 1). Sulphur Run received spilled chemicals and runoff from the firefighting operations. Chemicals from the derailment site and roadways reached storm drains and Sulphur Run during the initial response (ESI-Context section†). Chemicals spilled into Sulphur Run flowed through East Palestine, as well as directly by and underneath more than 130 residential, commercial, and municipal buildings through concrete boxed and corrugated metal culverts, and under bridges. Doors and windows of some buildings were less than 5 feet from the creek. At East

Palestine City Park, Sulphur Run drained into Leslie Run Creek which flowed to the south. East Palestine's municipal drinking water wells were located 1.25 miles west of the derailment site. According to public records, the groundwater in the area was "highly susceptible to contamination" due to the lack of a surficial clay layer, and Leslie Run was adjacent to mineral mines.<sup>6,7</sup> Some households in the area relied on private drinking water wells adjacent to Leslie Run, some of which had a water elevation of 3 ft below ground surface.
