Cite this: *Environ. Sci.: Water Res. Technol.*, 2021, 7, 274

This study was conducted to determine if the thermal degradation of various plastic drinking water pipes (i.e., PEX, HDPE, PP, PVC, and CPVC) may be a source of drinking water contamination. Widespread volatile organic compound (VOC) contamination was found in water distribution systems following three wildfires in California. A potential source of this contamination was thought to be due to the degradation of plastic components in drinking water distribution systems. Eleven plastic drinking water pipes, across eight brands, were exposed to elevated temperatures (200 °C to 400 °C), and subsequently submerged in water or in *n*-hexane to observe the extent of VOC leaching. Results indicated that thermally damaged drinking water pipes can be sources of VOC leaching, with ten of the eleven materials leaching benzene, a carcinogen, into water. As exposure temperature increased, an increase in VOC leaching was observed in the polyethylene materials. Conversely, in the vinyl materials the significant mass loss associated with high exposure temperature was inversely proportional to the amount of BTEX leaching that was observed

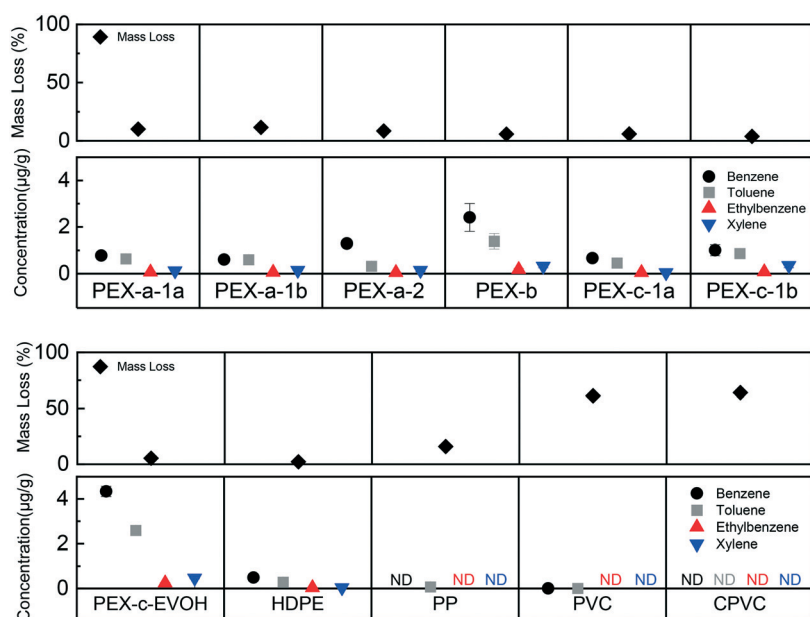
Fig. 2 Average amount of benzene, toluene, ethylbenzene, and xylene leaching observed after burning each material at 400 °C and extracting in water for 7 days. The error bars reflect the standard deviation of the measurements ($n = 3$). If no error bars are visible, this indicates the error bars are smaller than the symbol size. ND indicates the compound was not detected above the MDL.

Results showed that plastic pipe thermal exposure can generate BTEX, which can then leach from cooled plastics into water. BTEX was not found from new and non-thermally degraded plastics in water, while 10 of 11 thermally degraded plastic pipes leached at least one BTEX component (Fig. 2). The chemical leaching differences between products is likely attributed to differences between plastic characteristics and experimental conditions. PE materials lost less mass due to isothermal heating (5 wt% to 10 wt%) compared to the PVC and CPVC samples (61 wt% and 64 wt%, respectively) (Fig. 2). A detectable, but significantly lower amount of benzene and toluene was observed for the PVC pipe, and no BTEX was found for the CPVC pipe (Fig. 2). Additionally, there was a general trend of compound concentration leaching across the plastics where benzene > toluene > ethylbenzene ≈ xylene (Fig. 2). This trend could be attributed to several factors including compound production, water solubility, air volatilization, polymer solubility parameters, and/or partitioning into the aqueous phase. Octanol-water coefficients and solubility values mirror the trend of concentrations observed (Table S4†), indicating that benzene would most readily partition into the aqueous phase.
