Cite this: *Environ. Sci.: Water Res. Technol.*, 2021, 7, 274

DOI: 10.1039/d0ew00836b

Drinking water contamination from the thermal degradation of plastics: implications for wildfire and structure fire response†

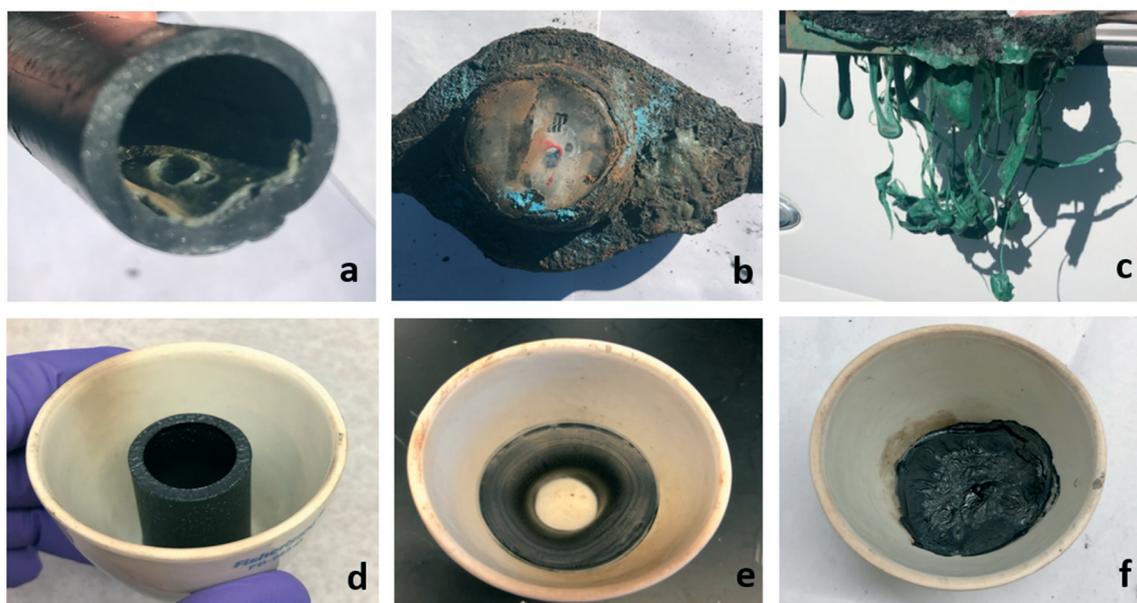
Fig. 1 Images of fire-damaged water system components including (a) a HDPE plastic pipe, (b) a water meter, and (c) a water meter cover following the Camp Fire. Thermally degraded pipe samples in laboratory experiments include the (d) PEX-c pipe degraded at 300 °C, (e) HDPE pipe degraded at 300 °C, and (f) HDPE pipe degraded at 400 °C.

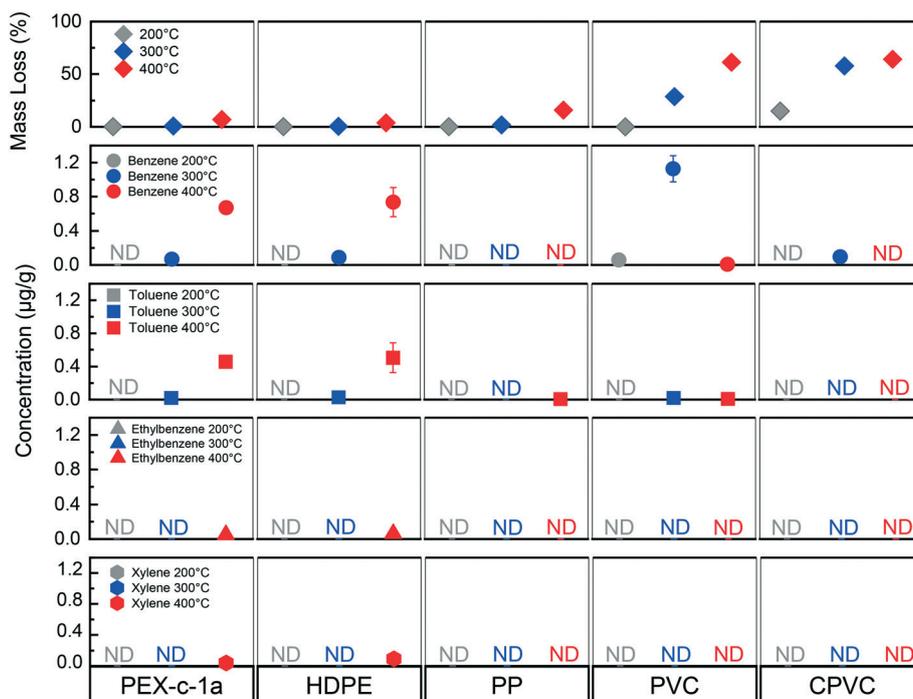
Fig. 3 Mean BTEX concentration after extracting each burned material at 200 °C, 300 °C, and 400 °C in water. The error bars reflect the standard deviation of the measurements ($n = 3$). If no error bars are visible, it indicates they were smaller than the symbol size. ND indicates the compound was not detected.

Different concentrations of BTEX were found in water after changing the isothermal heating temperature, such that two patterns emerged (Fig. 3). For the HDPE and PEX pipes, the amount of BTEX that leached into the water increased as the plastic degradation temperature increased from 200 °C to 400 °C (Fig. 3). Conversely, the greatest benzene concentration was found for the PVC pipe when exposed to 300 °C, with relatively less concentrations at 200 °C and 400 °C (Fig. 3). The CPVC pipe showed a similar pattern for benzene as the PVC pipe, however, at much lower concentrations (Fig. 3). This spike phenomenon for vinyl materials can potentially be explained by the lower amount of mass loss, where not all benzene produced during degradation volatilized out of the solid. The 300 °C exposure temperature was greater than the onset degradation temperature (Table 1) where dehydrochlorination would occur. However, the PVC pipe mass loss was only 23 wt% as opposed to 61 wt% at the 400 °C condition resulting in a more structurally intact plastic after degradation (Fig. S2†).

Despite structural similarities for the vinyl pipes, benzene was only detected in water exposed to the CPVC pipe at a fraction of the amount it was found in water exposed to the PVC material (Fig. 3). This difference may be explained by the additional chlorine atoms present on the CPVC polymer chains resulting in a greater number of chlorine substituted aromatic products when CPVC was thermally degraded.³⁴ A previous CPVC pyrolysis study found significantly more

Compared to vinyl pipes, greater BTEX concentrations were found as the degradation temperature increased for the HDPE and PEX materials (Fig. 3). The onset degradation temperature for both of these materials exceeds 430 °C (Table 1) which can explain why little to no BTEX leaching was observed at 200 °C and 300 °C. The increase in leaching between 300 °C and 400 °C can be attributed to the plastic pipes beginning to degrade and generating BTEX and other compounds. Elevated temperatures lead to the polymer chain undergoing chain scission resulting in the formation of alkenes.³² As the pipe is exposed to greater temperatures, the amount of polymer chain scission that occurs also increases. The increase in scission results in more alkene fragments that may subsequently undergo aromatization. A similar pattern was observed in a study of HDPE combustion by others, in which the benzene concentration in the air increased as the combustion temperatures increased from 500 °C to 800 °C.⁵¹ However, the increase in potential BTEX formation does not necessarily indicate that this trend of increased leaching as a function of temperature will

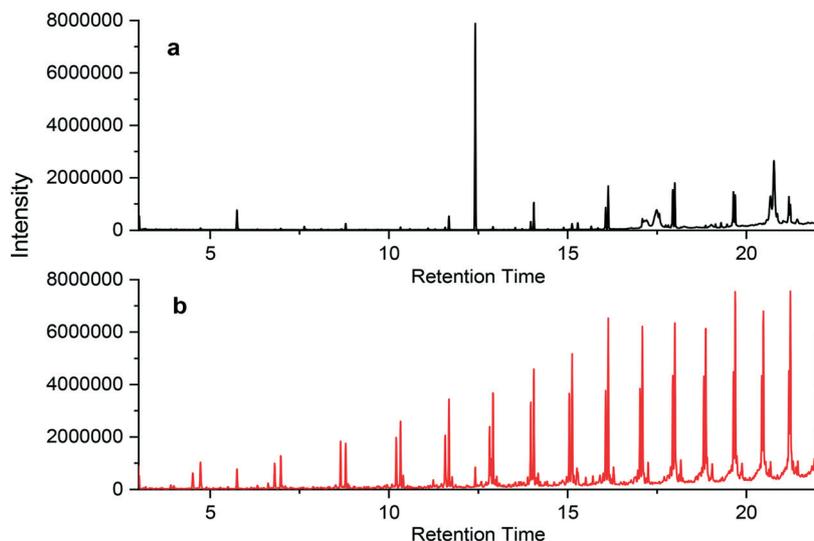
Fig. 4 Chromatograms of PEX-c-1a when (a) unburned and (b) burned at 400 °C, where samples were extracted in *n*-hexane. The internal standard is the peak at 5.8 minutes.

Leaching promoted by hexane extraction. As expected, a greater number of peaks were observed in the *n*-hexane extracts (32 to 134) compared to the water extracts (3 to 22) for all plastics (see example for PEX-c-1a in Fig. 4 and all other pipe types in Fig. S17–S26†). For the degraded PEX, HDPE, and PP pipes, between 100 to 134 unique compounds were leached into *n*-hexane, whereas for the degraded PVC and CPVC pipes between 30 to 41 compounds were leached (Fig. 4 and S17–S26†). While most compounds extracted from the new pipes were either straight chain or branched alkanes of varying lengths (Table S3†), thermal exposure led alkenes to represent the majority of compounds detected in the leachate (Table S5†). These aliphatic hydrocarbons are products of alkane hydrocarbon chain scission and are not typical drinking water contaminants. They have low aqueous solubility, which is why they were only detected in the hexane extracts and are generally less toxic than their cyclical or aromatic counterparts.^{56,57}

Generally, both the magnitude of the peak and the number of compounds increased after burning the materials. However, one notable exception occurred for the PEX-c pipes; one peak (retention time of 12.5 min) for the unburned pipe was significantly larger than that of any of the burned peaks (Fig. 4 and S21†). This peak likely represented the compound, di-*tert*-butylbenzene, which has been shown to be an ultraviolet light or radiolysis degradation product of the antioxidant Irgafos 168®.^{58,59} This compound was only observed in the leachate of the PEX-c materials, in which the crosslinking occurs using beta irradiation. This may explain why the magnitude of this degradation product was so large.⁶⁰ This peak decreased substantially in the burned plastic extract (Fig. 4 and S21†), indicating it may have been thermally decomposed.
