Cite this: *Environ. Sci.: Water Res. Technol.*, 2021, 7, 274

Drinking water contamination from the thermal degradation of plastics: implications for wildfire and structure fire response†

Kristofer P. Isaacson,^a Caitlin R. Proctor,^b Q. Erica Wang,^a Ethan Y. Edwards,^c Yoorae Noh,^c Amisha D. Shah^b and Andrew J. Whelton^a*

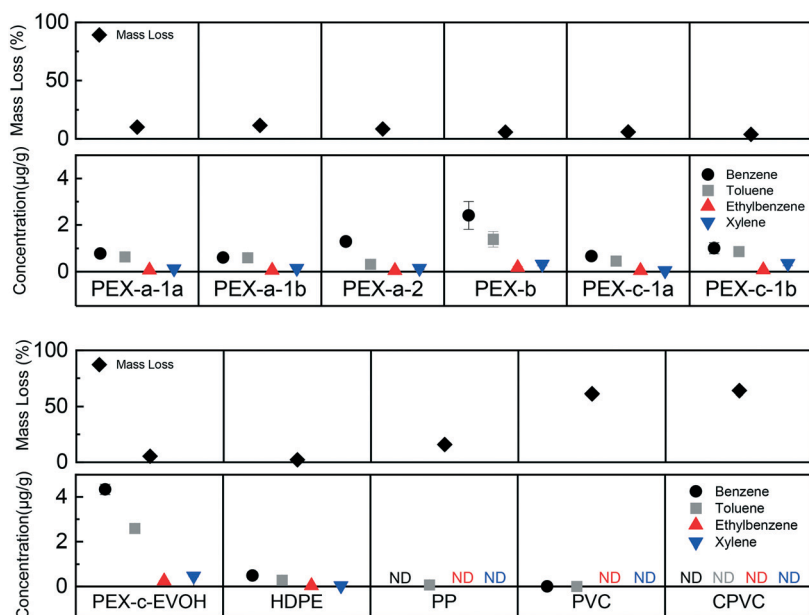
Fig. 2 Average amount of benzene, toluene, ethylbenzene, and xylene leaching observed after burning each material at 400 °C and extracting in water for 7 days. The error bars reflect the standard deviation of the measurements ($n = 3$). If no error bars are visible, this indicates the error bars are smaller than the symbol size. ND indicates the compound was not detected above the MDL.

Results showed that plastic pipe thermal exposure can generate BTEX, which can then leach from cooled plastics into water. BTEX was not found from new and non-thermally degraded plastics in water, while 10 of 11 thermally degraded plastic pipes leached at least one BTEX component (Fig. 2). The chemical leaching differences between products is likely attributed to differences between plastic characteristics and experimental conditions. PE materials lost less mass due to isothermal heating (5 wt% to 10 wt%) compared to the PVC and CPVC samples (61 wt% and 64 wt%, respectively) (Fig. 2). A detectable, but significantly lower amount of benzene and toluene was observed for the PVC pipe, and no BTEX was found for the CPVC pipe (Fig. 2). Additionally, there was a general trend of compound concentration leaching across the plastics where benzene > toluene > ethylbenzene ≈ xylene (Fig. 2). This trend could be attributed to several factors including compound production, water solubility, air volatilization, polymer solubility parameters, and/or partitioning into the aqueous phase. Octanol-water coefficients and solubility values mirror the trend of concentrations observed (Table S4†), indicating that benzene would most readily partition into the aqueous phase.

Little to no BTEX was found for the PP pipe, which has a similar structure to HDPE. The onset degradation temperature of the PP pipe (416 °C) was lower than that of the HDPE and PEX materials (Table 1), and unsurprisingly, the PP had more mass loss (~15 wt%) (Fig. 2) at the same temperature. In previous PP studies, benzene has been found in the air after pyrolysis between 300 °C to 600 °C.^{53,54} No prior studies were found that examined BTEX release into water from thermally damaged PP materials.
