CRITICAL REVIEW

Ongoing legacy contamination from a military radar station in Iceland: a case study

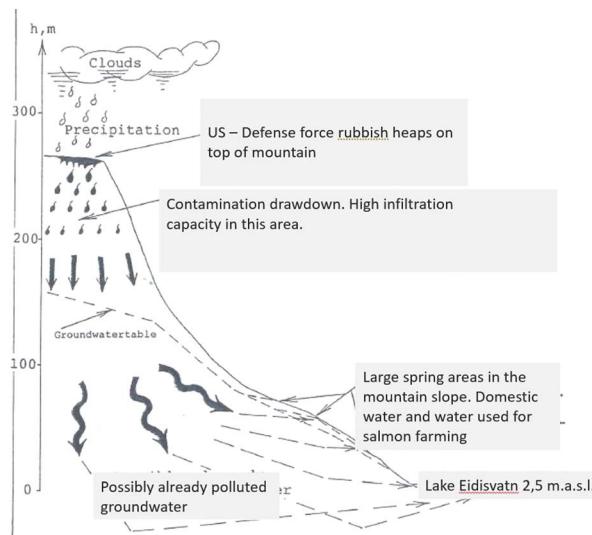
Fig. 2 Transport model of pollution spread at Heiðarfjall.⁴²

The engineering consultant's conclusion was that groundwater pollution would mostly spread southwards towards the farm, the estuary lake Eiðisvatn and the sea as shown in Fig. 2. Calculations of the pollution infiltration flow from the top of the mountain indicate that it would take at least 30 years to reach the springs on the south side of the mountain flowing to Eiði

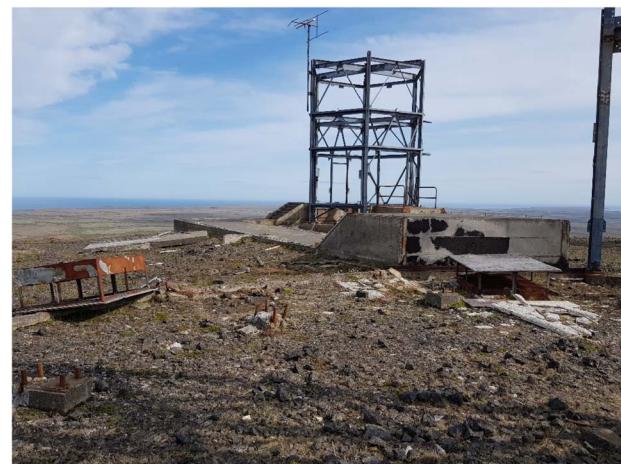
Fig. 4 The H-2 Station Radome area at Heiðarfjall, 26. 7. 2021 (M. J. Gunnarsdóttir).

The sites chosen for sampling by the ESG, see Fig. 3, were: (1) the Dump area (*ca.* 18.000 m^2) where debris, both during operating and later during clean-up, had been buried; (2) the Tropo area, with a communication building (still standing), and where two tropospheric communication dishes once stood; (3) the Sewage Outfall area; (4) the POL (petroleum oil and lubricant) Tank area, where a large fuel storage tank used to be situated. Sites 3 and 4 were on the southern edge of the summit area, directly above the Eiði farm; (5) the Garage area; (6) the Barracks area; (7) the Powerhouse area, and (8) Radome area (sites 5, 6, 7, and 8 are all situated at the Station area); (9) the lower-lying Catchment area, where a concrete drainage pipe was observed leading to a small pond; and (10) the Eiði stream area. Fig. 4 shows a recent picture of the Station area.

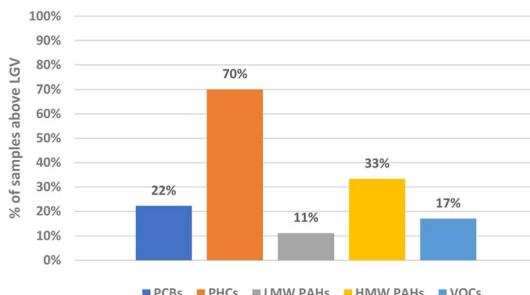
Fig. 5 Non-compliance of POPs with the LGW (lowest guideline value) in samples.¹⁰

POPs are non-compliant to the lowest guideline value, as shown in Fig. 5, from 11% for low molecular weight PAHs to

70% for PHCs. However, this is not representative as sampling is not evenly distributed and several sites are not tested for some POPs as shown in Table 1.

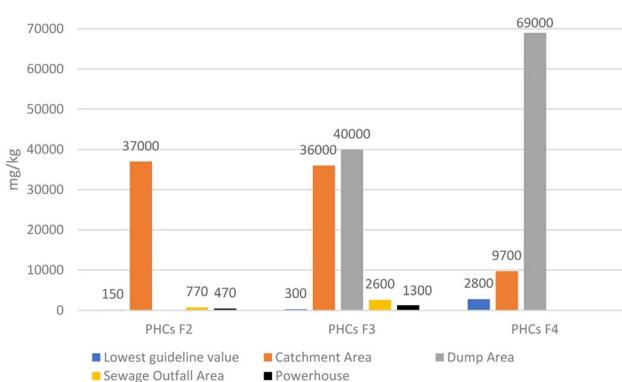
Fig. 6 PHCs (mg kg^{-1}) detected above the lowest guideline value for F2, F3 and F4 (150, 300, and 2800, respectively) at four areas. The highest value in each area of the four is shown in the figure.
