Cite this: *Environ. Sci.: Water Res. Technol.*, 2024, 10, 3007

Environmental and private property contamination following the Norfolk Southern chemical spill and chemical fires in Ohio†

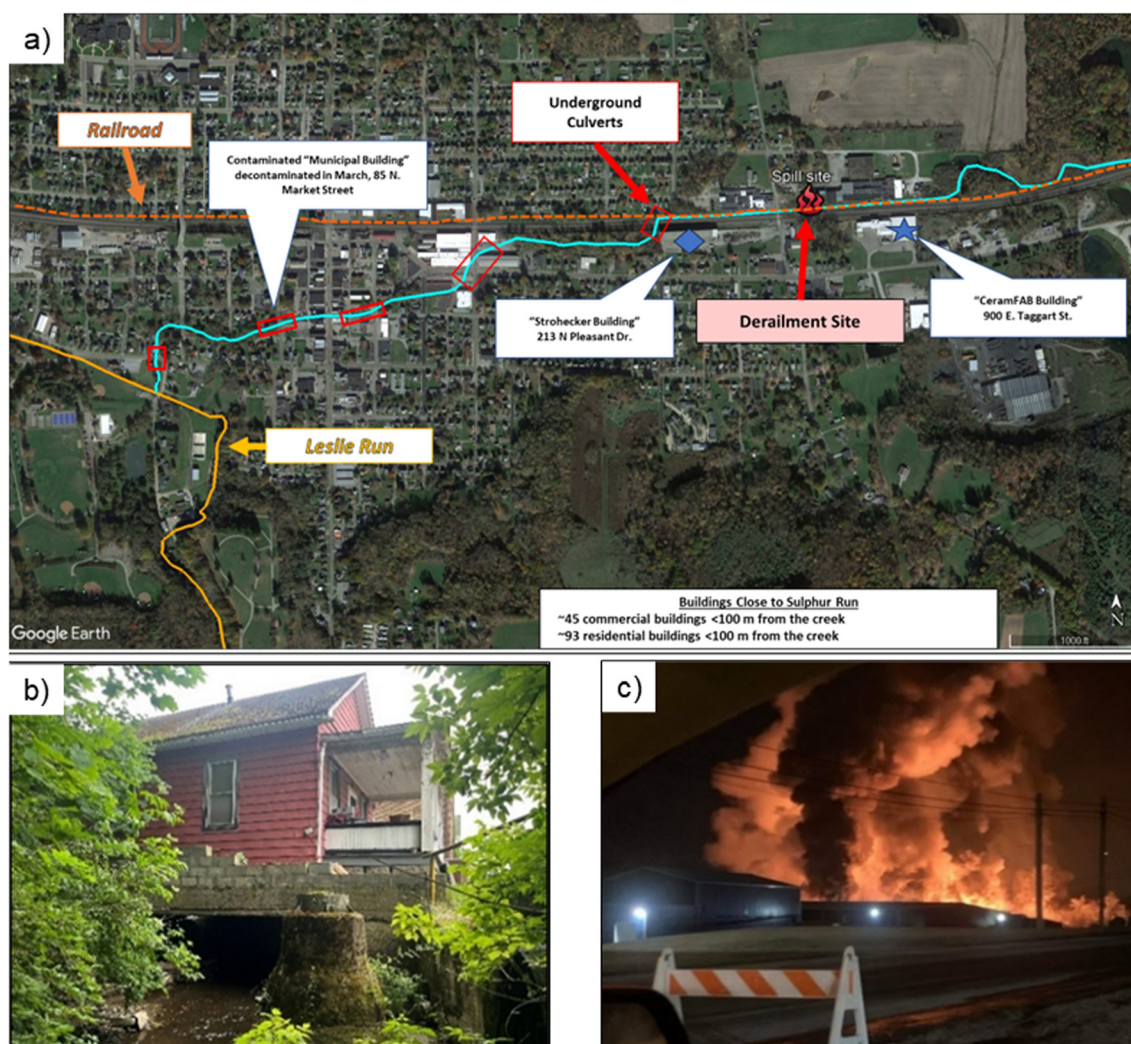
Fig. 1 a) Map showing the derailment site, culverts, and contaminated buildings near Sulphur Run, b) chemicals released from the derailment entered Sulphur Run and flowed into concrete culverts underneath residential, commercial, and municipal buildings, c) image of the chemical fire visible from East Taggart Street by the CeramFAB Building on February 3, 2023. This image was taken before the open burn was conducted February 6, 2023.

During the following months, concerns were raised about the fate of chemicals released as the derailment occurred on the Eastern side of East Palestine next to Sulphur Run creek (Fig. 1). Sulphur Run received spilled chemicals and runoff from the firefighting operations. Chemicals from the derailment site and roadways reached storm drains and Sulphur Run during the initial response (ESI-Context section†). Chemicals spilled into Sulphur Run flowed through East Palestine, as well as directly by and underneath more than 130 residential, commercial, and municipal buildings through concrete boxed and corrugated metal culverts, and under bridges. Doors and windows of some buildings were less than 5 feet from the creek. At East

Palestine City Park, Sulphur Run drained into Leslie Run Creek which flowed to the south. East Palestine's municipal drinking water wells were located 1.25 miles west of the derailment site. According to public records, the groundwater in the area was "highly susceptible to contamination" due to the lack of a surficial clay layer, and Leslie Run was adjacent to mineral mines.^{6,7} Some households in the area relied on private drinking water wells adjacent to Leslie Run, some of which had a water elevation of 3 ft below ground surface.

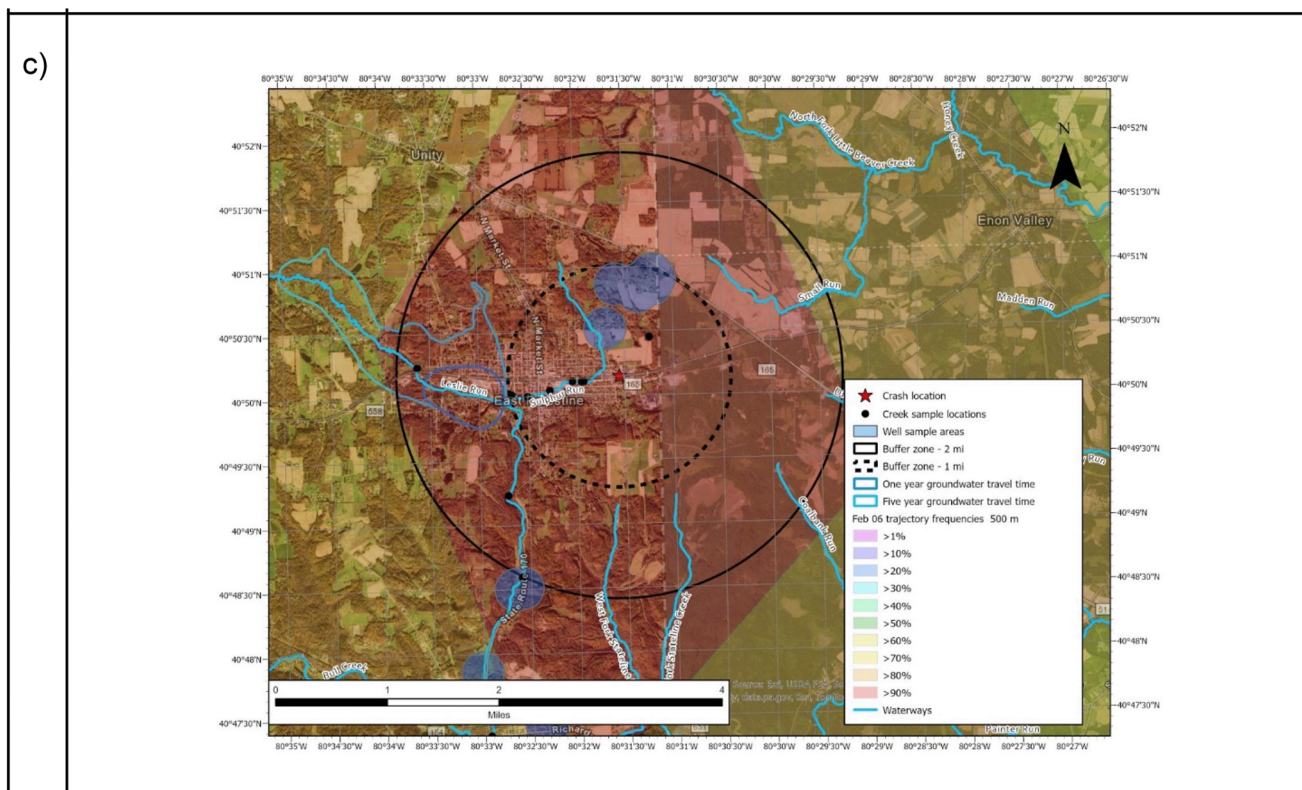
Fig. 3 (continued)

Fig. 3 The chemical plume area of impact (a) was simulated with the HYSPLIT model, (b) the chemical plume extended outside both the 1 mile evacuation zone and the shelter-in-place zone plotted with the creek sampling locations⁵² and (c) East Palestine area, with shelter in place and evacuation zones highlighting the areas where the study sampled private wells. Each image panel represents a different spatial scale.

directions, extending beyond the 1 mile evacuation zone. Polluted air traveled mostly to the immediate north of the burn (more than 19 out of 24 trajectories), with some likely blowing over Lake Erie and reaching Canada (Fig. 3). Before the open burn, air appears to have blown mostly to the east of the site. After the burn, air primarily traveled north, and trajectories used in the frequency calculation are in the ESI.† While the model applied did not include particulate deposition or transport, results suggest that atmospheric pollutants emitted travelled east and north of the derailment site. The residential and commercial buildings visited by the authors were also located within USEPA's soot footprint map,²⁴ and the modified High Resolution Rapid Refresh dispersion model impact zone identified by other investigators (Table ESI-7†). A limitation here is that the HYSPLIT model does not have the spatial resolution to capture the variability across the various sampling sites in this study.
