# Combined crystallographic study of king scallop (*Pecten maximus*) shells using SEM, EBSD and Raman spectroscopy

The shells of *Pecten maximus* (king scallop) are composed primarily of polycrystalline calcitic calcium carbonate, with a crucial aragonitic prismatic myostracum layer that facilitates soft tissue attachment and contributes to mechanical strength. Despite its importance, the impact of environmental stressors, such as metal contamination, on the myostracum remains underexplored. Hence, this study's main goal was to shed light on the microstructure and crystallography of king scallop shells, particularly the myostracum region, using a combination of scanning electron microscopy (SEM), electron backscatter diffraction (EBSD) analysis, and Raman spectroscopy. This approach was chosen to develop new protocols that integrate imaging techniques for a systematic analysis of pollution effects on shell growth and properties. Such an understanding is crucial for assessing the impact of environmental contamination on shell structure and composition. We compared samples from a metal contaminated site (Laxey) with those from non-contaminated site (Bradda) around the Isle of Man, t

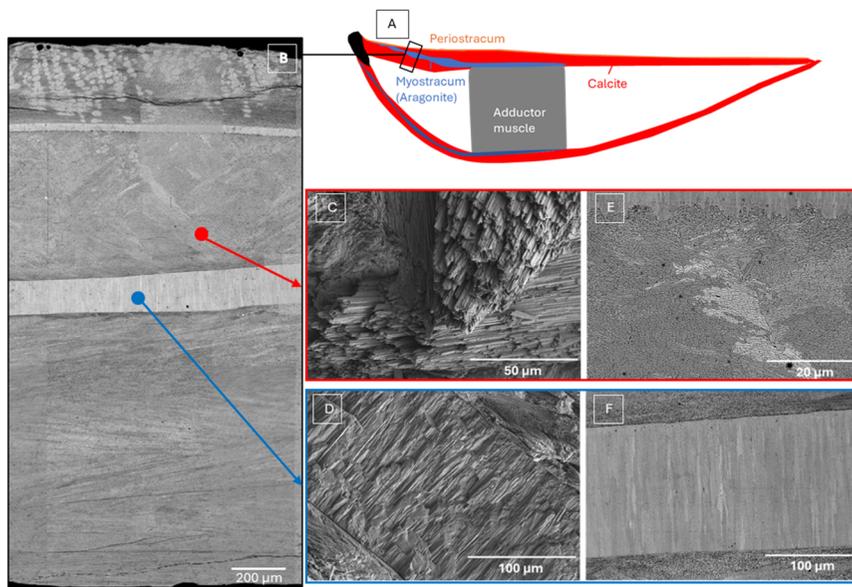
Fig. 1 (A) Schematic longitudinal section of a king scallop (*Pecten maximus*) shell, both valves. Of the organic parts only the adductor muscle is indicated showing its attachment to the shell via an aragonitic calcium carbonate layer. (B) Backscattered electrons stitched SEM images of a king scallop sample from a non-contaminated area after surface polishing. SEM images of king scallop in calcite (red) area: (C) secondary electron image of calcite foliated grains on laser cut surface and (E) backscattered electron image of calcite foliated grain after surface polishing. SEM images of king scallop myostracum aragonite prismatic layer (blue) area: (D) secondary electron image of myostracum layer on laser cut surface and (F) backscattered electron image of myostracum layer after surface polishing.

The soft tissues are attached to the shells *via* the myostracum layer (also known as the adductor muscle scar, see Fig. 1(A)), which bears tremendous contractile force and is crucial for the survival of molluscs.<sup>4</sup> Previous studies have shown that this myostracum layer is generally composed of prismatic aragonite.<sup>5</sup> However, to date, there are very few studies on the myostracum of king scallops *Pecten maximus* and its structural role for the bivalve including its impact on the fracture toughness.

Fig. 1 illustrates the scanning electron microscope (SEM) images of the cross-sectional surface of a king scallop sample from a non-contaminated area, as previously reported.<sup>11,12</sup> Fig. 1(B) displays a secondary electron SEM image of sample's section after polishing, revealing the general distribution of calcite and myostracum aragonite layers in king scallop shell from a non-contaminated site. Fig. 1(C) and (E) highlight the well-oriented, foliated calcite with sharp, thin laths with asymmetrical triangular endings, arranged in parallel clusters, while Fig. 1(D) shows the myostracum aragonite layer after Er:YAG dental laser cut with clearly oriented prismatic grains. Fig. 1(F) presents the same section after polishing, where the myostracum exhibits clearly elongated grains, with visible backscattered electron (BSE) channeling contrast indicative of the high crystallinity of the aragonite phase.

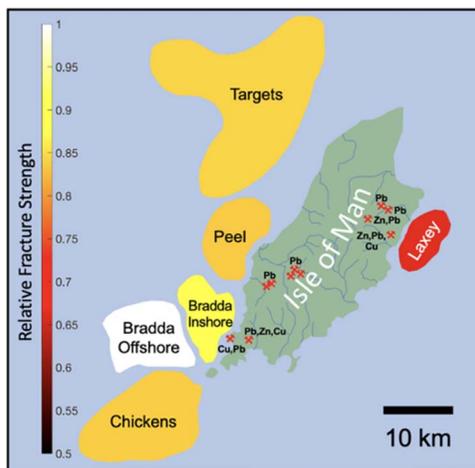
Fig. 2 Map of the relative mean fracture strength observed for *Pecten maximus* around the Isle of Man with the value for Bradda Offshore used to normalize the values for all other sites. Shells were collected from six sites around the Isle of Man in 2004. The color code indicates the value for the relative fracture strength. Laxey is the contaminated site, all the others are controls ( $n = 20$  per site, 120 in total). The value for the Laxey site is 0.66 whereas the values for the other sites are all above 0.83. Red symbols assign major historical mining sites for zinc, lead and copper ores with the order of importance indicated by their sequence position.<sup>10</sup>

The samples were collected in the coastal waters around the Isle of Man, located in the northern Irish Sea. Details of the scallop population selection are provided in previous studies.<sup>9,10</sup> Fig. 2 presents a map of the relative mean fracture strength observed for king scallops (*Pecten maximus*) around the Isle of Man, based on the collection site. Low fracture strength was observed in shells collected in the Laxey area, which is the closest to numerous previous metal ore mines and had the most highly contaminated sediment among sample sites. This provided us with an ideal opportunity to directly compare scallop populations from this contaminated site with those from sites with higher fracture strength/lower contamination levels, specifically the Bradda area. All other known environmental parameters, including water temperature, salinity, and nutrients, remained similar across the sites.

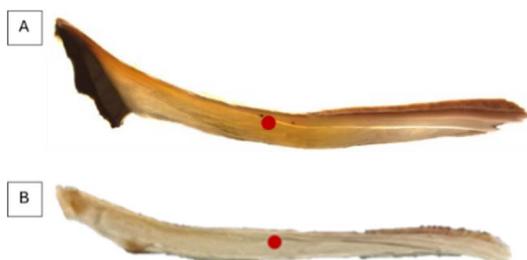
Fig. 3 (A) Scallop sample from non-contaminated Bradda area and (B) scallop sample from metal contaminated Laxey area, longitudinal section view. The region of interest is marked with a red circle.

one from Laxey, the contaminated site). The shells were cut using a diamond cut-off wheel (South Bay Technology Low Speed Diamond Wheel Saw MODEL 650) longitudinally (Fig. 3). The sectioned sample was then hand polished with lapping pads to a felt disk with a 50 nm colloidal silica suspension, to obtain a perfectly flat surface for future SEM observations and EBSD analysis. A 10 nm layer of carbon coating was necessary for conductivity. No etching process was applied.

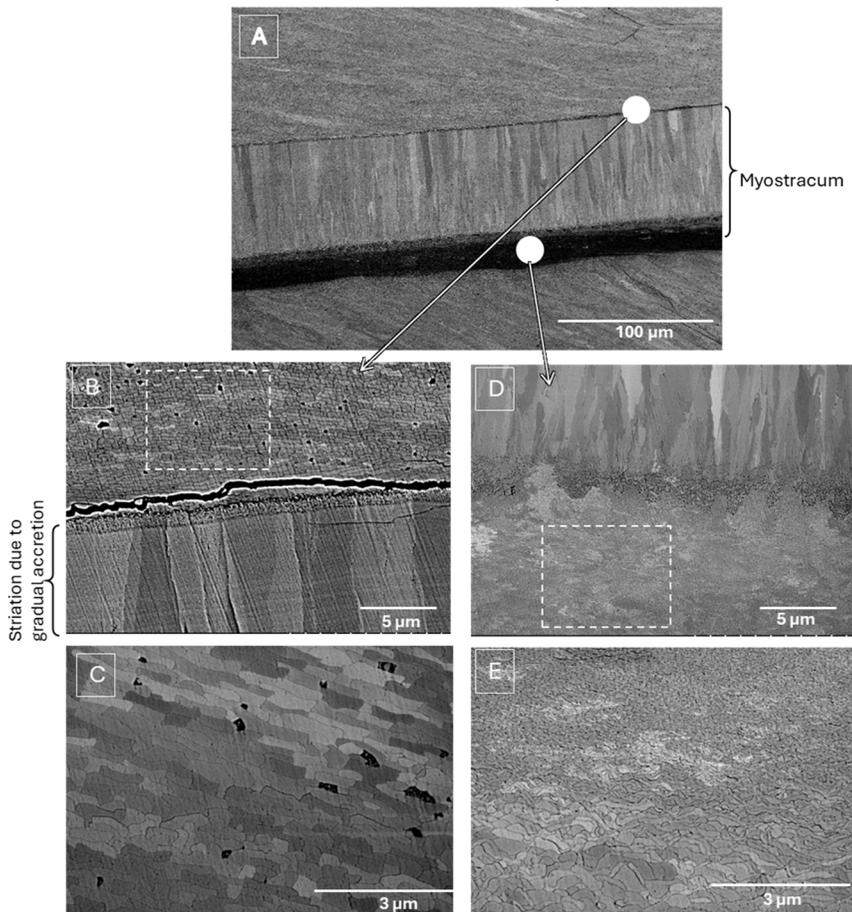
Non-contaminated site scallop shell, *Bradda*

Fig. 4 BSE micrographs of the myostracum region for the scallop shell collected in the non-contaminated Bradda area. (A) A general view of the region of interest. (B) The upper boundaries between the myostracum and the shell bulk. (C) The microstructures of the scallop in the region at the top of the myostracum. (D) The lower boundaries between the myostracum and the shell bulk. (E) The microstructures of the shell in the region below the myostracum.

Fig. 4(A) and 5(A) display an overall microstructural organization for the longitudinal section around the myostracum region of scallop shells respectively from non-contaminated and contaminated sites. These backscattered electron images show channeling contrast and provide an overview of crystal orientation variations, particularly within the myostracum, which is, in both types of scallops, clearly visible and sandwiched between two foliated calcite areas. This allows us

First, it is observed that the overall organization was similar for both types of scallops. Focusing on the myostracum, it consists of elongated, oriented grains. However, the grains in the lower part of both myostracum layers are notably fine and small. These grains gradually increase in both length and width towards the upper part of the myostracum, while maintaining a consistent growth orientation, resulting in a clear size gradient. Despite this similarity between the two types of shells, a noticeable difference in morphology and distribution is observed. The grains in the myostracum within the shell from the non-contaminated site appear more elongated and regularly arranged.

Examining the calcitic regions surrounding the myostracum reveals notable differences in microstructure. Fig. 4(B), (C), 5(B) and (C) provide a closer view of the region above the myostracum. In both shell types, the shape and grain distribution are uniform and consistent in size (around 1 micron in size). The boundary between the aragonite myostracum and the calcitic bulk is clearly defined, with homogeneous grains in the upper calcitic region, contrasting with the larger, elongated grains of the upper myostracum. The contrast variations between the grains are due to slight differences in their relative orientations, due to the BSE channeling contrast.

The boundary between the two microstructures in the lower myostracum appears less distinct as can be observed in Fig. 4(D) and 5(D). Again, there is little

Near the myostracum, the calcite grains are nanocrystalline (see Fig. 4(E) and 5(E)) and a size gradient is observed as the distance from the myostracum increases. In the shell from contaminated site, this gradient extends over a larger

Furthermore, growth lines can be identified in the Raman maps associated with the accretion sequence during the myostracum formation. These growth lines are also visible in the SEM image of samples from both contaminated and non-contaminated sites and are shown in Fig. 4(B) and 5(B).

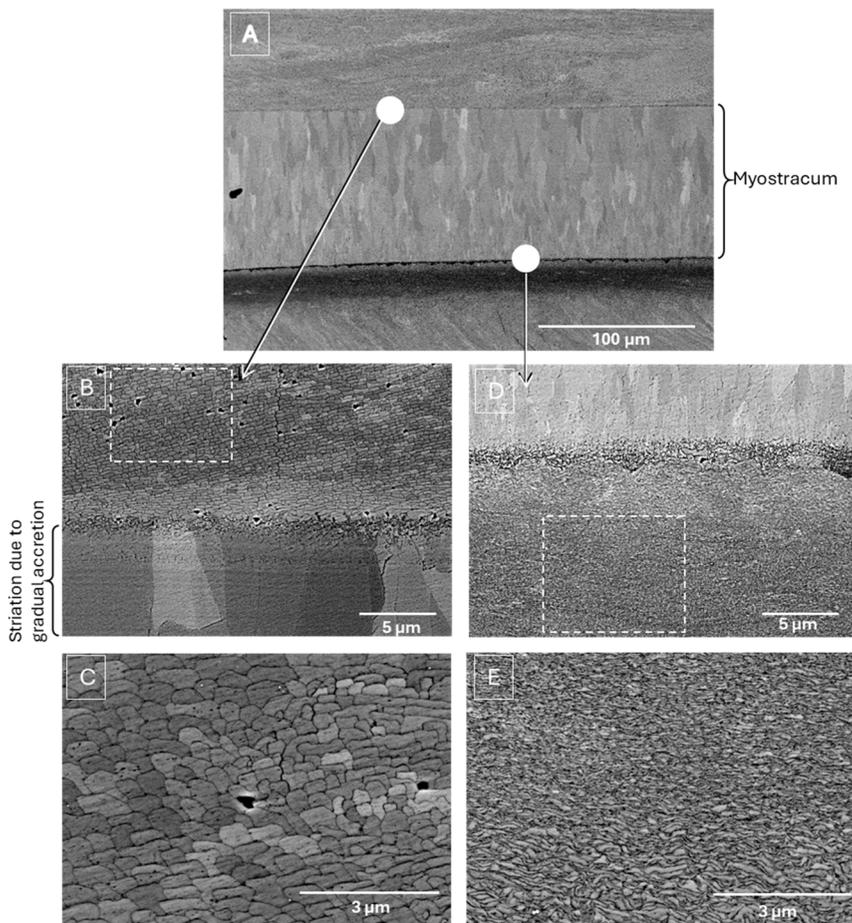
Contaminated site scallop shell, *Laxey*

Fig. 5 BSE micrographs of the myostracum region for the scallop shell collected in the contaminated Laxey area. (A) A general view of the region of interest. (B) The upper boundaries between the myostracum and the shell bulk. (C) The microstructures of the scallop in the region at the top of the myostracum. (D) The lower boundaries between the myostracum and the shell bulk. (E) The microstructures of the shell in the region below the myostracum.

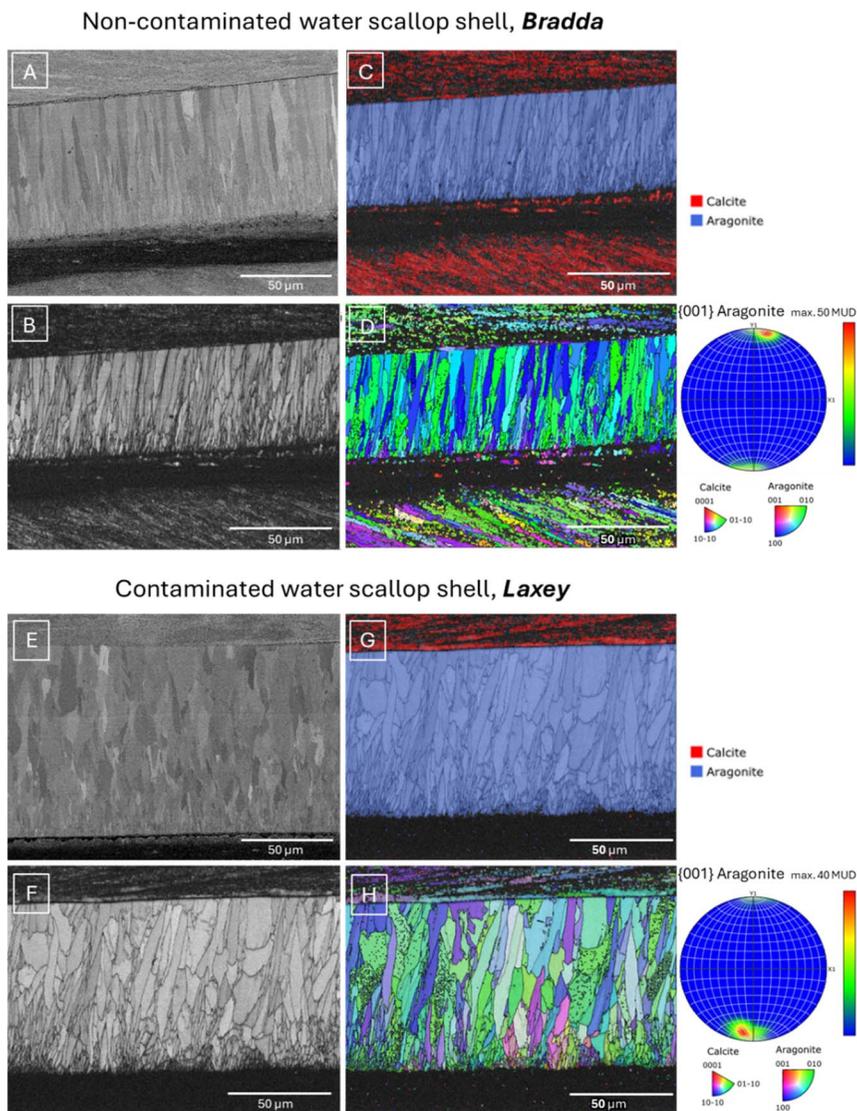
Fig. 6 (A) BSE image, (B) EBSD band contrast map, (C) EBSD phase map (D) IPF colored map and pole figure obtained on the myostracum region for the non-contaminated case. (E) BSE image, (F) EBSD band contrast map, (G) EBSD phase map (H) IPF colored map and pole figure obtained on the myostracum region for the shell from the contaminated site.

Following the SEM analysis, we performed EBSD analysis on an adjacent area, on the myostracum region. The EBSD maps presented in Fig. 6 provide the results obtained for both types of shell and give information on the crystallography of each shell section.

First, we can see on the phase map, in Fig. 6(C) and (G) that, in both cases, the well-oriented and crystallized myostracum layer is clearly composed of well-crystallized aragonite, surrounded by the calcite phase on top and a poorly indexed phase at the bottom. Thanks to the SEM images in Fig. 4(E) and 5(E), it was observed that the calcite grains beneath the myostracum are very fine. The extremely small size of these grains may partly explain the absence of EBSD detection in this region. However, calcite islands are detected at the lower boundary of the myostracum in the non-contamination affected shell, which are not observed in the contaminated shell, suggesting larger or better-crystallized calcite grains.

The EBSD orientation maps, presented in Fig. 6(D) and (H), focusing on the aragonite myostracum and accompanied by the pole figure, confirm the preferential orientation of the aragonite grains. When an oriented texture is present, pole figures reveal a cylindrical 'cluster' distribution. For both contaminated and non-contaminated sites scallop samples, we observe a concentration point with a nearly circular shape, indicating a clear, oriented texture of grains. A higher multiple uniform density (MUD) value reflects a stronger co-orientation. As we can see, the MUD value obtained in the myostracum region of the non-contamination affected sample is slightly higher than that of the shell from the contaminated site, revealing a slightly stronger co-orientation compared to the contaminated site sample. However, the difference remains too small to conclude any alteration of the myostracum microstructure due to pollution. The second phase of this project, with a more in-depth study on a selected panel of shells, will aim to obtain more data to validate these observations. Analyses of different areas throughout the entire length of the myostracum in the shells could also be interesting to observe the evolution of the crystallography of the myostracum as the shell grows.

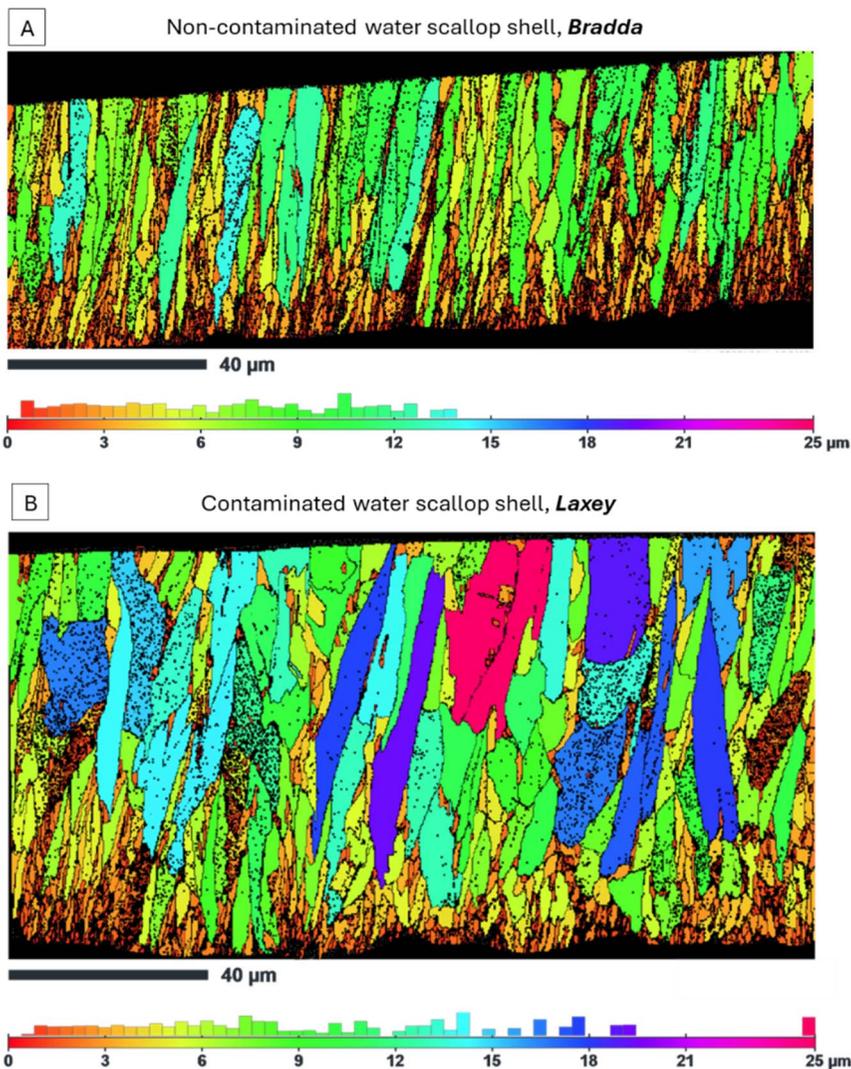
Fig. 7 EBSD grains maps with a color scale according to grain size (longest dimension) in the myostracum.

Additionally, EBSD analysis allows us to detect orientation variations, which helps determine the size of orientation domains or the grain size when grain boundaries are identified (non-indexed grain boundaries). Fig. 7 presents EBSD maps of the grain size distribution in the myostracum, for both shell types, with a colored scale corresponding to the grain longest dimension providing a quantitative analysis of the variation in grain size within the myostracum. The size variation is clearly visible, indicating submicron grain-sizes at the lower interface (red orange) which rapidly increase in size towards the upper interface.

The lower boundary is distinctly composed of small grains, which could reflect the early stages of growth since it is observable in both shells. The shell from the contaminated site, however, appears to have a broader grain distribution.

To obtain a more representative grain size distribution, it would be necessary to measure the grain sizes over a larger area to ensure a sufficient number of grains are sampled. However, even with the current map, it is already evident that the regular elongated shape observed in the non-contaminated site shell does not appear as consistently regular in the contaminated counterpart. In fact, surprisingly large grains can be observed (note turquoise, purple and magenta in Fig. 7(B)).

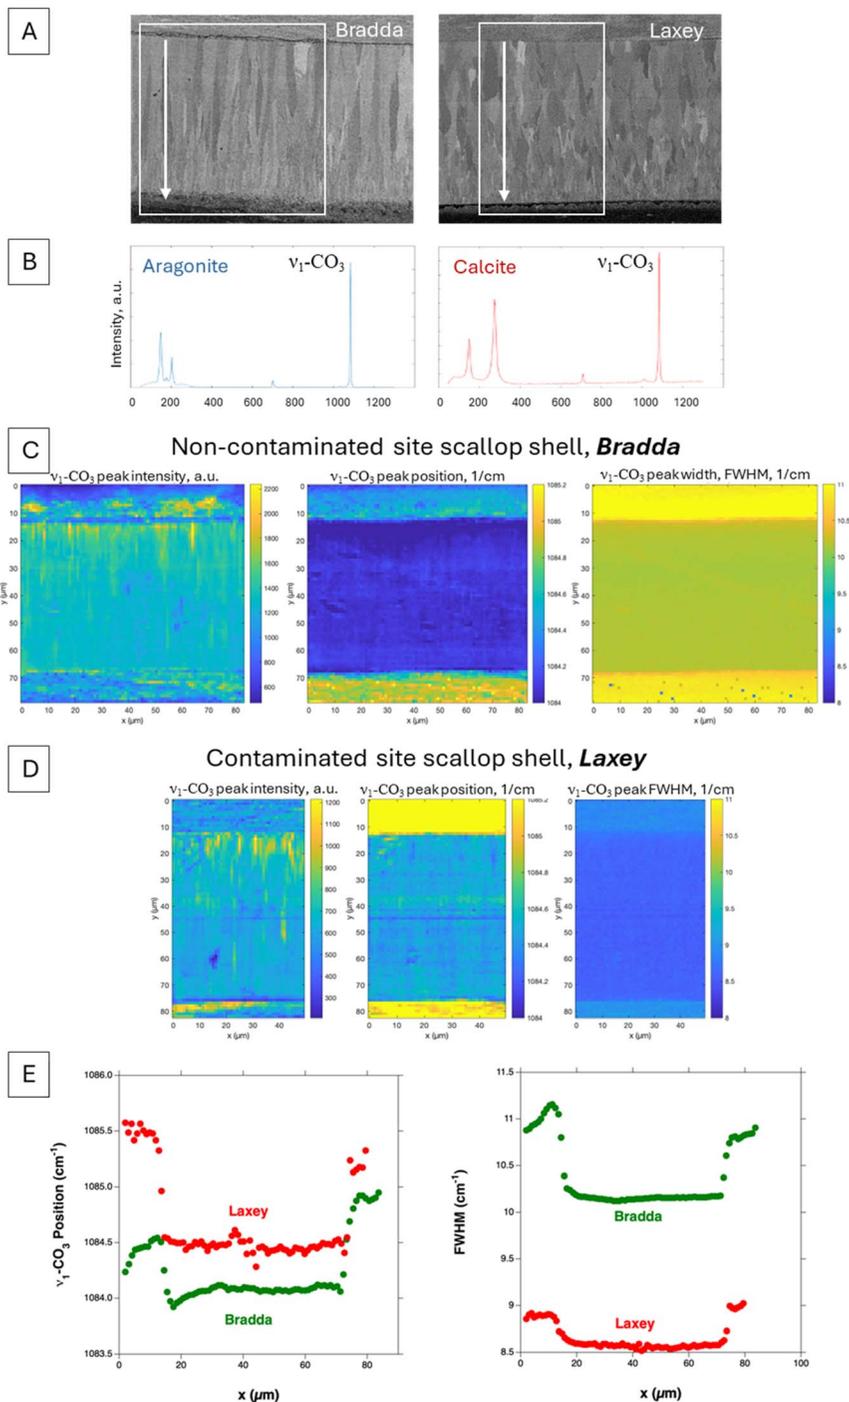
**Fig. 8** (A) BSE images of a sample from non-contaminated (Bradda) and contaminated (Laxey) sites; (B) Raman spectra taken from the myostracum and foliated regions of the Bradda sample, (C)  $\nu_1$ -CO<sub>3</sub> Raman maps evaluating peak intensity, position and full width at half maximum of the Bradda and (D) and Laxey samples, (E) comparison of line profiles from top to bottom of the  $\nu_1$ -CO<sub>3</sub> Raman position and full width at half maximum for Bradda and Laxey samples.

The parallel Raman study also revealed differences in response between the regions at the upper and lower boundaries of the myostracum. The results are presented in Fig. 8. Using the  $\nu_1$ -CO<sub>3</sub> symmetric stretching mode for Raman

mapping, we observed, for all analysed samples, systematic shifts in the peak position above, below and across the myostracum, with a difference of  $0.5 \text{ cm}^{-1}$  between each. In comparison to the aragonitic myostracum, the top calcite domain is  $0.5 \text{ cm}^{-1}$  higher, while the lower domain differs by  $1 \text{ cm}^{-1}$ . The peak position in samples from the non-contaminated site is overall shifted to smaller wavelengths. Moreover, the  $\nu_1\text{-CO}_3$  peak width is marginally higher for the non-contaminated site shells than in its contaminated counterpart. This variation in peak position and width may indicate intrinsic crystallite strain or be related to smaller grain sizes. It remains to be determined whether the crystallite size or intrinsic strain contribute to the peak shift and broadening. However, small and pre-strained crystallites have been identified in other mineralized tissues such as dental enamel, dentin, bone, and other bivalve shells indicating that it could be a “toughening” feature, rather than a random occurrence.<sup>21–23</sup>
