# Ongoing legacy contamination from a military radar station in Iceland: a case study

María J. Gunnarsdottir

This paper is a summary of environmental impacts from a former US military DEW line radar station in Iceland which operated from the mid-1950s to the 1970s. This station was one of four DEW line station stations that operated in Iceland during the Cold War era. During the time of operation and when dismantled, nearly all waste from the station was dumped in unlined pits on the mountain. Very limited cleaning of the site has been performed and the site is contaminated with PCBs, PHCs, PAHs and some inorganic elements.

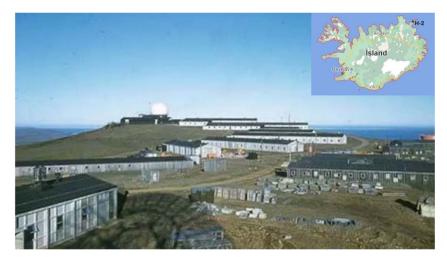
Fig. 1 The DEW line radar station at Heiðarfjall in 1958 (https://www.radomes.org/museum/acwgrnland.php)

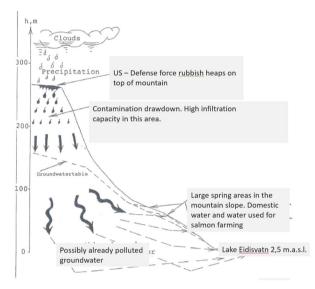
Transport model of pollution spread at Heiðarfjall.42

The engineering consultant's conclusion was that groundwater pollution would mostly spread southwards towards the farm, the estuary lake Eiðisvatn and the sea as shown in Fig. 2. Calculations of the pollution infiltration flow from the top of the mountain indicate that it would take at least 30 years to reach the springs on the south side of the mountain flowing to Eiði

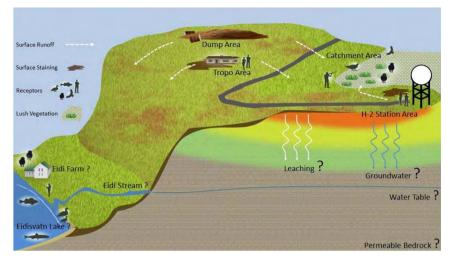
Fig. 3 Schematic picture of Heiðarfjall and the sites investigated by the ESG in 2017.10 Water source for Eidi farm is at the Eidi stream.

The sites chosen for sampling by the ESG, see Fig. 3, were: (1) the Dump area (*ca.* 18.000 m²) where debris, both during operating and later during clean-up, had been buried; (2) the Tropo area, with a communication building (still standing), and where two tropospheric communication dishes once stood; (3) the Sewage Outfall area; (4) the POL (petroleum oil and lubricant) Tank area, where a large fuel storage tank used to be situated. Sites 3 and 4 were on the southern edge of the summit area, directly above the Eiði farm; (5) the Garage area; (6) the Barracks area; (7) the Powerhouse area, and (8) Radome area (sites 5, 6, 7, and 8 are all situated at the Station area); (9) the lower-lying Catchment area, where a concrete drainage pipe was observed leading to a small pond; and (10) the Eiði stream area. Fig. 4 shows a recent picture of the Station area.
