## Ongoing legacy contamination from a military radar station in Iceland: a case study

Contamination in and around military radar stations in the Arctic has been an ongoing concern since first identified in the 1980s. This study reports on the environmental impact from a DEW line US military station that was operated on Heiðarfjall mountain in northeast Iceland from 1957 to 1970. This review is conducted as a part of work of the POPs Expert Group of the Arctic Monitoring and Assessment Program (AMAP) for an assessment report on local sources vs. long-range transport of Persistent Organic Pollutants (POPs) in the Arctic. The main resource for this summary is an evaluation of results from several reports on Heiðarfjall Langanes, one from an Icelandic Environmental Authority in 1993 and another from the Canadian Environmental Science Group (ESG) at the Royal Military College of Canada, which was commissioned in 2017 by the owners of the land that was used for the station. The results are compared to findings in scientific papers and reports for contamination at other military radar stations in Canada and Alaska. This review shows considerable contamination on Heiðarfjall over 50 year

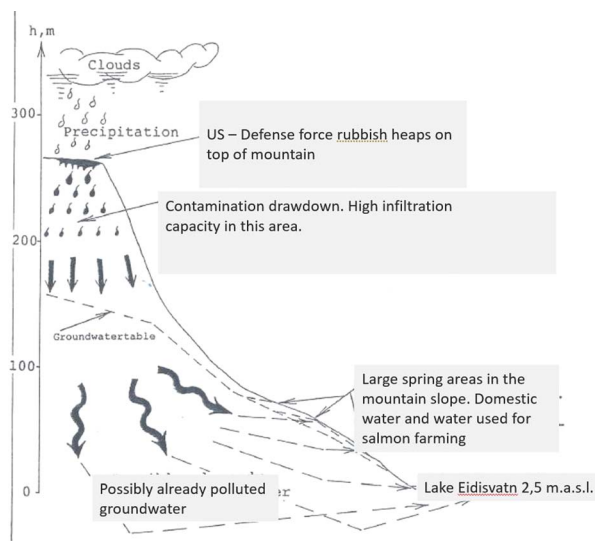
Fig. 2 Transport model of pollution spread at Heiðarfjall.<sup>42</sup>

The engineering consultant's conclusion was that groundwater pollution would mostly spread southwards towards the farm, the estuary lake Eidiavatn and the sea as shown in Fig. 2. Calculations of the pollution infiltration flow from the top of the mountain indicate that it would take at least 30 years to reach the springs on the south side of the mountain flowing to Eidi

and it would take at least another 70 years until it had disappeared, but some dilution could be expected.<sup>42</sup>

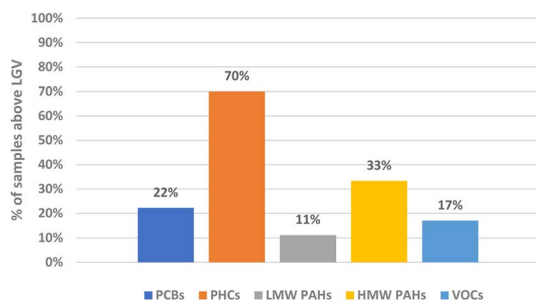
Fig. 5 Non-compliance of POPs with the LGV (lowest guideline value) in samples.<sup>10</sup>

POPs are non-compliant to the lowest guideline value, as shown in Fig. 5, from 11% for low molecular weight PAHs to
