Cite this: *Environ. Sci.: Water Res. Technol.*, 2021, 7, 274

This study was conducted to determine if the thermal degradation of various plastic drinking water pipes (*i.e.*, PEX, HDPE, PP, PVC, and CPVC) may be a source of drinking water contamination. Widespread volatile organic compound (VOC) contamination was found in water distribution systems following three wildfires in California. A potential source of this contamination was thought to be due to the degradation of plastic components in drinking water distribution systems. Eleven plastic drinking water pipes, across eight brands, were exposed to elevated temperatures (200 °C to 400 °C), and subsequently submerged in water or in *n*-hexane to observe the extent of VOC leaching. Results indicated that thermally damaged drinking water pipes can be sources of VOC leaching, with ten of the eleven materials leaching benzene, a carcinogen, into water. As exposure temperature increased, an increase in VOC leaching was observed in the polyethylene materials. Conversely, in the vinyl materials the significant mass loss associated with high exposure temperature was inversely proportional to the amount of BTEX leaching that was observ

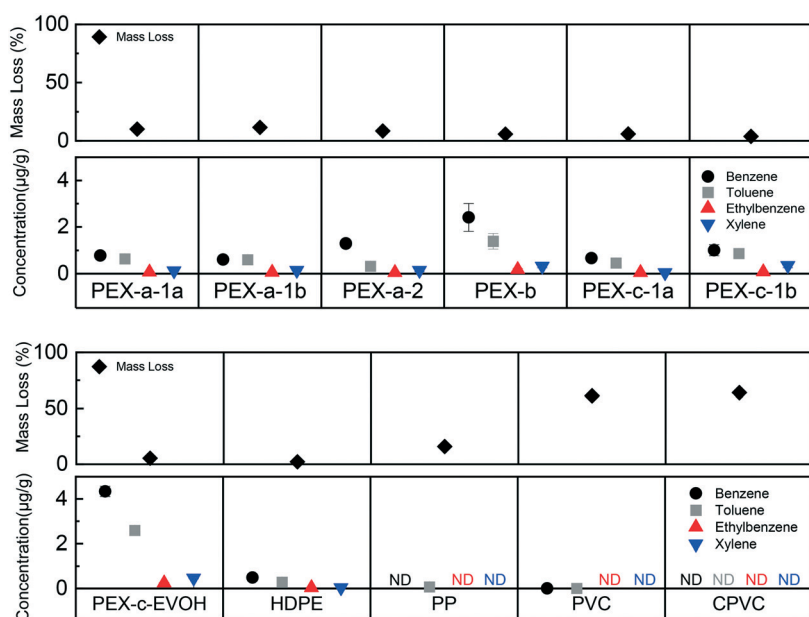
Fig. 2 Average amount of benzene, toluene, ethylbenzene, and xylene leaching observed after burning each material at 400 °C and extracting in water for 7 days. The error bars reflect the standard deviation of the measurements ($n = 3$). If no error bars are visible, this indicates the error bars are smaller than the symbol size. ND indicates the compound was not detected above the MDL.

Results showed that plastic pipe thermal exposure can generate BTEX, which can then leach from cooled plastics into water. BTEX was not found from new and non-thermally degraded plastics in water, while 10 of 11 thermally degraded plastic pipes leached at least one BTEX component (Fig. 2). The chemical leaching differences between products is likely attributed to differences between plastic characteristics and experimental conditions. PE materials lost less mass due to isothermal heating (5 wt% to 10 wt%) compared to the PVC and CPVC samples (61 wt% and 64 wt%, respectively) (Fig. 2). A detectable, but significantly lower amount of benzene and toluene was observed for the PVC pipe, and no BTEX was found for the CPVC pipe (Fig. 2). Additionally, there was a general trend of compound concentration leaching across the plastics where benzene > toluene > ethylbenzene ≈ xylene (Fig. 2). This trend could be attributed to several factors including compound production, water solubility, air volatilization, polymer solubility parameters, and/or partitioning into the aqueous phase. Octanol-water coefficients and solubility values mirror the trend of concentrations observed (Table S4[†]), indicating that benzene would most readily partition into the aqueous phase.

Little to no BTEX was found for the PP pipe, which has a similar structure to HDPE. The onset degradation temperature of the PP pipe (416 °C) was lower than that of the HDPE and PEX materials (Table 1), and unsurprisingly, the PP had more mass loss (~15 wt%) (Fig. 2) at the same temperature. In previous PP studies, benzene has been found in the air after pyrolysis between 300 °C to 600 °C.^{53,54} No prior studies were found that examined BTEX release into water from thermally damaged PP materials.
