# Combined crystallographic study of king scallop (*Pecten maximus*) shells using SEM, EBSD and Raman spectroscopy

DOI: 10.1039/d5fd00029g

The shells of *Pecten maximus* (king scallop) are composed primarily of polycrystalline calcitic calcium carbonate, with a crucial aragonitic prismatic myostracum layer that facilitates soft tissue attachment and contributes to mechanical strength. Despite its importance, the impact of environmental stressors, such as metal contamination, on the myostracum remains underexplored. Hence, this study's main goal was to shed light on the microstructure and crystallography of king scallop shells, particularly the myostracum region, using a combination of scanning electron microscopy (SEM), electron backscatter diffraction (EBSD) analysis, and Raman spectroscopy. This approach was chosen to develop new protocols that integrate imaging techniques for a systematic analysis of pollution effects on shell growth and properties. Such an understanding is crucial for assessing the impact of environmental contamination on shell structure and composition. We compared samples from a metal contaminated site (Laxey) with those from non-contaminated site (Bradda)

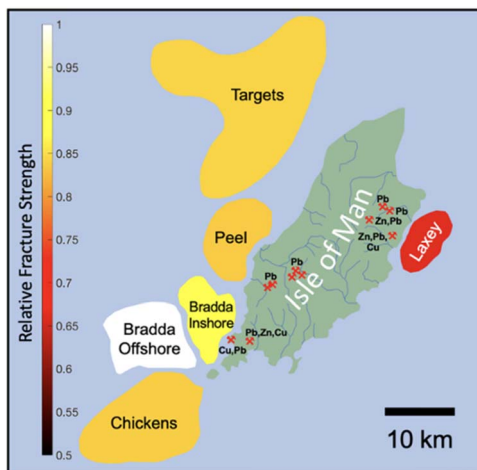
Fig. 2 Map of the relative mean fracture strength observed for *Pecten maximus* around the Isle of Man with the value for Bradda Offshore used to normalize the values for all other sites. Shells were collected from six sites around the Isle of Man in 2004. The color code indicates the value for the relative fracture strength. Laxey is the contaminated site, all the others are controls ( $n = 20$  per site, 120 in total). The value for the Laxey site is 0.66 whereas the values for the other sites are all above 0.83. Red symbols assign major historical mining sites for zinc, lead and copper ores with the order of importance indicated by their sequence position.<sup>10</sup>

The samples were collected in the coastal waters around the Isle of Man, located in the northern Irish Sea. Details of the scallop population selection are provided in previous studies.<sup>9,10</sup> Fig. 2 presents a map of the relative mean fracture strength observed for king scallops (*Pecten maximus*) around the Isle of Man, based on the collection site. Low fracture strength was observed in shells collected in the Laxey area, which is the closest to numerous previous metal ore mines and had the most highly contaminated sediment among sample sites. This provided us with an ideal opportunity to directly compare scallop populations from this contaminated site with those from sites with higher fracture strength/lower contamination levels, specifically the Bradda area. All other known environmental parameters, including water temperature, salinity, and nutrients, remained similar across the sites.

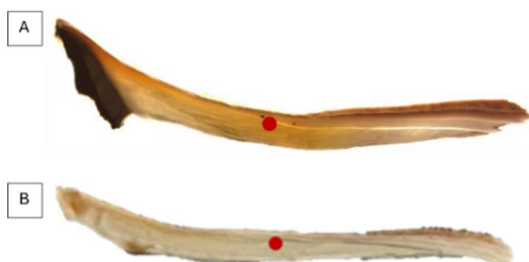
Fig. 3 (A) Scallop sample from non-contaminated Bradda area and (B) scallop sample from metal contaminated Laxey area, longitudinal section view. The region of interest is marked with a red circle.

one from Laxey, the contaminated site). The shells were cut using a diamond cut-off wheel (South Bay Technology Low Speed Diamond Wheel Saw MODEL 650) longitudinally (Fig. 3). The sectioned sample was then hand polished with lapping pads to a felt disk with a 50 nm colloidal silica suspension, to obtain a perfectly flat surface for future SEM observations and EBSD analysis. A 10 nm layer of carbon coating was necessary for conductivity. No etching process was applied.

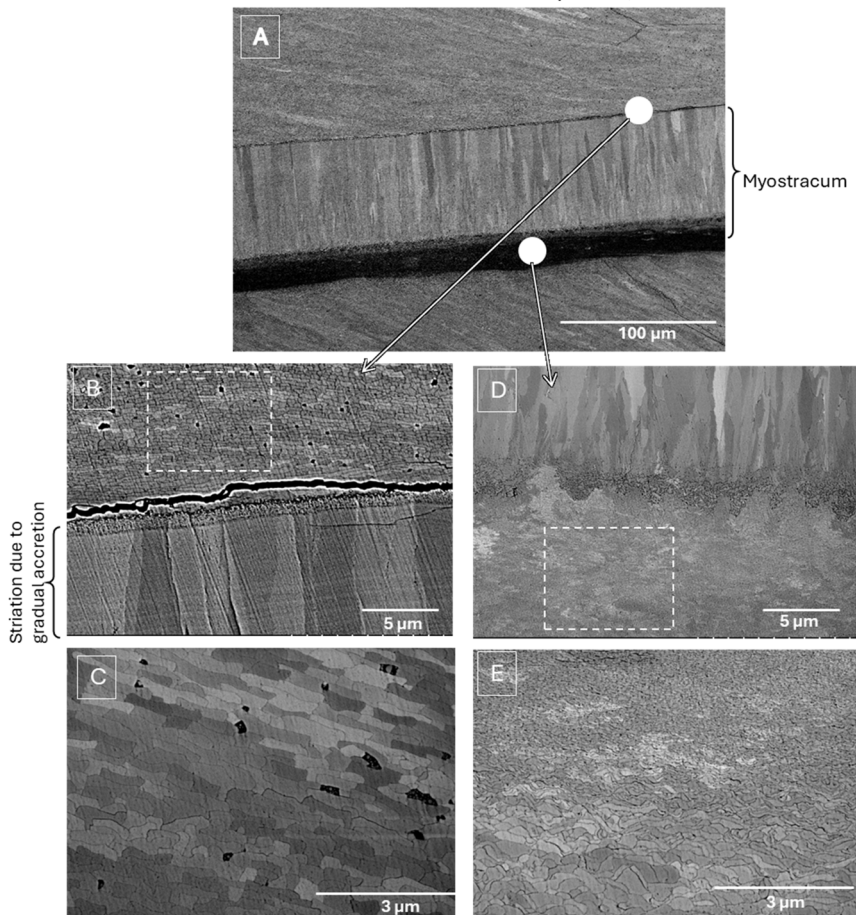
Non-contaminated site scallop shell, *Bradda*

Fig. 4 BSE micrographs of the myostracum region for the scallop shell collected in the non-contaminated Bradda area. (A) A general view of the region of interest. (B) The upper boundaries between the myostracum and the shell bulk. (C) The microstructures of the scallop in the region at the top of the myostracum. (D) The lower boundaries between the myostracum and the shell bulk. (E) The microstructures of the shell in the region below the myostracum.

Fig. 4(A) and 5(A) display an overall microstructural organization for the longitudinal section around the myostracum region of scallop shells respectively from non-contaminated and contaminated sites. These backscattered electron images show channeling contrast and provide an overview of crystal orientation variations, particularly within the myostracum, which is, in both types of scallops, clearly visible and sandwiched between two foliated calcite areas. This allows us

First, it is observed that the overall organization was similar for both types of scallops. Focusing on the myostracum, it consists of elongated, oriented grains. However, the grains in the lower part of both myostracum layers are notably fine and small. These grains gradually increase in both length and width towards the upper part of the myostracum, while maintaining a consistent growth orientation, resulting in a clear size gradient. Despite this similarity between the two types of shells, a noticeable difference in morphology and distribution is observed. The grains in the myostracum within the shell from the non-contaminated site appear more elongated and regularly arranged.

Examining the calcitic regions surrounding the myostracum reveals notable differences in microstructure. Fig. 4(B), (C), 5(B) and (C) provide a closer view of the region above the myostracum. In both shell types, the shape and grain distribution are uniform and consistent in size (around 1 micron in size). The boundary between the aragonite myostracum and the calcitic bulk is clearly defined, with homogeneous grains in the upper calcitic region, contrasting with the larger, elongated grains of the upper myostracum. The contrast variations between the grains are due to slight differences in their relative orientations, due to the BSE channeling contrast.

The boundary between the two microstructures in the lower myostracum appears less distinct as can be observed in Fig. 4(D) and 5(D). Again, there is little

difference between the two types of shells. This “blurred” transition is likely linked to nanocrystalline grains present at this interface, both in the myostracum and in the adjacent calcitic bulk. The grains in the lower myostracum are particularly tiny and thin, making the boundary between the two microstructures gradual within a region of 1–2  $\mu\text{m}$  thickness.

Near the myostracum, the calcite grains are nanocrystalline (see Fig. 4(E) and 5(E)) and a size gradient is observed as the distance from the myostracum increases. In the shell from contaminated site, this gradient extends over a larger

Furthermore, growth lines can be identified in the Raman maps associated with the accretion sequence during the myostracum formation. These growth lines are also visible in the SEM image of samples from both contaminated and non-contaminated sites and are shown in Fig. 4(B) and 5(B).

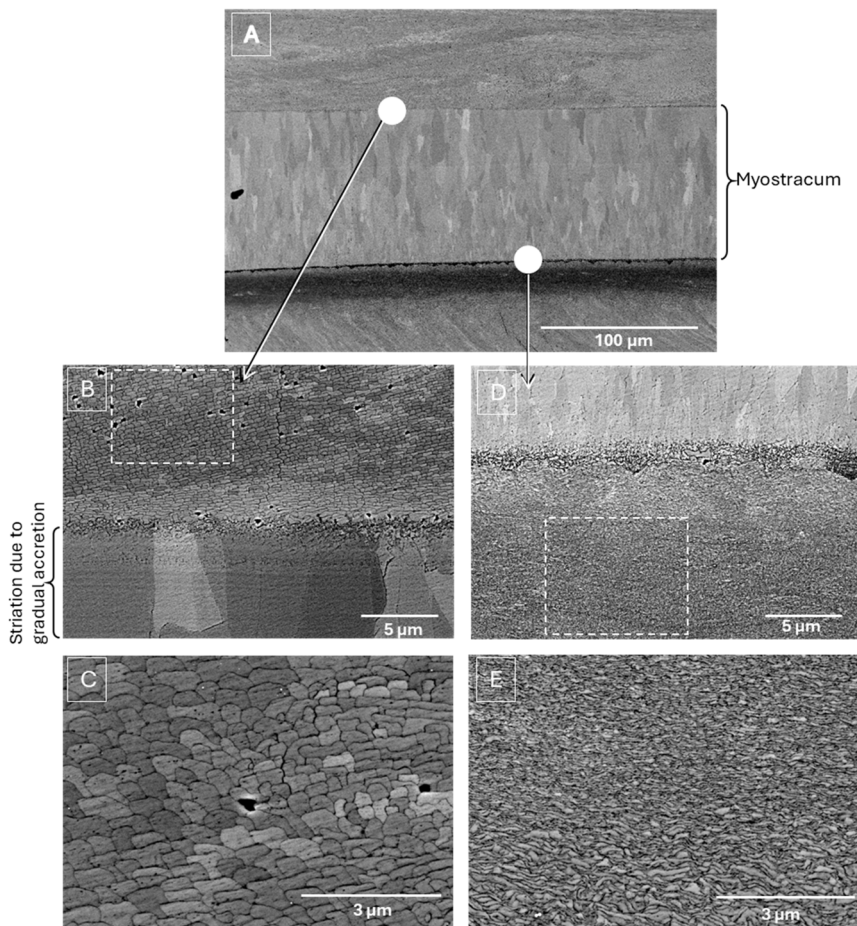
Contaminated site scallop shell, *Laxey*

Fig. 5 BSE micrographs of the myostracum region for the scallop shell collected in the contaminated Laxey area. (A) A general view of the region of interest. (B) The upper boundaries between the myostracum and the shell bulk. (C) The microstructures of the scallop in the region at the top of the myostracum. (D) The lower boundaries between the myostracum and the shell bulk. (E) The microstructures of the shell in the region below the myostracum.

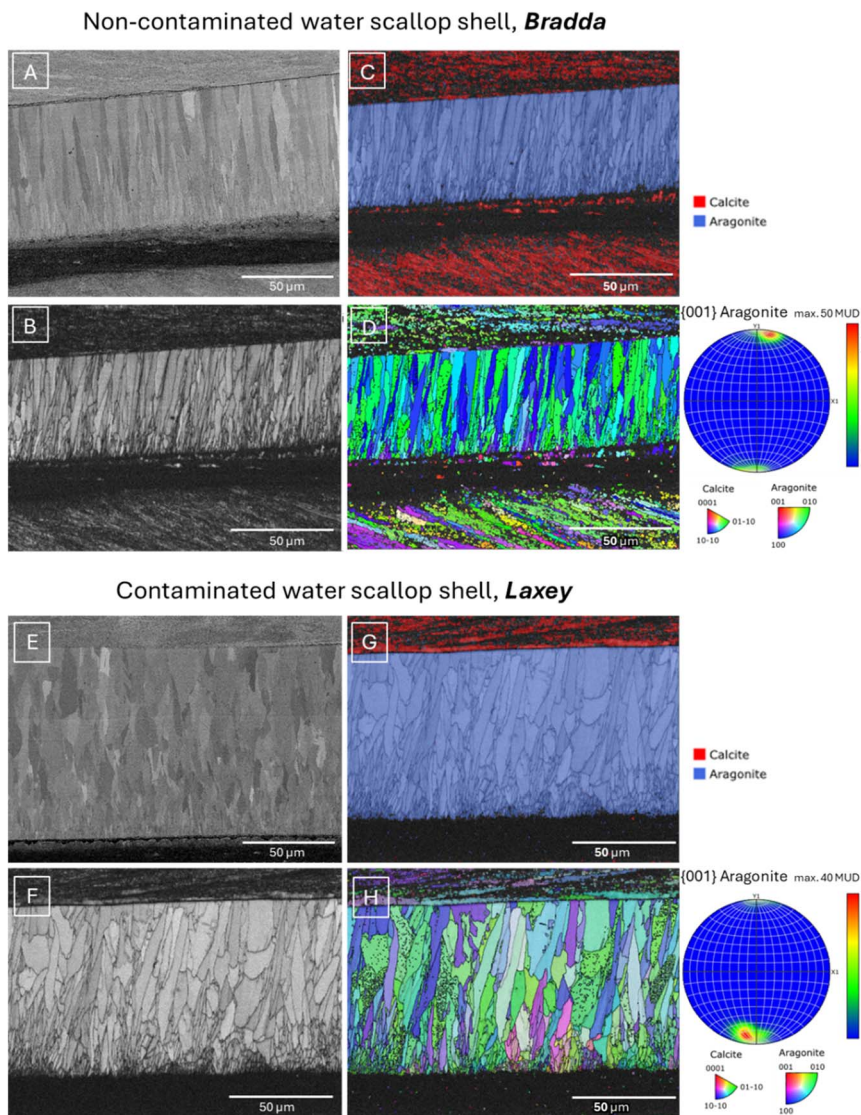
**Fig. 6** (A) BSE image, (B) EBSD band contrast map, (C) EBSD phase map (D) IPF colored map and pole figure obtained on the myostracum region for the non-contaminated case. (E) BSE image, (F) EBSD band contrast map, (G) EBSD phase map (H) IPF colored map and pole figure obtained on the myostracum region for the shell from the contaminated site.

Following the SEM analysis, we performed EBSD analysis on an adjacent area, on the myostracum region. The EBSD maps presented in Fig. 6 provide the results obtained for both types of shell and give information on the crystallography of each shell section.

First, we can see on the phase map, in Fig. 6(C) and (G) that, in both cases, the well-oriented and crystallized myostracum layer is clearly composed of well-crystallized aragonite, surrounded by the calcite phase on top and a poorly indexed phase at the bottom. Thanks to the SEM images in Fig. 4(E) and 5(E), it was observed that the calcite grains beneath the myostracum are very fine. The extremely small size of these grains may partly explain the absence of EBSD detection in this region. However, calcite islands are detected at the lower boundary of the myostracum in the non-contamination affected shell, which are not observed in the contaminated shell, suggesting larger or better-crystallized calcite grains.

The EBSD orientation maps, presented in Fig. 6(D) and (H), focusing on the aragonite myostracum and accompanied by the pole figure, confirm the preferential orientation of the aragonite grains. When an oriented texture is present, pole figures reveal a cylindrical 'cluster' distribution. For both contaminated and non-contaminated sites scallop samples, we observe a concentration point with a nearly circular shape, indicating a clear, oriented texture of grains. A higher multiple uniform density (MUD) value reflects a stronger co-orientation. As we can see, the MUD value obtained in the myostracum region of the non-contamination affected sample is slightly higher than that of the shell from the contaminated site, revealing a slightly stronger co-orientation compared to the contaminated site sample. However, the difference remains too small to conclude any alteration of the myostracum microstructure due to pollution. The second phase of this project, with a more in-depth study on a selected panel of shells, will aim to obtain more data to validate these observations. Analyses of different areas throughout the entire length of the myostracum in the shells could also be interesting to observe the evolution of the crystallography of the myostracum as the shell grows.

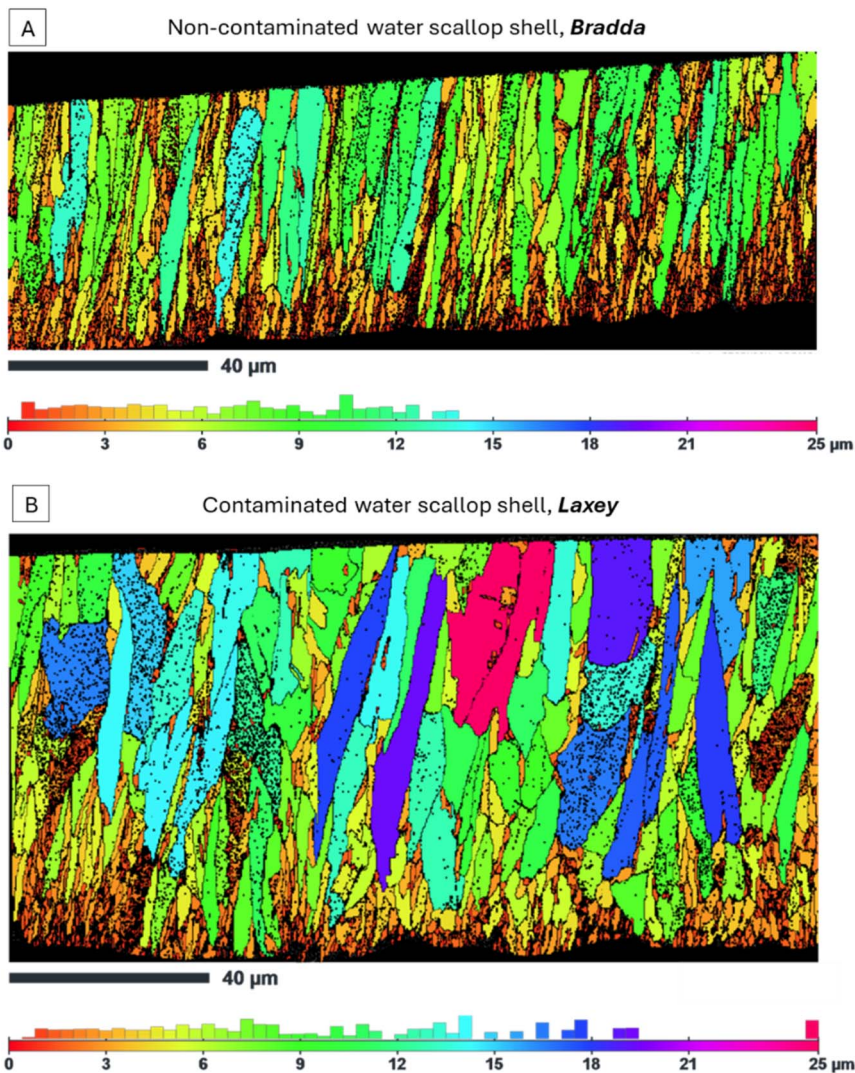
Fig. 7 EBSD grains maps with a color scale according to grain size (longest dimension) in the myostracum.

Additionally, EBSD analysis allows us to detect orientation variations, which helps determine the size of orientation domains or the grain size when grain boundaries are identified (non-indexed grain boundaries). Fig. 7 presents EBSD maps of the grain size distribution in the myostracum, for both shell types, with a colored scale corresponding to the grain longest dimension providing a quantitative analysis of the variation in grain size within the myostracum. The size variation is clearly visible, indicating submicron grain-sizes at the lower interface (red orange) which rapidly increase in size towards the upper interface.

The lower boundary is distinctly composed of small grains, which could reflect the early stages of growth since it is observable in both shells. The shell from the contaminated site, however, appears to have a broader grain distribution.

To obtain a more representative grain size distribution, it would be necessary to measure the grain sizes over a larger area to ensure a sufficient number of grains are sampled. However, even with the current map, it is already evident that the regular elongated shape observed in the non-contaminated site shell does not appear as consistently regular in the contaminated counterpart. In fact, surprisingly large grains can be observed (note turquoise, purple and magenta in Fig. 7(B)).
