# Combined crystallographic study of king scallop (*Pecten maximus*) shells using SEM, EBSD and Raman spectroscopy

DOI: 10.1039/d5fd00029g

The shells of *Pecten maximus* (king scallop) are composed primarily of polycrystalline calcitic calcium carbonate, with a crucial aragonitic prismatic myostracum layer that facilitates soft tissue attachment and contributes to mechanical strength. Despite its importance, the impact of environmental stressors, such as metal contamination, on the myostracum remains underexplored. Hence, this study's main goal was to shed light on the microstructure and crystallography of king scallop shells, particularly the myostracum region, using a combination of scanning electron microscopy (SEM), electron backscatter diffraction (EBSD) analysis, and Raman spectroscopy. This approach was chosen to develop new protocols that integrate imaging techniques for a systematic analysis of pollution effects on shell growth and properties. Such an understanding is crucial for assessing the impact of environmental contamination on shell structure and composition. We compared samples from a metal contaminated site (Laxey) with those from non-contaminated site (Bradda)

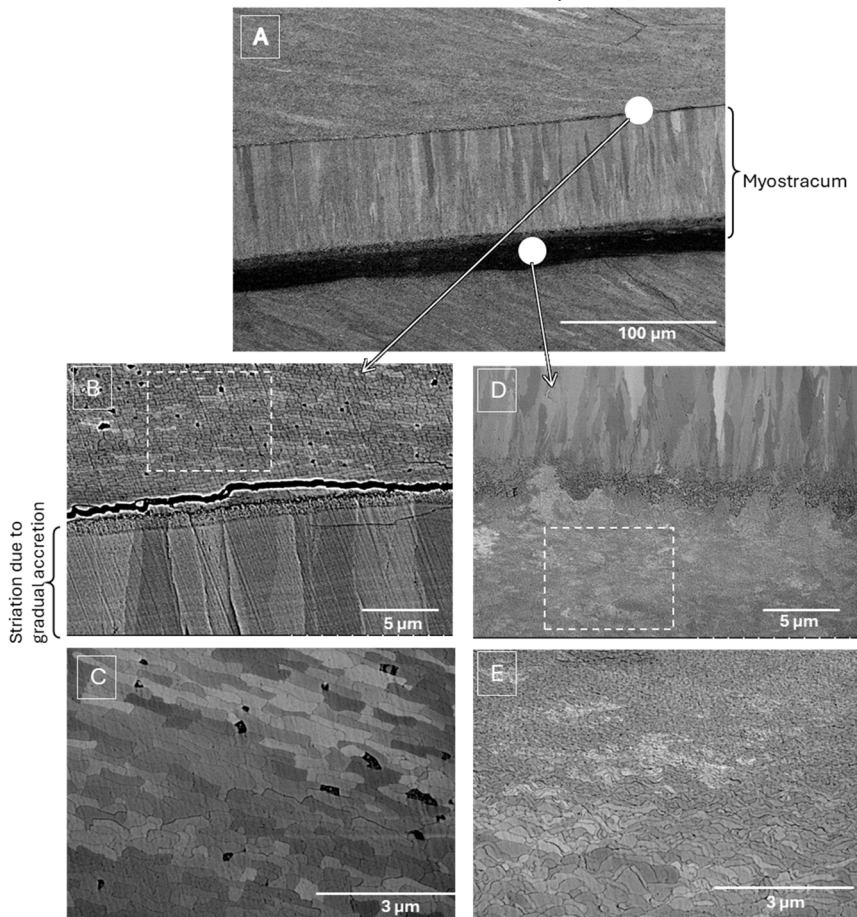
Non-contaminated site scallop shell, *Bradda*

Fig. 4 BSE micrographs of the myostracum region for the scallop shell collected in the non-contaminated Bradda area. (A) A general view of the region of interest. (B) The upper boundaries between the myostracum and the shell bulk. (C) The microstructures of the scallop in the region at the top of the myostracum. (D) The lower boundaries between the myostracum and the shell bulk. (E) The microstructures of the shell in the region below the myostracum.

Fig. 4(A) and 5(A) display an overall microstructural organization for the longitudinal section around the myostracum region of scallop shells respectively from non-contaminated and contaminated sites. These backscattered electron images show channeling contrast and provide an overview of crystal orientation variations, particularly within the myostracum, which is, in both types of scallops, clearly visible and sandwiched between two foliated calcite areas. This allows us

First, it is observed that the overall organization was similar for both types of scallops. Focusing on the myostracum, it consists of elongated, oriented grains. However, the grains in the lower part of both myostracum layers are notably fine and small. These grains gradually increase in both length and width towards the upper part of the myostracum, while maintaining a consistent growth orientation, resulting in a clear size gradient. Despite this similarity between the two types of shells, a noticeable difference in morphology and distribution is observed. The grains in the myostracum within the shell from the non-contaminated site appear more elongated and regularly arranged.

Examining the calcitic regions surrounding the myostracum reveals notable differences in microstructure. Fig. 4(B), (C), 5(B) and (C) provide a closer view of the region above the myostracum. In both shell types, the shape and grain distribution are uniform and consistent in size (around 1 micron in size). The boundary between the aragonite myostracum and the calcitic bulk is clearly defined, with homogeneous grains in the upper calcitic region, contrasting with the larger, elongated grains of the upper myostracum. The contrast variations between the grains are due to slight differences in their relative orientations, due to the BSE channeling contrast.

The boundary between the two microstructures in the lower myostracum appears less distinct as can be observed in Fig. 4(D) and 5(D). Again, there is little

Near the myostracum, the calcite grains are nanocrystalline (see Fig. 4(E) and 5(E)) and a size gradient is observed as the distance from the myostracum increases. In the shell from contaminated site, this gradient extends over a larger

Furthermore, growth lines can be identified in the Raman maps associated with the accretion sequence during the myostracum formation. These growth lines are also visible in the SEM image of samples from both contaminated and non-contaminated sites and are shown in Fig. 4(B) and 5(B).

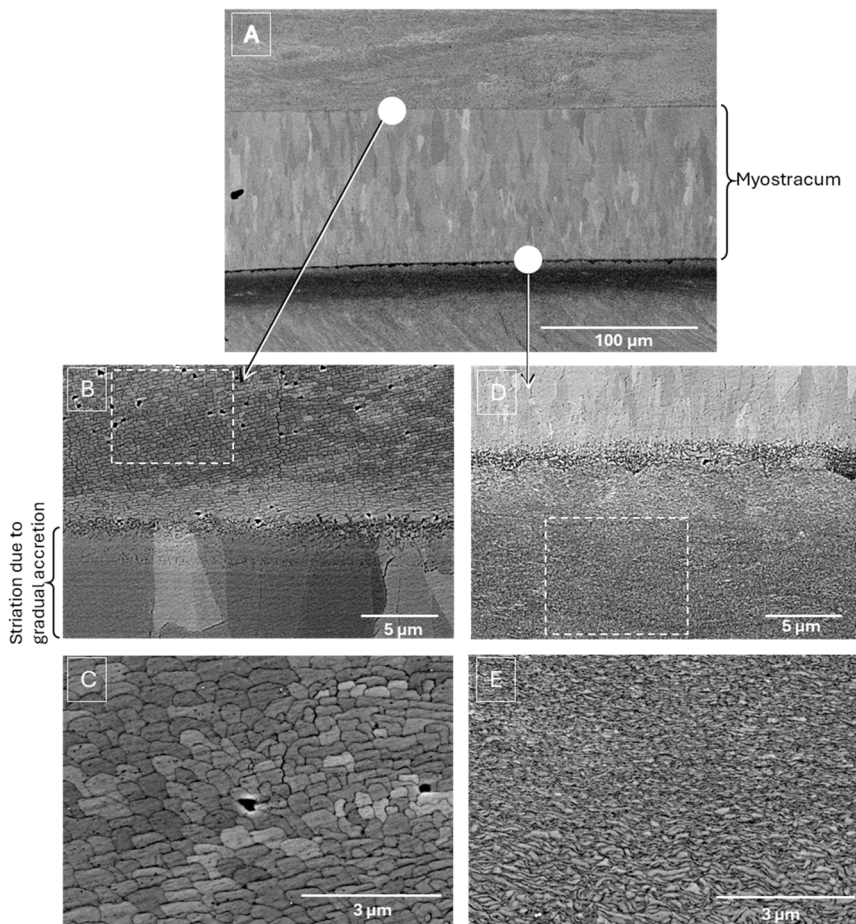
Contaminated site scallop shell, *Laxey*

Fig. 5 BSE micrographs of the myostracum region for the scallop shell collected in the contaminated Laxey area. (A) A general view of the region of interest. (B) The upper boundaries between the myostracum and the shell bulk. (C) The microstructures of the scallop in the region at the top of the myostracum. (D) The lower boundaries between the myostracum and the shell bulk. (E) The microstructures of the shell in the region below the myostracum.

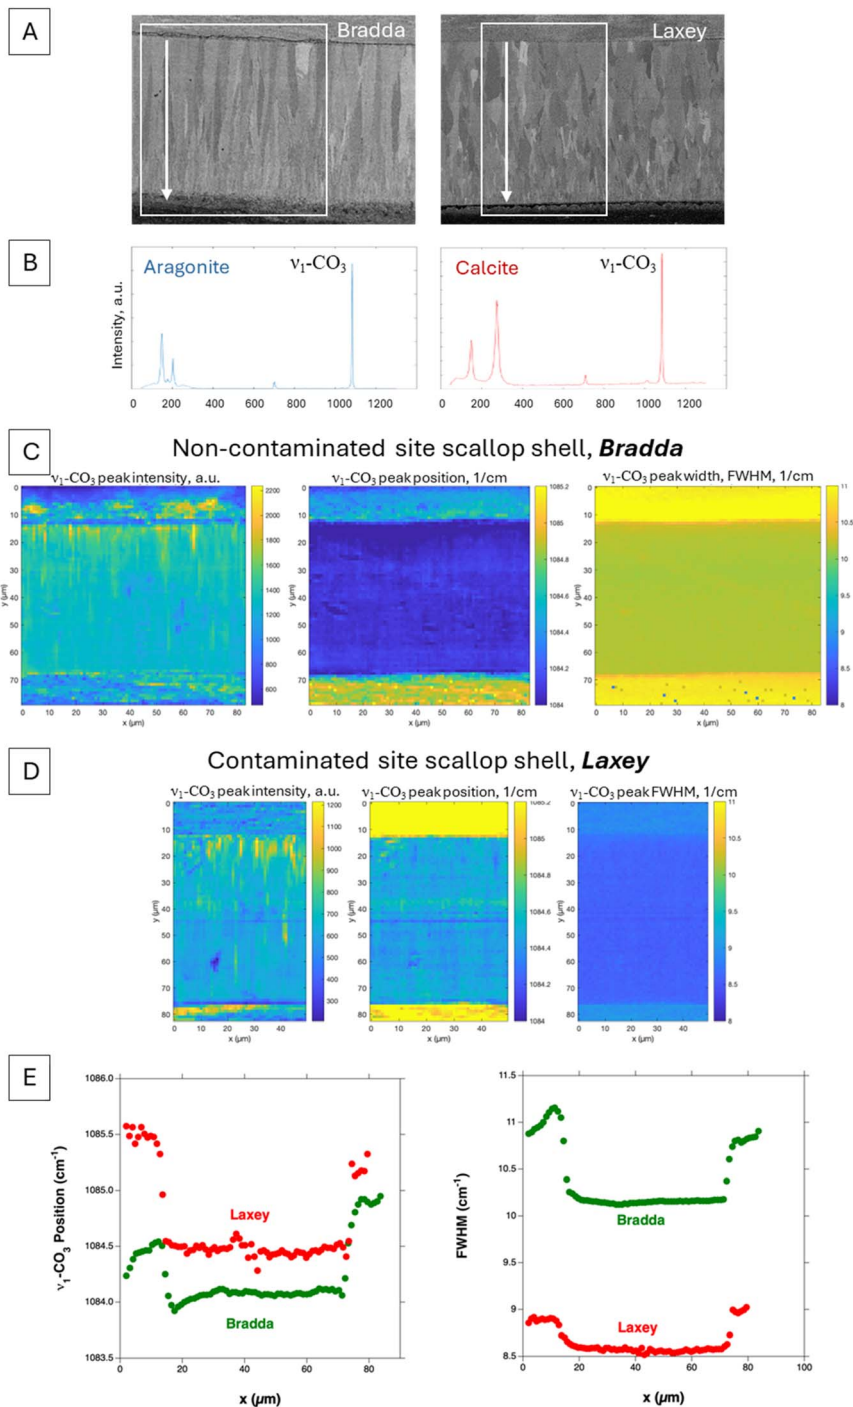
**Fig. 8** (A) BSE images of a sample from non-contaminated (Bradda) and contaminated (Laxey) sites; (B) Raman spectra taken from the myostracum and foliated regions of the Bradda sample, (C)  $\nu_1$ -CO<sub>3</sub> Raman maps evaluating peak intensity, position and full width at half maximum of the Bradda and (D) and Laxey samples, (E) comparison of line profiles from top to bottom of the  $\nu_1$ -CO<sub>3</sub> Raman position and full width at half maximum for Bradda and Laxey samples.

The parallel Raman study also revealed differences in response between the regions at the upper and lower boundaries of the myostracum. The results are presented in Fig. 8. Using the  $\nu_1$ -CO<sub>3</sub> symmetric stretching mode for Raman

mapping, we observed, for all analysed samples, systematic shifts in the peak position above, below and across the myostracum, with a difference of  $0.5 \text{ cm}^{-1}$  between each. In comparison to the aragonitic myostracum, the top calcite domain is  $0.5 \text{ cm}^{-1}$  higher, while the lower domain differs by  $1 \text{ cm}^{-1}$ . The peak position in samples from the non-contaminated site is overall shifted to smaller wavelengths. Moreover, the  $\nu_1\text{-CO}_3$  peak width is marginally higher for the non-contaminated site shells than in its contaminated counterpart. This variation in peak position and width may indicate intrinsic crystallite strain or be related to smaller grain sizes. It remains to be determined whether the crystallite size or intrinsic strain contribute to the peak shift and broadening. However, small and pre-strained crystallites have been identified in other mineralized tissues such as dental enamel, dentin, bone, and other bivalve shells indicating that it could be a “toughening” feature, rather than a random occurrence.<sup>21–23</sup>
