Cite this: *Environ. Sci.: Water Res. Technol.*, 2016, 2, 164

Survey of green building water systems reveals elevated water age and water quality concerns†

William J. Rhoads,* Amy Pruden and Marc A. Edwards

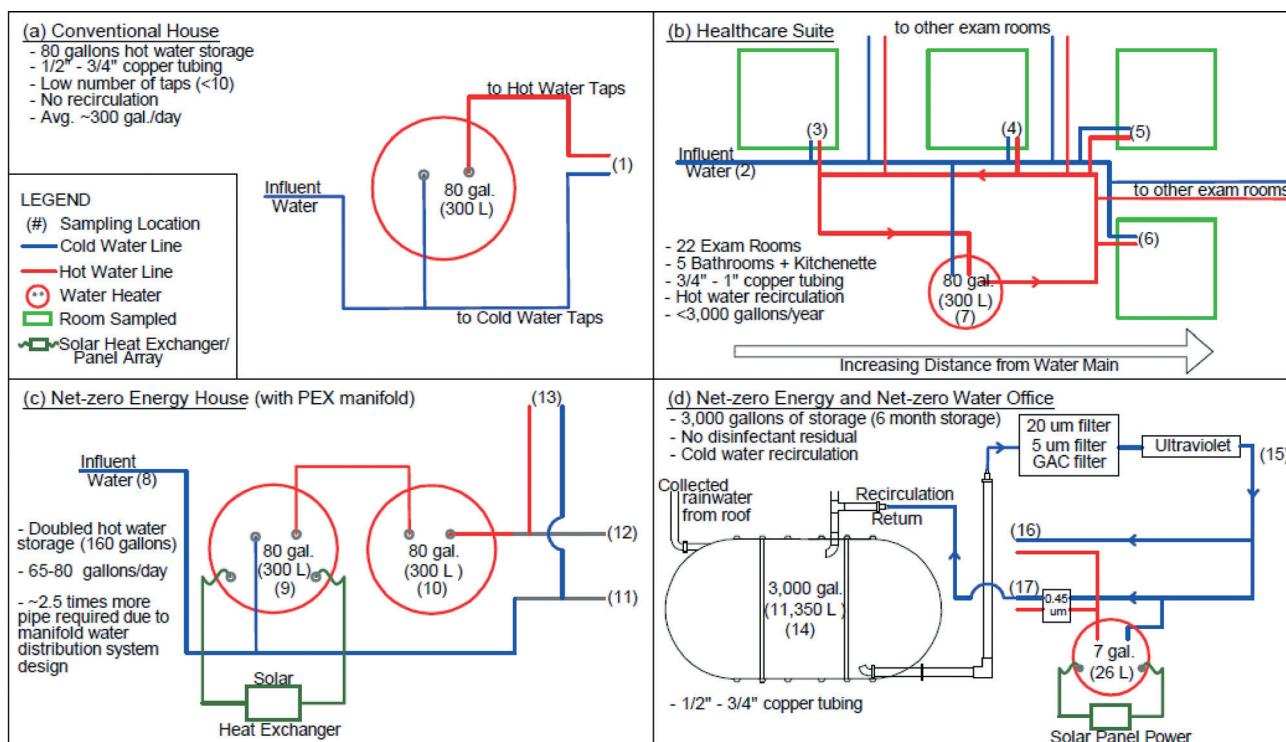
Fig. 1 Plumbing schematics and sampling locations for each field site.

Note: Numbers 1-17 in parentheses indicate sampling locations referred to in Table 2.

Four buildings with a cross-section of energy and water conservation strategies were surveyed and sampled to explore effects of green plumbing systems on water quality (Table 1). The buildings included a conventional house with no conservation features (Fig. 1a), a healthcare suite (Fig. 1b), a net-zero energy house (Fig. 1c), and a net-zero energy and net-zero water office building (Fig. 1d).

This study provided detailed documentation of the potable water systems in three innovative green buildings (Fig. 1). After reviewing the characteristics of each water system and closely examining trends in disinfectant residuals within the buildings, we provide an overview of microbial sampling from each building.

minutes of flushing was necessary to establish a chloramine residual similar to that present in the main distribution system (Fig. 2a). Taps at these locations are typically used for 15–30 seconds at a time; therefore, it is unlikely that a chloramine residual is ever present in portions of this plumbing system. Approximately 30 minutes of flushing was required at the net-zero energy house to establish a residual in the cold water system during the first site visit. In contrast, the conventional home had a residual of 0.71 mg L⁻¹ chlorine as Cl₂ in stagnant cold water. The water heaters at the net-zero house had <0.15 mg L⁻¹ chlorine as Cl₂ during a 20 minute flush due to the added storage volume and water age associated with the solar heater (Fig. 1c).

^a Sampling location numbers refer to locations depicted in Fig. 1. ^b Average (and median) of the four exam rooms is reported. ^c BD = below detection. ^d BQL = below quantification limit.

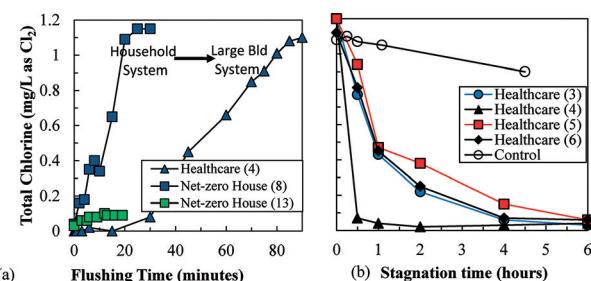
Note: Sampling locations indicated in parenthesis in the figure legends correspond to sample locations depicted in Figure 1.

Fig. 2 Total chlorine residual concentrations (a) as a function of stagnation in one room at the healthcare suite (large building system above), a tap near the head of the building at the net-zero house (household system above), and during three showering events at net-zero house, and (b) as a function of stagnation in several rooms at FS#1 (control represents identical water placed in a glass container with no head space).

The healthcare suite also showed evidence of very rapid disinfectant residual decay. In all four exam rooms monitored, the first-order decay rate of chloramine in the plumbing was 20–144 times greater than in well-flushed (>80 minutes) water collected from the same tap and placed into a glass container with no headspace (*i.e.*, “control,” Fig. 2b). The highest rate of decay (sample location 4) was observed in
