Unravelling and quantifying the aging processes of commercial  $\text{Li}(\text{Ni}_{0.5}\text{Co}_{0.2}\text{Mn}_{0.3})\text{O}_2/\text{graphite}$  lithium-ion batteries under constant current cycling

See Siyu Jin, Yaolin Xu *et al.*,  
*J. Mater. Chem. A*, 2023, **11**, 41.

DOI: 10.1039/d2ta05960f

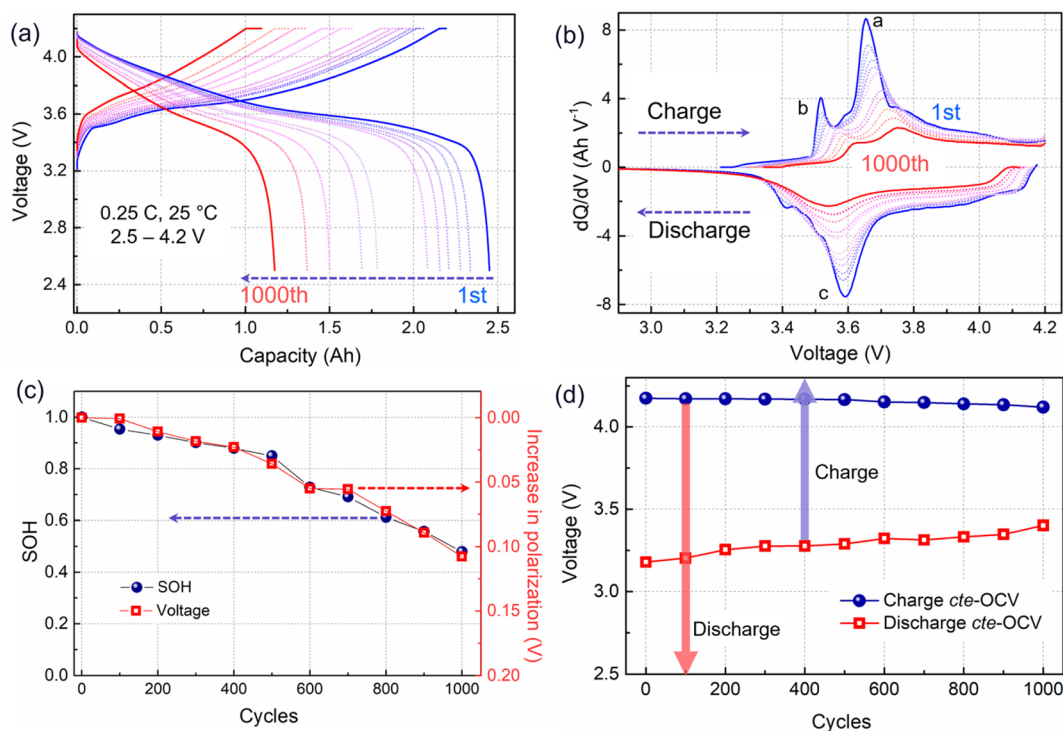
Fig. 1 Electrochemical behavior from the reference performance test (RPT) after every one hundred cycles at 0.25C (0.55 A) and 25 °C. (a) Charge and discharge curves, (b) IC curves, (c) SOH and polarization evolution (shift of the b peak in (b)) over cycling, and (d) charging and discharging cte-OCV. The arrows represent the real voltage window of discharging/charging.

ICA and cte-OCV techniques were employed to preliminarily diagnose the battery degradation mechanisms. The charging/discharging curves from eleven RPTs are presented in Fig. 1a. With the battery aging evolution, the charging plateau shows an increasing trend, whereas the discharge plateau becomes lower.

Then, the voltage gap between the charging and discharging plateaus, which is associated with the battery impedance, is gradually increasing. Meanwhile, the voltage plateau is significantly shortened, corresponding to a decrease in capacity. To further clarify the process of voltage plateau evolution, ICA was applied to the charging–discharging curves in Fig. 1a, and the obtained results are shown in Fig. 1b. The IC curves are associated with the phase transitions of active materials during the Li<sup>+</sup> shuttle, corresponding to the a and b peaks in the charging process and c peak in the discharging process. Along with cycling, the IC peaks in the charging process show an obvious shift toward a higher voltage, implying a polarization increase.<sup>20</sup> Usually, the shift of the higher voltage peak a may be related to a disproportionate loss of the active material at the positive and negative electrodes.<sup>21</sup> In this work, we choose the shift of the b peak at a lower potential to quantify the increase in polarization, as shown in Fig. 1c. The progression of the capacity fade (expressed as SOH) is clearly related to the increase in polarization.

A close-to-equilibrium open-circuit voltage (cte-OCV) measurement was carried out to analyze the OCV behavior with battery aging, as shown in Fig. 1d. The discharging cte-OCV increases gradually, due to the increase in polarization. As expected, the charging cte-OCV did not increase, instead a slightly decreasing trend is observed. This will lead to a decreased charging OCV range as well as a decreased charging capacity.

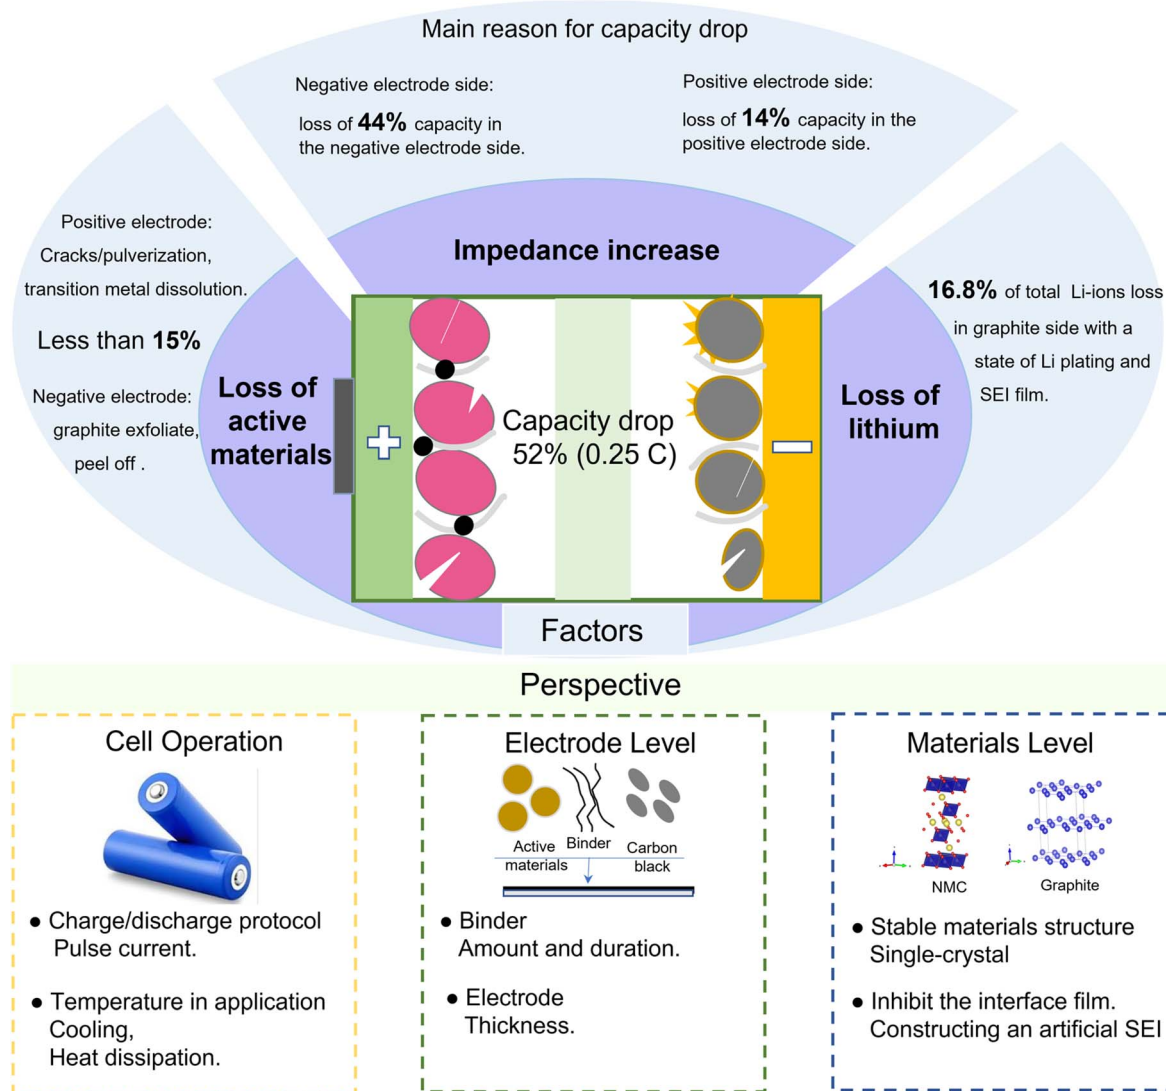
Fig. 7 Overview of the processes related to battery capacity fade and perspectives for extending the cycle life.

To further extend the battery life, some measures can be taken to stabilize the battery performance from the aspects of full-cell operation, electrode fabrication, or electrode material preparation. At the full-cell application level, the impedance increase can be inhibited by some reasonable charging/discharging protocols, such as dynamic pulse current.<sup>6</sup> The thickening of the SEI film is mainly caused by the repeated formation and cracking processes, resulting in an increased interface impedance and a deteriorated battery performance. The application of pulse current in LIBs can construct a high stability and low impedance SEI film.<sup>40</sup> Then, the increase in interface impedance can be effectively inhibited. Furthermore, adjusting the frequency and duty cycle of pulse current can achieve a fast charging. Besides, the temperature of the battery during operation is high and the surface temperature is close to 50 °C, even at room temperature. The high temperature will exacerbate the side reactions at the electrode interface, and then transition metals from the positive electrode will dissolve in the electrolyte and deposit on the graphite surface, resulting in the loss of active materials and an impedance increase. Therefore, heat dissipation or cooling systems are needed for the battery to operate in high-temperature environments.

At the electrode level, the phenomenon of active materials peeling is obvious for both aged positive and negative electrodes, and the formed debris detaches from the electrodes and current collectors, not only causing the loss of active materials but also hindering the diffusion of Li-ions. A durable binder is necessary to build a tight connection between the active materials and the current collector. Besides, the thickness of electrodes is also an important parameter for the battery performance. With a thicker electrode, the Li-ion transport path is longer, resulting in a battery impedance increase. However, a smaller electrode thickness will lead to a low energy density. Furthermore, the thickness of electrodes is also related to the

ratio of the negative electrode capacity and positive electrode capacity, *i.e.*, the *N/P* ratio. A high *N/P* ratio means excess graphite as well as SEI film formation, while a lower *N/P* will lead to the formation of Li-plating.<sup>8</sup> Therefore, the thickness of electrodes (*N/P*) can be optimized to reduce the loss of active materials and inhibit the impedance increase.

At the material level, the pulverization and volume expansion of the cathode particles are serious, which will enlarge the transfer path of Li-ions, resulting in an increased impedance. The cathode materials with a single-crystal structure will effectively inhibit pulverization and volume expansion. Besides, the lower specific surface area of single-crystal particles also inhibits the amount of interface film and the dissolution of transition metals.<sup>41</sup> For the interface film, constructing an artificial SEI on the graphite surface can inhibit the deposition derived from electrolyte decomposition and the anion solvation effect, resulting in a stable electrode/electrolyte interface as well as superior cycling stability.<sup>42</sup>
