Cite this: *Energy Environ. Sci.*,  
2025, 18, 9254

# Investigating the effect of lithiation on polycrystalline NMC811 Li-ion battery cathode cracking using *in situ* SEM micromechanical testing

Aigerim Omirkhan, <sup>\*ab</sup> Oriol Gavalda-Diaz, <sup>a</sup> Siyang Wang, <sup>a</sup>  
Ifan E. L. Stephens, <sup>ab</sup> Finn Giuliani <sup>a</sup> and Mary P. Ryan <sup>\*ab</sup>

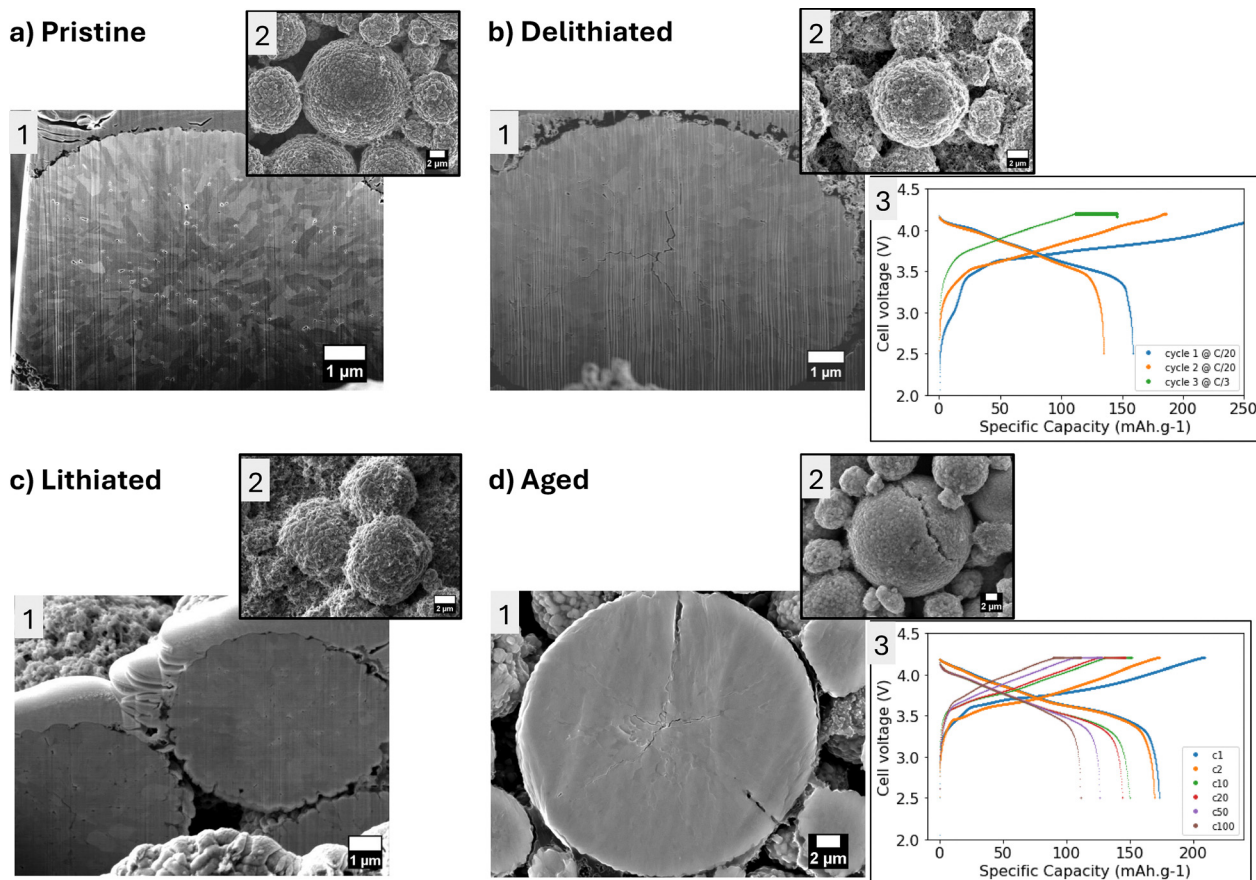
**Fig. 1** SEM characterisation and electrochemical cycling of NMC811 cathodes. (a) Cross section of pristine polycrystalline uncalendered NMC811 cathode showing absence of crack at the centre (1). No cracks are visible on the surface of the secondary particles (2); (b) cross section of NMC811 cathode particle in delithiated state showing the presence of the crack at the centre of the particle (1). The cracks were not visible on the surface SEM images (2). The sample was extracted from the full cell configuration cycled with 2 formation cycles at C/20 rate and 1 charging cycle at C/3 rate (3); (c) the cross section of the (re)lithiated samples showing two particles: with (left) and without (crack) in the center (1). No cracks were visible on top SEM images (2); (d) the cross section of aged NMC811 cathode particle (1) in (re)lithiated state showing the cracks at the centre of the particle. Cracks can also be observed on outer surfaces of secondary particles (2). The sample was cycled in a full cell configuration with 2 formation cycles at C/20 rate and 98 cycles at C/3 rate (3).

Polycrystalline NMC811 particles were characterised under different electrochemical states. Fig. 1 shows the SEM micrographs of pristine, delithiated, lithiated and aged polycrystalline NMC811 particles following prolonged cycling. The morphology of the secondary particles in the as-received state is shown in Fig. 1a-2 and in SI1: Fig S2a and b, where the 100–300 nm range primary particles are assembled into spherical secondary particles of 5–15 µm diameter. No cracks were observed in the cross sections of pristine, as-received NMC811 cathode particles (Fig. 1a-1). Following 2 formation cycles at C/20 rate and 1 charge to 4.2 V at C/3 rate, there are no apparent cracks on the top view SEM

image (Fig. 1b-2). However, once the cross-section was exposed using broad-beam argon milling, small cracks were observed at the centre of the delithiated particle (Fig. 1b-1). Note that similar result is observed when the cross-sectioning was carried out using either a Ga<sup>+</sup> ion beam or Xe plasma, confirming that the preparation method did not induce cracking of the material (SI1: Fig. S3a and b). There was also a noticeable increase in porosity between the primary particles of NMC811 in the delithiated state, compared to the homogeneity observed in the pristine particles. This can be related to the primary particle inhomogeneity and lattice mismatch at high SOC.<sup>12,28</sup> The origin of this lattice mismatch lies in the formation of rigid rock-salt or spinel layers on the surface of the layered NMC811. During delithiation, the layered structure undergoes *a/b* lattice parameter contraction and initial *c*-axis expansion, followed by rapid contraction. On the other hand, the rock-salt structure remains unchanged owing to the absence of Li activity, resulting in a considerable lattice mismatch during delithiation at high SOC. Indeed, TEM characterisation of the NMC811 sample delithiated to 4.2 V *vs.* Li/Li<sup>+</sup> confirms the presence of rock-salt layer, alongside cation-mixed and layered structures (SI1: Fig. S4).

Fig. 1c-1 shows the cross sections of two (re)lithiated NMC811 particles: one with a visible crack at the centre and one without. Study of intragranular cracking in polycrystalline NMC811 showed reversible formation of nanoscale cracks at delithiated state in early cycling.<sup>29</sup> If no contact with electrolyte has occurred, these closed yet resulted in increased lattice spacing. Over time, the surface was irreversibly reduced as evident by evolution of rock-salt layer that was found inside the primary particle. Similarly, initial intergranular cracks (and pores) in secondary particles were shown to close up upon (re)lithiation during discharge as evidenced by operando X-ray computed tomography (XCT).<sup>26</sup> Authors tracked the particles during 10 cycles and showed that cumulative effect of volume expansion and contraction over repeated cycles lead to more damaged particles. It must be noticed that the small cracks similar to one depicted in Fig. 1c-1 can be challenging to track *via* XCT as its size is much smaller than the resolution of the synchrotron technique (<325 nm).

Upon ageing the sample through continuous cycling between 2.5 V and 4.2 V, cracks become visible on the external faces of the particle, suggesting that the internal cracks are now more established on the surface of the particle (Fig. 1d-2). This agrees with the significant cycle-on-cycle capacity reduction seen during electrochemical cycling of the cell in Fig. 1d-3. When cracks are sufficiently wide for the electrolyte ingress, fresh cathode areas are exposed to electrolyte infiltration. The reaction takes place at these sites, resulting in CEI formation, which reduces the amount of active material and increases the cathode impedance. It also creates more surface for cation mixing, rock-salt reconstruction and gas evolution.<sup>23,30</sup> This increases the fatigued phase concentration, which is defined as areas with large mismatch between the layered and epitaxially grown rock-salt layers.<sup>28</sup> Quantifying the strength of NMC811 particles as a function of state of charge and cycling history is an important step in understanding the link between

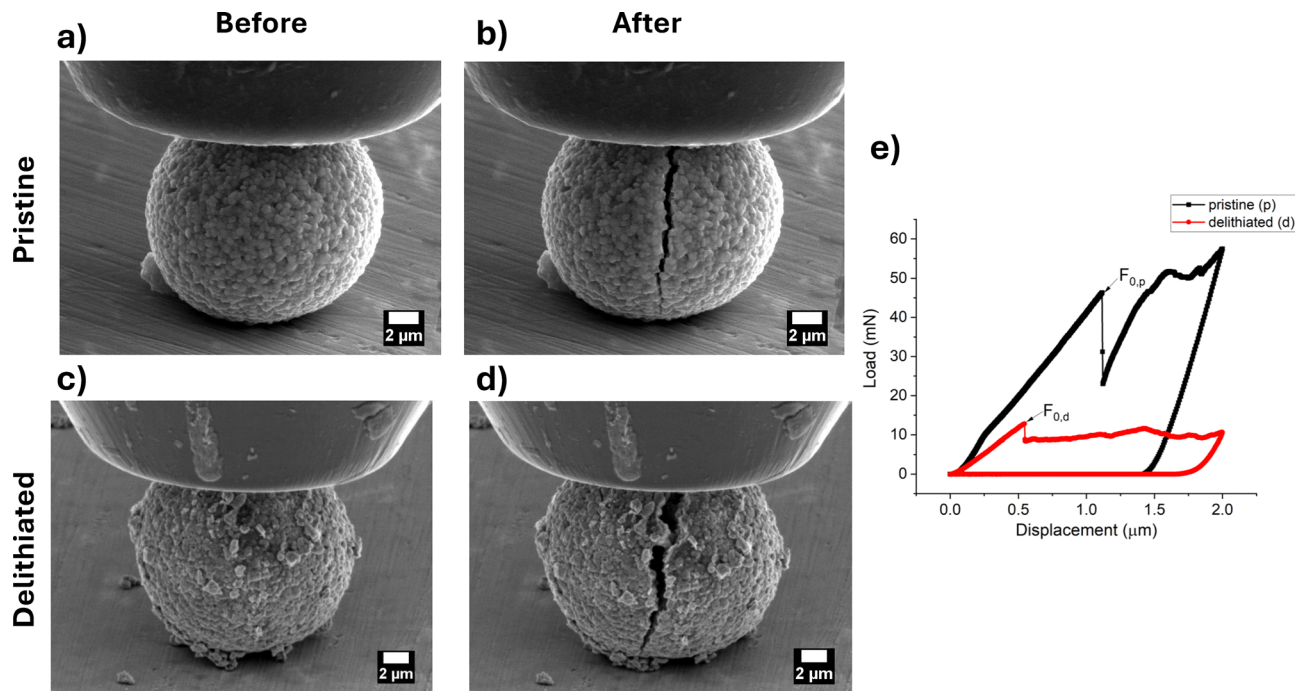
Fig. 2 The SEM images of NMC811 secondary particles before and after intragranular crack appearance in the pristine (a) and (b) and delithiated (c) and (d) states. The corresponding load–displacement curves (e) are presented with the critical loads denoted as  $F_{0,p}$  and  $F_{0,d}$  for pristine and delithiated particles respectively.

the particle can be approximated to 0.9 times the critical load divided by the square of the particle diameter, *i.e.* the distance between loading points. This assumes that the fracture takes place due to tensile stress over the centre of the particle. Fig. 2a and b present the SEM images just before and immediately after crack appearance on the pristine, which exists in the lithiated state, NMC811 particle (full videos of particle loading tests can be found in SI2). Similar SEM images are presented in Fig. 2c and d for the delithiated NMC811 particle extracted from a full coin cell charged to 4.2 V at C/20 rate. The fracture of the particles occurred at loads denoted in Fig. 2e as the critical load,  $F_0$ . For both pristine (lithiated) and delithiated particles, the crack propagates from the centre of the particle along the grain boundaries between the primary particles. For similar particle sizes, the critical load for delithiated particles  $F_{0,d}$  is considerably lower than that of the pristine, lithiated cathode particles  $F_{0,p}$ . This indicates a reduction in the strength of the particles upon delithiation during the battery charging, even on the first cycle.

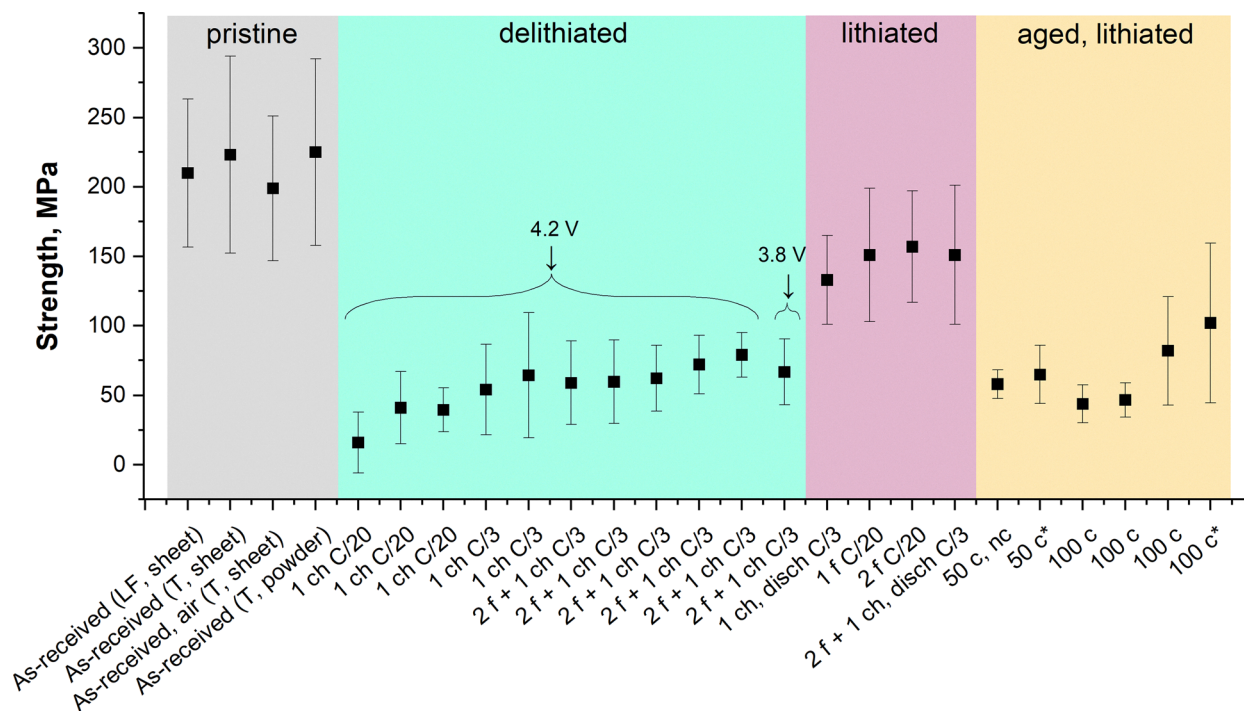
**Fig. 3** Average particle strength of polycrystalline NMC811 as a function of electrochemical cycling history, comparing pristine and cycled samples in delithiated, lithiated, and aged states. Error bars represent standard deviation. Pristine particles were either in powder form or extracted from cast sheet electrodes provided by two suppliers: Targray Technology International (non-calendered, T) and Li-FUN Technology (calendered, LF). Cycled particles were obtained from NMC811 vs. graphite coin cells cycled in LP50 electrolyte, unless marked with an asterisk (\*), indicating NMC811 vs. lithium metal cells. Aged samples are in the lithiated state. Electrochemical history is denoted using the following notation: ch – charged; disch – discharged; f – formation cycle; C/3 and C/20 – cycling rates. For example, “2f + 1 ch C/3” indicates 2 formation cycles (at C/20 rate) followed by 1 charge at C/3 rate, resulting in a delithiated cathode state.

**Strength of pristine NMC811 samples.** Fig. 3 presents the results averaged from 277 powder compression tests across 25 samples in pristine, delithiated, lithiated states, and aged after 50 and 100 cycles (see SI1, Table S1 for number of particles tested per sample). Broadly, there was no correlation between the particle strength and the diameter of the cycled particles (SI1: Fig. S6). The strength of the particles was calculated using Hiramatsu and Oka equation mentioned earlier. As-received pristine NMC811 cathode samples extracted from cast cathode sheets had strengths of  $210 \pm 53$  MPa and  $223 \pm 71$  MPa for calendered and non-calendered samples respectively. Since these samples were sourced from different suppliers, and given the standard deviation reported, we are unable to confirm if the calendaring process affected the strength of the particles. We have also exposed several particles to air for 2 hours and did not observe statistically significant strength reduction ( $199 \pm 52$  MPa). Pristine powder sample had strength of  $225 \pm 67$  MPa and is in good agreement with non-calendered cast electrode sample.

**Strength of delithiated NMC811 samples.** As mentioned in the previous section, the cross-section SEM images revealed the presence of cracks in the sample charged to 4.2 V at C/20 rate. These particles had the average strength of  $16 \pm 22$  MPa in non-calendered sample, while calendered samples had average strength of  $41 \pm 26$  MPa and  $40 \pm 16$  MPa across two samples, indicating a dramatic decrease in strength during the first delithiation event. Calendaring electrodes is known to enhance interfacial contact, which can improve rate capability during cycling.<sup>31</sup> During slow delithiation at C/20, differences in lithium extraction between calendered and uncalendered

**Strength of aged NMC811 samples.** Finally, we can see in Fig. 3 that aging NMC811 material *via* extended cycling results in further reduction of the particle strength compared to as-received and lithiated samples. Across 6 aged samples, the particle strength after 50 cycles was  $58 \pm 10$  MPa (full cell) and  $65 \pm 21$  MPa (half-cell); while the variation after 100 cycles was quite prominent with average strength values between  $44 \pm 14$  MPa and  $82 \pm 39$  MPa measured for full cells, and  $102 \pm 58$  MPa for half-cell configurations. Interestingly, this gradual reduction during aging is recorded both in high-capacity cells and cells with average performance (SI1: Fig. S8) as cycle-on-cycle capacity reduction is measured in all aged samples. This is likely caused by formation of permanent cracks (*i.e.* cracks that reach the surface of the particle and do not reduce in size on cycling), through layered structure transformation into the spinel and rock-salt structures, increasing lattice mismatch between these structures. Indeed, it was reported that prolonged cycling in polycrystalline NMC811 particles is associated with atomic-level transformations including rock-salt layer formation on crack surfaces, transition metal dissolution consistent with rock-salt layer, as well as strain and lattice distortions using scanning transmission electron microscopy (STEM) and electron energy loss spectroscopy (EELS).<sup>29</sup> Another study presented the TEM results of aged NMC811 samples after 100 cycles, where electrochemically inactive rock-salt layer

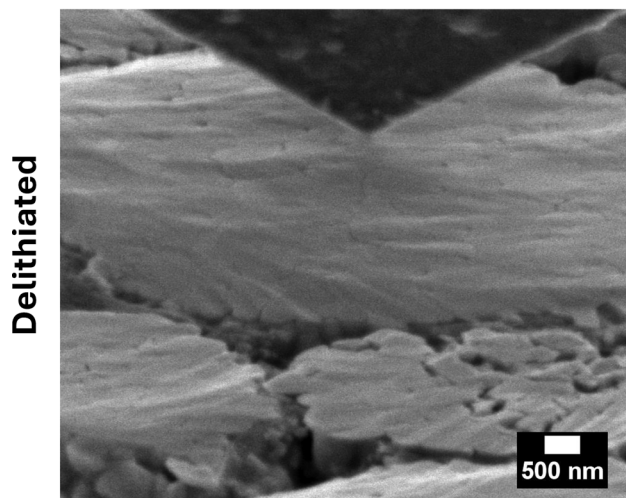
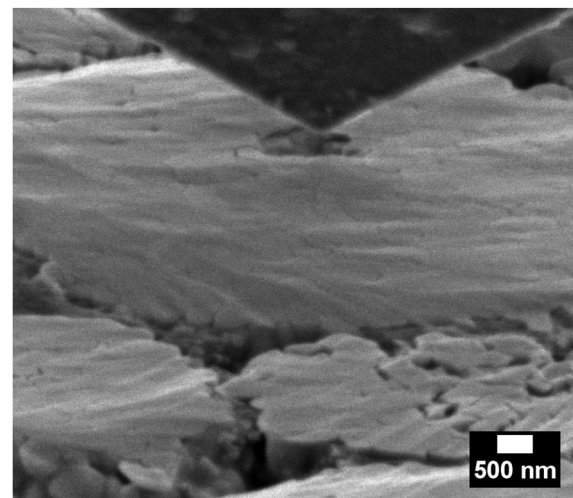
**Fig. 4** Snapshots extracted from a real time video recorded during *in situ* nanoindentation testing showing the cross-section of NMC811 sample and the cube corner nanoindenter tip (a) prior to and (b) following the application of a 3 mN load. The sample was charged to 4.2 V vs. Li/Li<sup>+</sup> and disassembled in the delithiated state.

*In situ* nanoindentation was used to corroborate single particle powder compression test results. Fig. 4 presents the snapshots taken during nanoindentation test, where the delithiated polycrystalline NMC811 particle cross-section was subject to 3 mN load. The hardness and elastic modulus of the pristine (lithiated) NMC811 particle cross-sections were compared to that of charged (delithiated) NMC811 particles in Table 1. The mechanical properties obtained from nanoindentation are in good agreement with those derived from powder compression, where significant reduction is seen at high SOC. Lithium ions shuttle out of the NMC811 structure during charging, resulting in a significantly weaker structure. As mentioned previously, TEM characterisation of delithiated NMC811 revealed the presence of rock-salt layer alongside layered and cation-mixed phases. This can result in significant anisotropic strain in the material. Fig. 4a and b reveal the presence of intergranular gaps at the boundaries between primary particles in the delithiated NMC811 sample at high SOC, observable as distinct separations along the grain boundaries. This apparent reduction in boundary strength, exacerbated by strain due to phase change, is one of the reasons for the decreased hardness observed in the nanoindentation tests. Voids between the primary particles of NMC811 at delithiated state are commonly occurring phenomena and were observed in TEM analysis (see SI1: Fig. S4a and b) as well as during Atom Probe Tomography (APT) sample preparation (SI1: Fig. S5).
