Cite this: *Environ. Sci.: Adv.*, 2024, 3, 972

Ongoing legacy contamination from a military radar station in Iceland: a case study

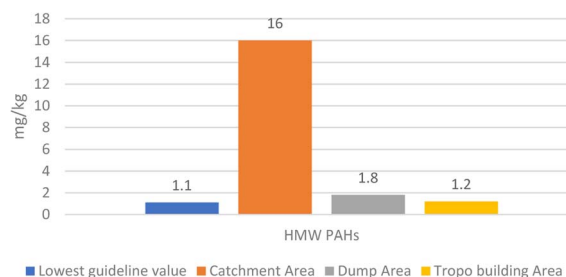
Fig. 7 HMW PAHs (mg kg⁻¹) tested in five areas with the content exceeding the lowest guideline value (1.1 mg kg⁻¹) in three areas. The highest values detected in the three areas are shown.

PAHs are released during incomplete combustion of petroleum products or from petroleum spill. They are persistent in the environment and several have multiple adverse health effects.²⁷ PAHs were summarized in two categories, low molecular weight PAHs (LMW PAHs) and high molecular weight PAHs (HMW PAHs), with the latter being more toxic and carcinogenic.⁵¹ Fifteen PAHs were tested (5 LMW and 10 HMW) in nine samples from five areas (Dump, Trope, Sewage outfall, Powerhouse and Catchment), see Table 1, and found to exceed the lowest guideline value at three areas: Catchment, Dump and Trope areas. The highest values in both categories (LMW and HMW) were found at the Catchment area (Table 2). See Fig. 7 for results for HMW PAHs.
