Cite this: *Energy Environ. Sci.*,
2025, 18, 264

Removal of residual contaminants by minute-level washing facilitates the direct regeneration of spent cathodes from retired EV Li-ion batteries†

DOI: 10.1039/d4ee03021d

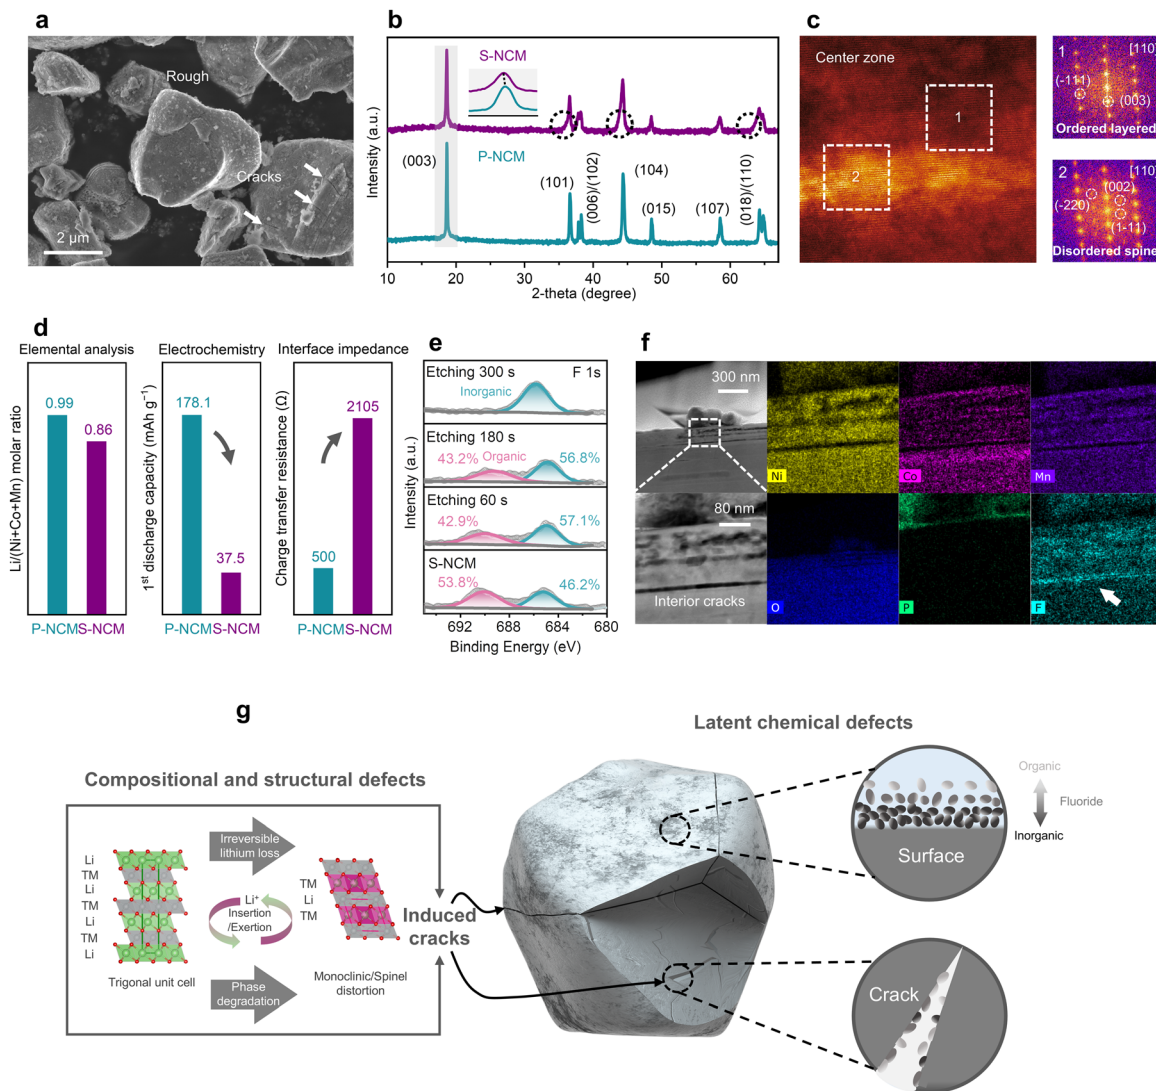
Fig. 1 Neglected chemical residuals on the 250k-miles-serviced cathode. (a) SEM image and (b) XRD pattern of the degraded S-NCM. The black dotted circle accentuates the subtle peaks that do not belong to the layered structure; (c) high-resolution HAADF-STEM images on the central area of the S-NCM particle and the FFT patterns of the selected dark and bright regions; (d) comprehensive comparison of lithium loss in degraded powders measured by ICP-OES, electrochemical capacity, and charge-transfer resistance analyses in the half-cell using S-NCM and P-NCM powders as cathode active materials; (e) F 1s XPS patterns of S-NCM powders for different sputtering times using an ion-beam. Based on the calculated integral area, the proportional values of the organics and inorganics in fluoride are presented in the patterns; (f) HAADF-STEM images based on focused ion beam cutting and an enlarged view displaying the interior microcracks. Corresponding EDS mapping analysis indicates the presence of F elements along these microcracks pointed out by a white arrow. (g) Deficiencies of S-NCM addressed before direct regeneration, including the compositional and structural aspects (e.g., irreversible lithium-ionic loss, phase degradation, internal and external cracks) and latent chemical defects (e.g., surface and crack-edge impurities enriching the F element).

As shown in the Materials and methods and Fig. S1 (ESI†), a series of pretreatments, such as sorting, dismantling, crushing, and shredding, were employed to collect the spent NCM cathode (denoted as S-NCM) with minor metal and polyvinylidene fluoride (PVDF) binder (Table S3 and Fig. S2, ESI†). First, a comprehensive comparison between S-NCM and pristine NCM cathodes (P-NCM) was conducted to identify the failure mechanism of the S-NCM materials. As shown in scanning electron microscope (SEM) images (Fig. 1a and Fig. S3, ESI†), the end-of-life battery S-NCM cathode showed intensive rough surface residuals with minor cracks after 250 000-mile service, with the planar gliding degradation and cracks in the single-crystal cathode consistent with previous reports.^{26,27} The X-ray diffraction (XRD) analysis, shown in Fig. 1b, demonstrated that the S-NCM still preserved an ordered layered $R\bar{3}m$ structure with a minor degraded phase near the (101), (104), and (018) peaks, possibly corresponding to the subtle monoclinic phase transition due to lithium loss.²⁸ According to the high angle annular dark field scanning transmission electron microscopy (HAADF-STEM) analysis and fast Fourier transform (FFT) pattern (Fig. 1c and Fig. S4, ESI†), the degraded S-NCM cathode showed a spinel phase in zone 2 and exhibited significant spatial heterogeneity. Besides the structural degradation, the inductively coupled plasma optical emission spectrometry (ICP-OES) result (Fig. 1d and Table S4, ESI†) indicated that, even after the long-term cycling, the end-of-life S-NCM cathode showed only 13.1% loss of Li inventory compared to the pristine P-NCM. Contradictorily, the specific capacity of S-NCM significantly declined to 37.5 mA h g⁻¹ compared to 178.1 mA h g⁻¹ for the P-NCM, as shown in Fig. 1d. Especially in the follow-up cycle, see Fig. S5 (ESI†), the S-NCM cathode exhibited a capacity of less than 10 mA h g⁻¹ after 100 cycles. Note that, there was only 13.1% Li deficiencies, which could not sufficiently account for the 78.9% capacity fading of S-NCM. Therefore, to further reveal the origin of the poor electrochemical performance, electrochemical impedance spectroscopy (EIS) characterization was conducted, as shown in Fig. 1d and Fig. S6 (ESI†), the charge-transfer resistance (R_{ct}) for S-NCM steeply climbed to 2105 Ω and was

four times larger than the P-NCM of 500 Ω . The increased impedance deteriorates the Li^+ diffusion, thus leading to the critical capacity decay. Therefore, the surface state of the spent cathode was recognized as the key issue limiting its capacity delivery, compared to compositional lithium loss and structural bulk defects.

To understand the surface state of the spent cathode, energy-dispersive spectroscopy (EDS) element mapping and X-ray photoelectron spectroscopy (XPS) were conducted. As shown in Fig. S7–S9, and Tables S5, S6 (ESI[†]), the S-NCM cathode surface residuals consisted of C, O, F, and P elements, and displayed a surface-rich gradient distribution, as revealed

by XPS with etching. The F 1s XPS peaks with etching for S-NCM are shown in Fig. 1e, where two F 1s peaks could be observed before sputtering, with the major peak centered at 685.5 eV, which was attributed to inorganic fluorides and the minor F 1s peak centered at 690.4 eV, which could be assigned to organic fluorides, with the ratio of 53.8% for organic fluorides.²⁹ However, the organic-related F peak declined significantly after sputtering, and completely disappeared after 300 s Ar^+ sputtering. The surface-rich distribution of organic fluoride was consistent with the cathode electrolyte interphase (CEI) composition previously reported.^{29,30}

To further reveal the microscopic distribution of those F-rich residuals, SEM combined with time-of-flight secondary ion mass spectrometry (SEM-ToF-SIMS) characterization was conducted for the cycled cathode. The results are shown in Fig. S10 and Videos S1, S2 (ESI[†]). Based on the spatial distribution of F⁻ secondary ion fragments, it was confirmed that fluoride impurities were primarily deposited on the particle surface. Moreover, during the long-time battery service, it could be observed from the HAADF-STEM image and corresponding element mapping (see Fig. 1f) that, in the S-NCM cathode, the fluorides could spread into the interior of the cathode along the intragranular cracks. Coincidentally, from the selected FFT figure shown in Fig. S4 (ESI[†]), the existence of an amorphous ring was observed along the intragranular cracking, which may be related to the fluorides also observed in the bulk. To sum up, the collected S-NCM exhibited limited structural and compositional degradation, while preserving the fluoride-containing impurities aggregated on the surface and along the intragranular cracks, as illustrated in Fig. 1g.

Furthermore, it was previously widely accepted that the source of F-rich impurities in the spent cathode was due to decomposition of the PVDF binder during the heat delamination process at around 350 °C;^{11,23–25,31} however, during the thermal decomposition of PVDF, most the fluoride-containing products were gas species (*i.e.*, HF) and fragments (–CF– and –CH–CF–),^{32–34} which are subject to ejection instead of propagating along the cathode intragranular cracks. To confirm the source of those observed residual impurities, four kinds of cathodes with varying cycling conditions were collected and examined, namely cathode laminates with/without electrolyte filling, and laminates from 125k and 250k miles-serviced batteries, as listed in Table S7 (ESI[†]). The SEM images and electrochemical performance are shown in Fig. S11 and S12 (ESI[†]). Compared with the pristine one (sample A), the other spent cathodes from battery formation and cycling exhibited a rough surface and limited discharge capacity. Notably, the laminate from formation only but with no cycling (sample B), which it was believed would retain the full lithium inventory and show negligible structural degradation since it had not undergone charge/discharge cycling, showed a poor discharge capacity, which was the same as the other long-cycled ones. Moreover, the heat exfoliation used to pyrolyze the adhesive binders deteriorated the original CEI layer on the spent cathodes and generated more harmful byproducts (*e.g.*, Li₂CO₃, Li₃PO₄, LiF). This, combined with electrolyte decomposition during electrochemical cycling, exacerbates chemical degradation, resulting in a significant capacity decline. Therefore, the above comparison revealed that the cathode residual impurities should originate from the electrolyte components (such as LiPF₆, DMC, ethylene carbonate (EC)) decomposition during battery formation, cycling, and common heat exfoliation, leading to severe capacity loss in spent cathodes (Fig. 1d).

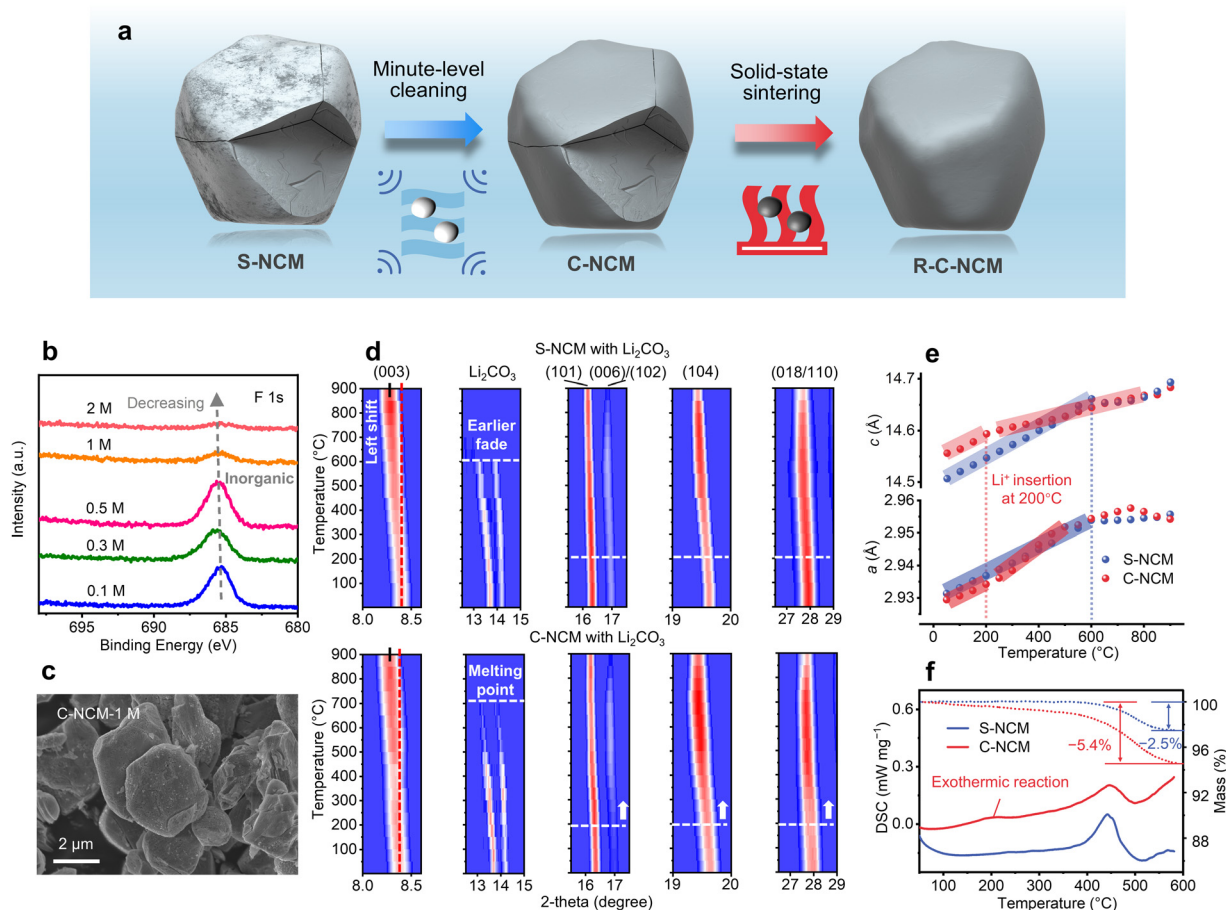
Fig. 2 Removal of the impurities and change in the crystal structure during the direct regeneration process combined with pretreatment. (a) Traditional direct regeneration path using solid-state sintering and the minute-level pretreatment introduced in an advanced path targeted to the critical obstacles within degraded cathode materials; (b) F 1s XPS fine patterns of C-NCM undergoing ultrasonic stirring in solutions with different concentrations; (c) SEM image of C-NCM obtained by soaking S-NCM in 1 M HNO₃ solution; (d) partial *in situ* XRD patterns of S-NCM and C-NCM mixed with a Li resource, keeping a constant heating rate (20 °C min⁻¹) and holding the temperature for diffraction at 50 °C intervals; (e) evolution of the unit cell parameters *a* and *c* for S-NCM (blue symbols) and C-NCM (red symbols) mixed with Li slate through Rietveld refinement. The earlier Li⁺ insertion at 200 °C changed the variation tendency of the unit parameters for the sample after cleaning. (f) Heat generation measured by DSC from mixtures.

morphology of the cathode remained unchanged, which may be related to the Li⁺/H⁺ exchange mechanism with the stabilizing lattice structure.^{40,41} Moreover, as shown in Fig. 2b and Fig. S22 (ESI[†]), based on the charge/discharge efficiency, we further optimized the solution concentration as 1 M in the following investigations.

To reveal the effect of the residuals during the direct regeneration of the recycled cathode, *in situ* XRD characterizations were compared following the regeneration of S-NCM and C-NCM. During the heating, the unit cell lattice first nearly linearly expanded until there was a differentiation of the expansion ratio caused by the lithium insertion. As shown in Fig. 2d, the shift of the (003) peak of C-NCM was less pronounced than that of S-NCM when heating to 900 °C, indicating its unit cell lattice *c* was not expanded as much as for the S-NCM due to its more efficient lithium insertion. Therefore, more lithium insertion was observed for the C-NCM cathode. Correspondingly, the Li₂CO₃ in the mixture of S-NCM and C-NCM also performed differently, whereby the Li₂CO₃ in the

C-NCM cathode was consumed gradually until it disappeared at its melting point around 730 °C, while the Li₂CO₃ in the S-NCM cathode completely vanished at around only 600 °C, and this earlier consumption of the lithium source may be attributed to the reaction between Li₂CO₃ and the residual impurities (such as LiF, LiOH, and Li₃PO₄) by co-melting, vaporizing, and replenishing in S-NCM.⁴² Equivalently, the high angle reflection peak intensity spanning from (006) to (110), representing the layered structure, significantly increased starting from around 200 °C for the C-NCM cathode after the purifying treatment compared to there being no obvious enhancement for S-NCM, indicating the better repair of the layered structure during heating. To further unveil the underlying mechanism, Rietveld refinement of each XRD pattern was conducted, which can depict the continuous change of the unit cell parameters during regeneration. Generally, the unit cell parameter *c* decreases and *a* increases with the insertion of Li ions into a layered structure, similar to in the discharge process.²⁸ As shown in Fig. 2e, the lattice evolution of the S- and C-NCM

cathodes were compared. For C-NCM, the lattice c expansion slope became obviously flatter at 200 °C, denoting a lattice c shrinkage at this temperature induced by the Li-ion insertion and repairing. However, for the S-NCM without undergoing purifying treatment for the residuals, the lattice expanded still nearly linearly with no obvious lithium insertion until 600 °C. Concurrently, the lattice a expansion slope became steeper at 200 °C for C-NCM. Last but not least, Differential scanning calorimetry (DSC) characterization was also conducted during the regeneration process to confirm the lithium insertion pattern for the S- and C-NCM cathodes, which can trace the lithium replenishment associated with the exothermic reaction as reported by others.⁴³ As shown in Fig. 2f, the characteristic exothermic reaction at around 200 °C was only observed for C-NCM, confirmed the earlier lithium insertion after the purifying treatment. The earlier lithium insertion was also supported by the CO₂ gas release observed during Li₂CO₃ decomposition to supply the lithium source for the C-NCM cathode, as shown Fig. S23 (ESI[†]). Moreover, from the thermogravimetric results

shown in Fig. 2f, the weight loss of C-NCM was 5.4%, which was significantly larger than that of S-NCM of 2.5%, indicating that more Li₂CO₃ was activated and decomposed to provide the lithium source for C-NCM.^{43,44} To sum up, through multiple *in situ* and *ex situ* characterizations, we proved that, with a purifying pretreatment, the direct regeneration could be facilitated to start at a lower temperature of 200 °C from the spent cathode.

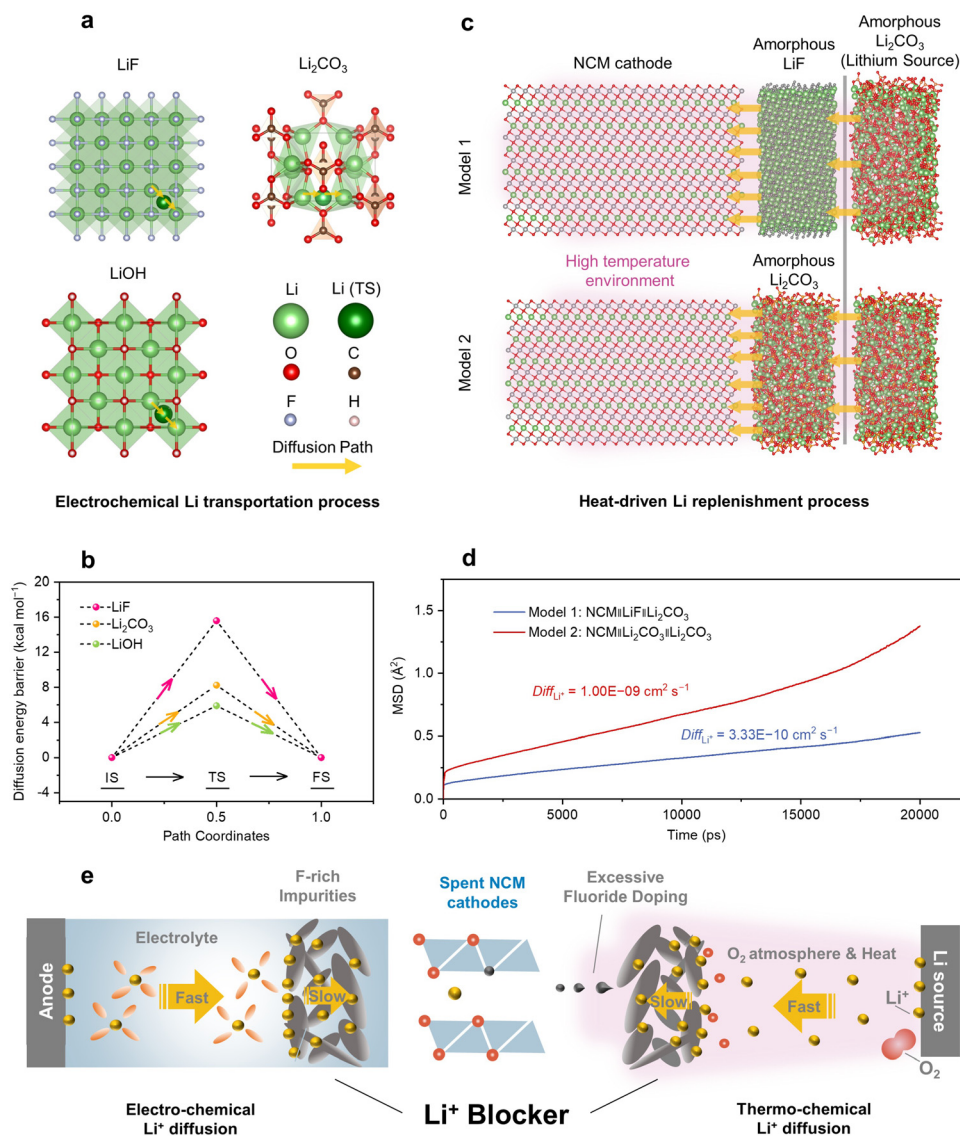
Fig. 5 Role of the F-rich impurities as a blocker in electrochemical and thermochemical Li^+ diffusion as ascertained from thermodynamic and kinetic simulations. (a) Illustrations of the selected migration pathways with a similar distance for Li^+ inside the crystal lattice of three common components. The initial state, transition state, and final state of Li^+ transportation are denoted as IS, TS, and FS, respectively. (b) Calculated energy diffusion barrier for Li ions in selected phases. (c) Two models for stimulating the kinetics of Li transportation in direct regeneration. Model 1 consists of the NCM cathode substrate, the amorphous LiF layer, and Li_2CO_3 as a lithium source in direct regeneration, which is denoted as NCM||LiF|| Li_2CO_3 . In Model 2 (NCM|| Li_2CO_3 || Li_2CO_3 in short), the middle LiF layer is replaced by a common residual alkali (Li_2CO_3), which is used to simulate the regeneration of NCM cathodes after cleaning pretreatment. Each shape symbol is the same as for Fig. 5a. (d) MSD of the Li atoms in 20 ns and calculated Li^+ diffusivity based on the above model. "E – 9" means 10^{-9} . (e) Mechanism diagram for preventing the NCM cathodes from reusing and directly regenerating under the influence of impurities.

According to the above results (Fig. 1d, Fig. S6, S16 (ESI†), and Fig. 4h, i), the migration rate of lithium ions was significantly influenced by the residual impurities; therefore it was crucial to theoretically investigate their influence on capacity delivery in the reuse case and during direct regeneration. Considering the impurities were mostly concentrated at the surface before and after regeneration, and that F-rich residuals could be observed, as shown in Fig. S9 and S10 (ESI†) and Fig. 3c, we chose three representative inorganic components (LiF , Li_2CO_3 , and LiOH) in the CEI layer⁴⁸ or residual alkali⁴⁹ to calculate the Li^+ diffusion from a thermodynamic perspective, and their structures are shown in Fig. 5a. By maintaining a similar distance and concentration of mobile Li-ions, the diffusion energy barrier of lithium ions (ΔE_{Li^+}) during the cycling of spent cathodes within the different crystal structures (Fig. 5b) allowed valid comparisons. We found that the ΔE_{Li^+} of the LiF phase, as a common inorganic component from CEI, was about 2 and 3 times higher than that of the LiOH and Li_2CO_3 phases from

Fig. 5b. Therefore, this result confirmed that the presence of fluoride-rich impurity residuals on the cathode surface significantly increased the diffusion resistance of Li ions when cycling, ultimately exacerbating the cell impedance and interfacial parasitic reactions (Fig. 1d). To comprehend the larger-scale kinetic characteristics and understand the effect of impurity coatings during heating for regeneration of the spent cathodes, two molecular dynamics models were established for simulating Li^+ transportation at 1000 K over 20 ns. Specifically, Model 1 was devised to include an impurity barrier consisting of a LiF layer (Fig. 5c and Fig. S33, ESI†). Through computing the mean square displacement (MSD) of Li atoms and fitting curves (Fig. 5d), we determined that the Li diffusivity ($\text{Diff}_{\text{Li}^+}$) of Model 1 was 3.33×10^{-10} , which was an order of magnitude lower than that of Model 2 (1.00×10^{-9}). The differences in molecular dynamics models under practical conditions suggest that fluoride-rich impurity coatings increase the resistance to Li-ion diffusion into spent cathodes with Li deficiencies during thermo-driven regeneration, leading to inadequate compositional and structural recovery.

As illustrated in Fig. 5e, the impurity phase containing the F element served as an electro- and thermo-diffusion blocker of Li ions hindering the reuse and direct regeneration of the spent cathode. In the spent cathodes collected by physical pretreatment and collection from used lithium-ion batteries, the ubiquitous electrolyte was decomposed to form an ion barrier with slow ion diffusivity. However, these impurities have long been overlooked in most studies (Table S2, ESI†), mainly due to the use of lab-scale degraded cathodes and fine manual separation pretreatment. In previous studies,^{12–16,42} the latent impact of the residual impurities on direct regeneration remains untouched because impurities are easily converted into other inconspicuous matter in extreme physical or chemical regeneration environments. Looking ahead, the direct regeneration of next-generation sensitive cathode materials, such as Li-rich Mn-based, Co-free, and ultra-high-Ni cathode materials, faces serious challenges from these latent impurities if they enter the recycling circle. From another perspective, establishing the controlling law for the inherent impurities doping within the closed-loop material flow could instructively enhance the performance of such recycled materials in the future. Moreover, only by revealing the effect of the overlooked impurities or by getting rid of impurities, can evolving technologies and mechanisms for direct regeneration and upcycling be reasonably evaluated.⁵⁰
