Cite this: *Environ. Sci.: Water Res. Technol.*, 2016, 2, 164

Survey of green building water systems reveals elevated water age and water quality concerns†

William J. Rhoads,* Amy Pruden and Marc A. Edwards

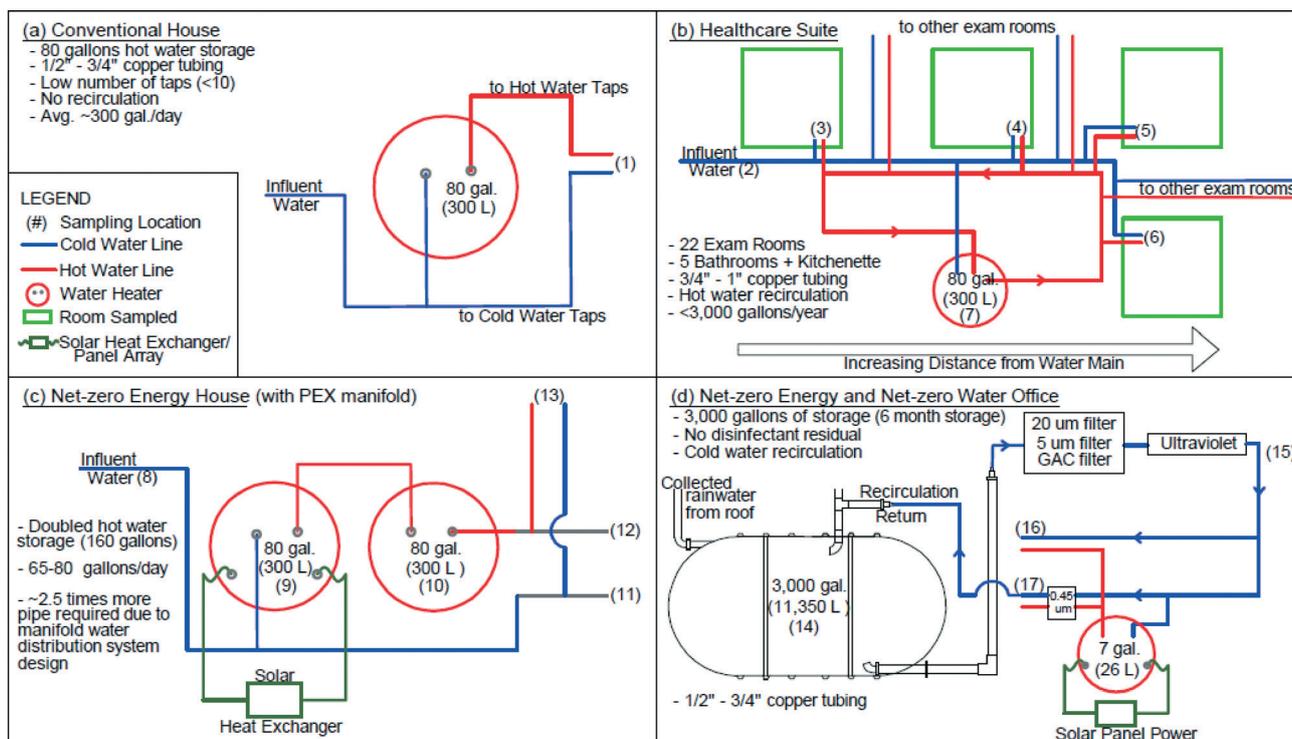
Note: Numbers 1-17 in parentheses indicate sampling locations referred to in Table 2.

Fig. 1 Plumbing schematics and sampling locations for each field site.

Four buildings with a cross-section of energy and water conservation strategies were surveyed and sampled to explore effects of green plumbing systems on water quality (Table 1). The buildings included a conventional house with no conservation features (Fig. 1a), a healthcare suite (Fig. 1b), a net-zero energy house (Fig. 1c), and a net-zero energy and net-zero water office building (Fig. 1d).

This study provided detailed documentation of the potable water systems in three innovative green buildings (Fig. 1). After reviewing the characteristics of each water system and closely examining trends in disinfectant residuals within the buildings, we provide an overview of microbial sampling from each building.

minutes of flushing was necessary to establish a chloramine residual similar to that present in the main distribution system (Fig. 2a). Taps at these locations are typically used for 15–30 seconds at a time; therefore, it is unlikely that a chloramine residual is ever present in portions of this plumbing system. Approximately 30 minutes of flushing was required at the net-zero energy house to establish a residual in the cold water system during the first site visit. In contrast, the conventional home had a residual of 0.71 mg L⁻¹ chlorine as Cl₂ in stagnant cold water. The water heaters at the net-zero house had <0.15 mg L⁻¹ chlorine as Cl₂ during a 20 minute flush due to the added storage volume and water age associated with the solar heater (Fig. 1c).

^a Sampling location numbers refer to locations depicted in Fig. 1. ^b Average (and median) of the four exam rooms is reported. ^c BD = below detection. ^d BQL = below quantification limit.

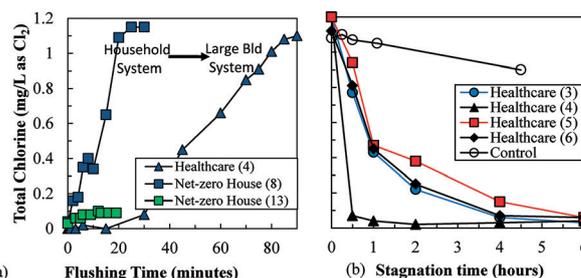
Note: Sampling locations indicated in parenthesis in the figure legends correspond to sample locations depicted in Figure 1.

Fig. 2 Total chlorine residual concentrations (a) as a function of stagnation in one room at the healthcare suite (large building system above), a tap near the head of the building at the net-zero house (household system above), and during three showering events at net-zero house, and (b) as a function of stagnation in several rooms at FS#1 (control represents identical water placed in a glass container with no head space).

The healthcare suite also showed evidence of very rapid disinfectant residual decay. In all four exam rooms monitored, the first-order decay rate of chloramine in the plumbing was 20–144 times greater than in well-flushed (>80 minutes) water collected from the same tap and placed into a glass container with no headspace (*i.e.*, “control,” Fig. 2b). The highest rate of decay (sample location 4) was observed in
