## Ongoing legacy contamination from a military radar station in Iceland: a case study

Contamination in and around military radar stations in the Arctic has been an ongoing concern since first identified in the 1980s. This study reports on the environmental impact from a DEW line US military station that was operated on Heiðarfjall mountain in northeast Iceland from 1957 to 1970. This review is conducted as a part of work of the POPs Expert Group of the Arctic Monitoring and Assessment Program (AMAP) for an assessment report on local sources vs. long-range transport of Persistent Organic Pollutants (POPs) in the Arctic. The main resource for this summary is an evaluation of results from several reports on Heiðarfjall Langanes, one from an Icelandic Environmental Authority in 1993 and another from the Canadian Environmental Science Group (ESG) at the Royal Military College of Canada, which was commissioned in 2017 by the owners of the land that was used for the station. The results are compared to findings in scientific papers and reports for contamination at other military radar stations in Canada and Alaska. This review shows considerable contamination on Heiðarfjall over 50 year

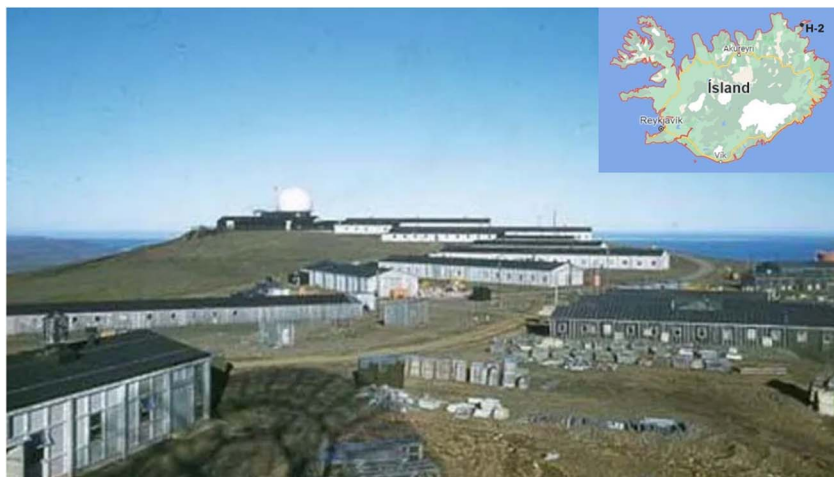
Fig. 1 The DEW line radar station at Heiðarfjall in 1958 (<https://www.radomes.org/museum/acwgrnland.php>).

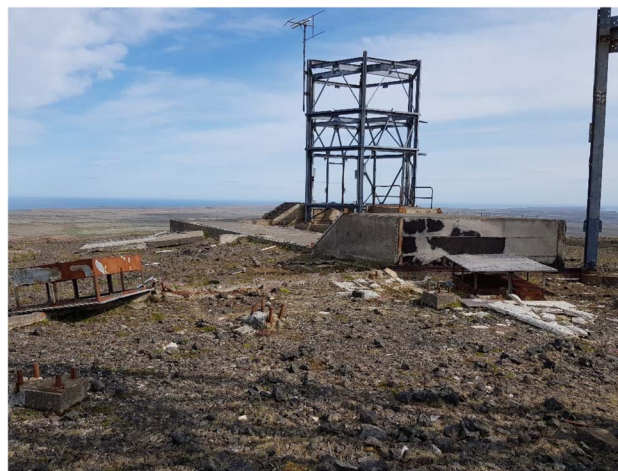
Fig. 4 The H-2 Station Radome area at Heiðarfjall, 26. 7. 2021 (M. J. Gunnarsdottir).

The sites chosen for sampling by the ESG, see Fig. 3, were: (1) the Dump area (*ca.*  $18.000 \text{ m}^2$ ) where debris, both during operating and later during clean-up, had been buried; (2) the Tropo area, with a communication building (still standing), and where two tropospheric communication dishes once stood; (3) the Sewage Outfall area; (4) the POL (petroleum oil and lubricant) Tank area, where a large fuel storage tank used to be situated. Sites 3 and 4 were on the southern edge of the summit area, directly above the Eiði farm; (5) the Garage area; (6) the Barracks area; (7) the Powerhouse area, and (8) Radome area (sites 5, 6, 7, and 8 are all situated at the Station area); (9) the lower-lying Catchment area, where a concrete drainage pipe was observed leading to a small pond; and (10) the Eiði stream area. Fig. 4 shows a recent picture of the Station area.
