## Survey of green building water systems reveals elevated water age and water quality concerns†

William J. Rhoads,\* Amy Pruden and Marc A. Edwards

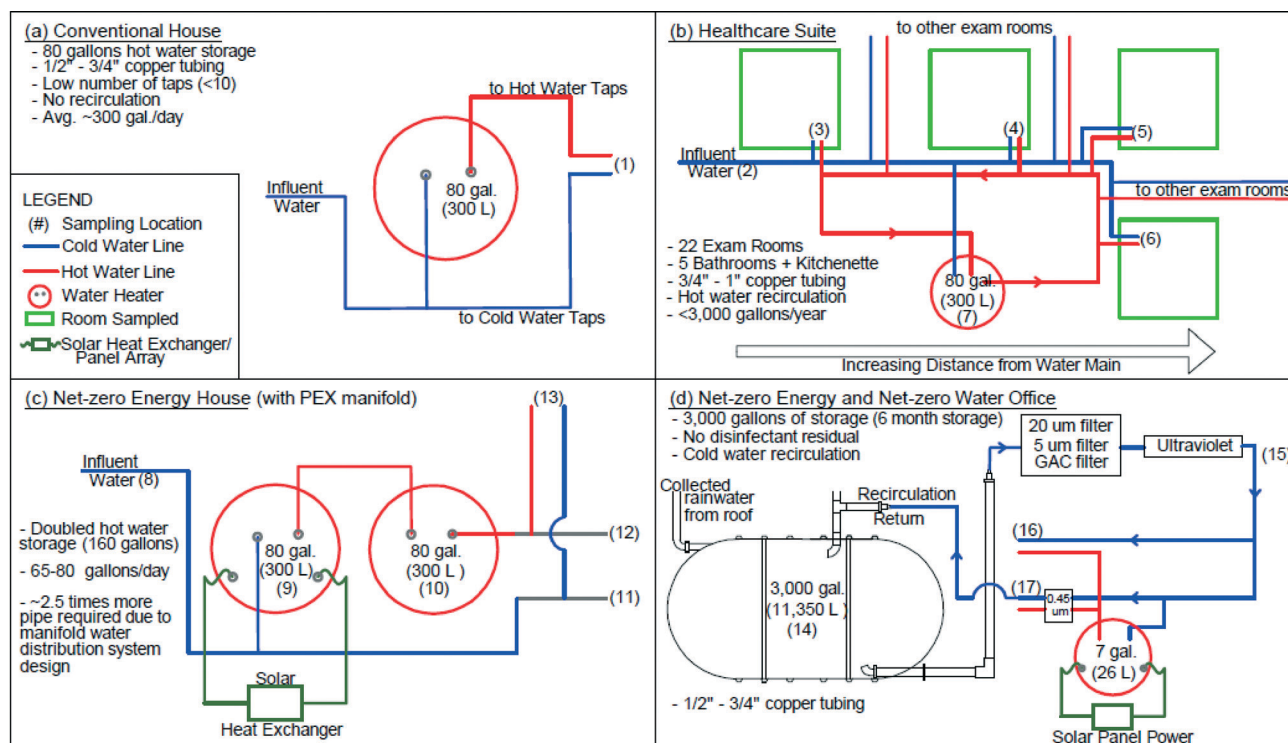
Fig. 1 Plumbing schematics and sampling locations for each field site.

Note: Numbers 1-17 in parentheses indicate sampling locations referred to in Table 2.

Four buildings with a cross-section of energy and water conservation strategies were surveyed and sampled to explore effects of green plumbing systems on water quality (Table 1). The buildings included a conventional house with no conservation features (Fig. 1a), a healthcare suite (Fig. 1b), a net-zero energy house (Fig. 1c), and a net-zero energy and net-zero water office building (Fig. 1d).

This study provided detailed documentation of the potable water systems in three innovative green buildings (Fig. 1). After reviewing the characteristics of each water system and closely examining trends in disinfectant residuals within the buildings, we provide an overview of microbial sampling from each building.

minutes of flushing was necessary to establish a chloramine residual similar to that present in the main distribution system (Fig. 2a). Taps at these locations are typically used for 15–30 seconds at a time; therefore, it is unlikely that a chloramine residual is ever present in portions of this plumbing system. Approximately 30 minutes of flushing was required at the net-zero energy house to establish a residual in the cold water system during the first site visit. In contrast, the conventional home had a residual of 0.71 mg L<sup>-1</sup> chlorine as Cl<sub>2</sub> in stagnant cold water. The water heaters at the net-zero house had <0.15 mg L<sup>-1</sup> chlorine as Cl<sub>2</sub> during a 20 minute flush due to the added storage volume and water age associated with the solar heater (Fig. 1c).
