## CRITICAL REVIEW

## Ongoing legacy contamination from a military radar station in Iceland: a case study

This paper is a summary of environmental impacts from a former US military DEW line radar station in Iceland which operated from the mid-1950s to the 1970s. This station was one of four DEW line station stations that operated in Iceland during the Cold War era. During the time of operation and when dismantled, nearly all waste from the station was dumped in unlined pits on the mountain. Very limited cleaning of the site has been performed and the site is contaminated with PCBs, PHCs, PAHs and some inorganic elements.

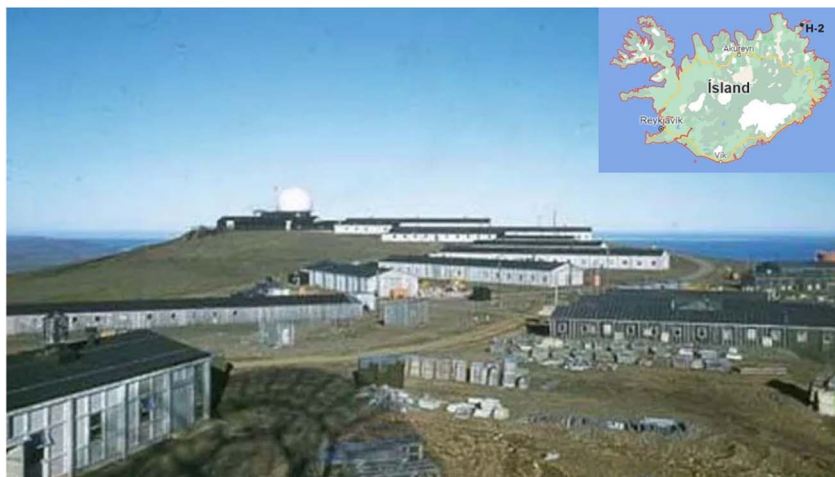
Fig. 1 The DEW line radar station at Heiðarfjall in 1958 (<https://www.radomes.org/museum/acwgrnland.php>).

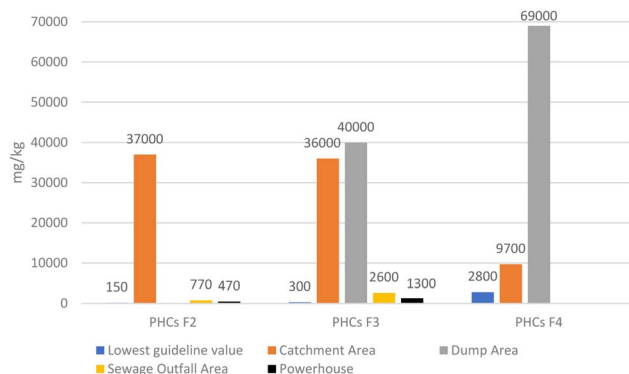
Fig. 6 PHCs (mg kg<sup>-1</sup>) detected above the lowest guideline value for F2, F3 and F4 (150, 300, and 2800, respectively) at four areas. The highest value in each area of the four is shown in the figure.
