Cite this: *Environ. Sci.: Water Res. Technol.*, 2021, 7, 274

## Drinking water contamination from the thermal degradation of plastics: implications for wildfire and structure fire response†

Kristofer P. Isaacson,<sup>a</sup> Caitlin R. Proctor,<sup>b</sup> Q. Erica Wang,<sup>a</sup> Ethan Y. Edwards,<sup>c</sup> Yoorae Noh,<sup>c</sup> Amisha D. Shah<sup>c</sup> and Andrew J. Whelton<sup>\*ac</sup>

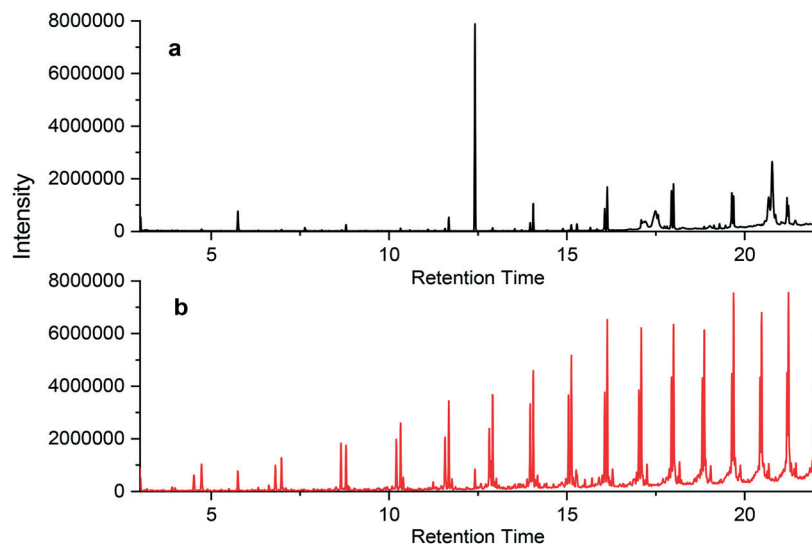
Fig. 4 Chromatograms of PEX-c-1a when (a) unburned and (b) burned at 400 °C, where samples were extracted in *n*-hexane. The internal standard is the peak at 5.8 minutes.

**Leaching promoted by hexane extraction.** As expected, a greater number of peaks were observed in the *n*-hexane extracts (32 to 134) compared to the water extracts (3 to 22) for all plastics (see example for PEX-c-1a in Fig. 4 and all other pipe types in Fig. S17–S26†). For the degraded PEX, HDPE, and PP pipes, between 100 to 134 unique compounds were leached into *n*-hexane, whereas for the degraded PVC and CPVC pipes between 30 to 41 compounds were leached (Fig. 4 and S17–S26†). While most compounds extracted from the new pipes were either straight chain or branched alkanes of varying lengths (Table S3†), thermal exposure led alkenes to represent the majority of compounds detected in the leachate (Table S5†). These aliphatic hydrocarbons are products of alkane hydrocarbon chain scission and are not typical drinking water contaminants. They have low aqueous solubility, which is why they were only detected in the hexane extracts and are generally less toxic than their cyclical or aromatic counterparts.<sup>56,57</sup>

Generally, both the magnitude of the peak and the number of compounds increased after burning the materials. However, one notable exception occurred for the PEX-c pipes; one peak (retention time of 12.5 min) for the unburned pipe was significantly larger than that of any of the burned peaks (Fig. 4 and S21†). This peak likely represented the compound, di-*tert*-butylbenzene, which has been shown to be an ultraviolet light or radiolysis degradation product of the antioxidant Irgafos 168®.<sup>58,59</sup> This compound was only observed in the leachate of the PEX-c materials, in which the crosslinking occurs using beta irradiation. This may explain why the magnitude of this degradation product was so large.<sup>60</sup> This peak decreased substantially in the burned plastic extract (Fig. 4 and S21†), indicating it may have been thermally decomposed.
