Cite this: *Environ. Sci.: Water Res. Technol.*, 2021, 7, 274

DOI: 10.1039/d0ew00836b

Drinking water contamination from the thermal degradation of plastics: implications for wildfire and structure fire response†

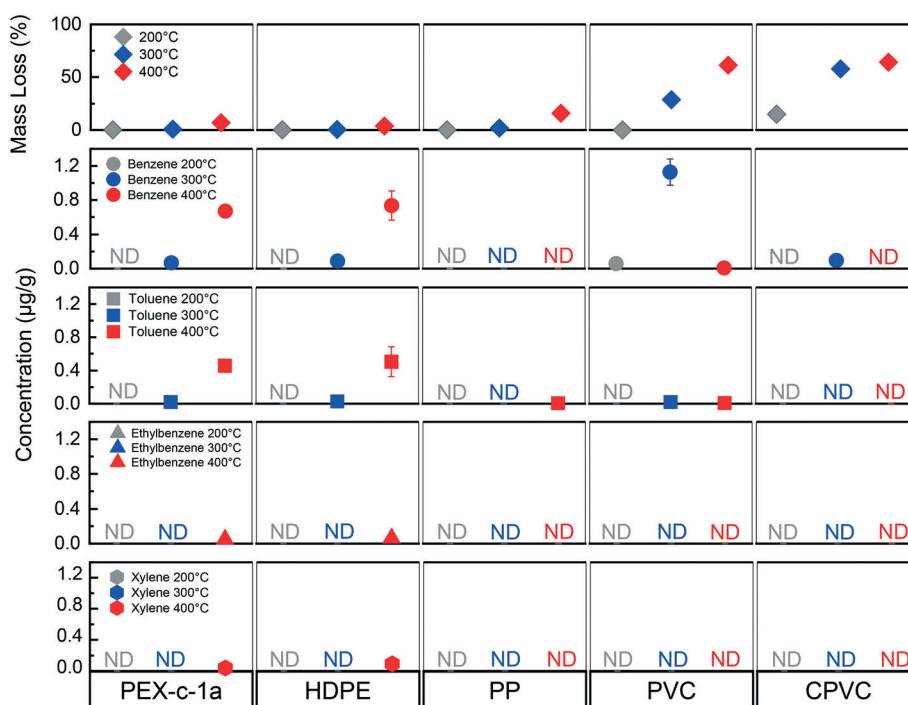
Fig. 3 Mean BTEX concentration after extracting each burned material at 200 °C, 300 °C, and 400 °C in water. The error bars reflect the standard deviation of the measurements ($n = 3$). If no error bars are visible, it indicates they were smaller than the symbol size. ND indicates the compound was not detected.

Different concentrations of BTEX were found in water after changing the isothermal heating temperature, such that two patterns emerged (Fig. 3). For the HDPE and PEX pipes, the amount of BTEX that leached into the water increased as the plastic degradation temperature increased from 200 °C to 400 °C (Fig. 3). Conversely, the greatest benzene concentration was found for the PVC pipe when exposed to 300 °C, with relatively less concentrations at 200 °C and 400 °C (Fig. 3). The CPVC pipe showed a similar pattern for benzene as the PVC pipe, however, at much lower concentrations (Fig. 3). This spike phenomenon for vinyl materials can potentially be explained by the lower amount of mass loss, where not all benzene produced during degradation volatilized out of the solid. The 300 °C exposure temperature was greater than the onset degradation temperature (Table 1) where dehydrochlorination would occur. However, the PVC pipe mass loss was only 23 wt% as opposed to 61 wt% at the 400 °C condition resulting in a more structurally intact plastic after degradation (Fig. S2†).

Despite structural similarities for the vinyl pipes, benzene was only detected in water exposed to the CPVC pipe at a fraction of the amount it was found in water exposed to the PVC material (Fig. 3). This difference may be explained by the additional chlorine atoms present on the CPVC polymer chains resulting in a greater number of chlorine substituted aromatic products when CPVC was thermally degraded.³⁴ A previous CPVC pyrolysis study found significantly more

Compared to vinyl pipes, greater BTEX concentrations were found as the degradation temperature increased for the HDPE and PEX materials (Fig. 3). The onset degradation temperature for both of these materials exceeds 430 °C (Table 1) which can explain why little to no BTEX leaching was observed at 200 °C and 300 °C. The increase in leaching between 300 °C and 400 °C can be attributed to the plastic pipes beginning to degrade and generating BTEX and other compounds. Elevated temperatures lead to the polymer chain undergoing chain scission resulting in the formation of alkenes.³² As the pipe is exposed to greater temperatures, the amount of polymer chain scission that occurs also increases. The increase in scission results in more alkene fragments that may subsequently undergo aromatization. A similar pattern was observed in a study of HDPE combustion by others, in which the benzene concentration in the air increased as the combustion temperatures increased from 500 °C to 800 °C.⁵¹ However, the increase in potential BTEX formation does not necessarily indicate that this trend of increased leaching as a function of temperature will

continue.³² Both the partitioning of BTEX into the air and mass loss are also increasing with system temperature, indicating that there may be an optimal degradation temperature for observing the maximum BTEX formation much like what was observed with the PVC at 300 °C.
