Cite this: *Environ. Sci.: Water Res. Technol.*, 2021, 7, 274

This study was conducted to determine if the thermal degradation of various plastic drinking water pipes (*i.e.*, PEX, HDPE, PP, PVC, and CPVC) may be a source of drinking water contamination. Widespread volatile organic compound (VOC) contamination was found in water distribution systems following three wildfires in California. A potential source of this contamination was thought to be due to the degradation of plastic components in drinking water distribution systems. Eleven plastic drinking water pipes, across eight brands, were exposed to elevated temperatures (200 °C to 400 °C), and subsequently submerged in water or in *n*-hexane to observe the extent of VOC leaching. Results indicated that thermally damaged drinking water pipes can be sources of VOC leaching, with ten of the eleven materials leaching benzene, a carcinogen, into water. As exposure temperature increased, an increase in VOC leaching was observed in the polyethylene materials. Conversely, in the vinyl materials the significant mass loss associated with high exposure temperature was inversely proportional to the amount of BTEX leaching that was observ

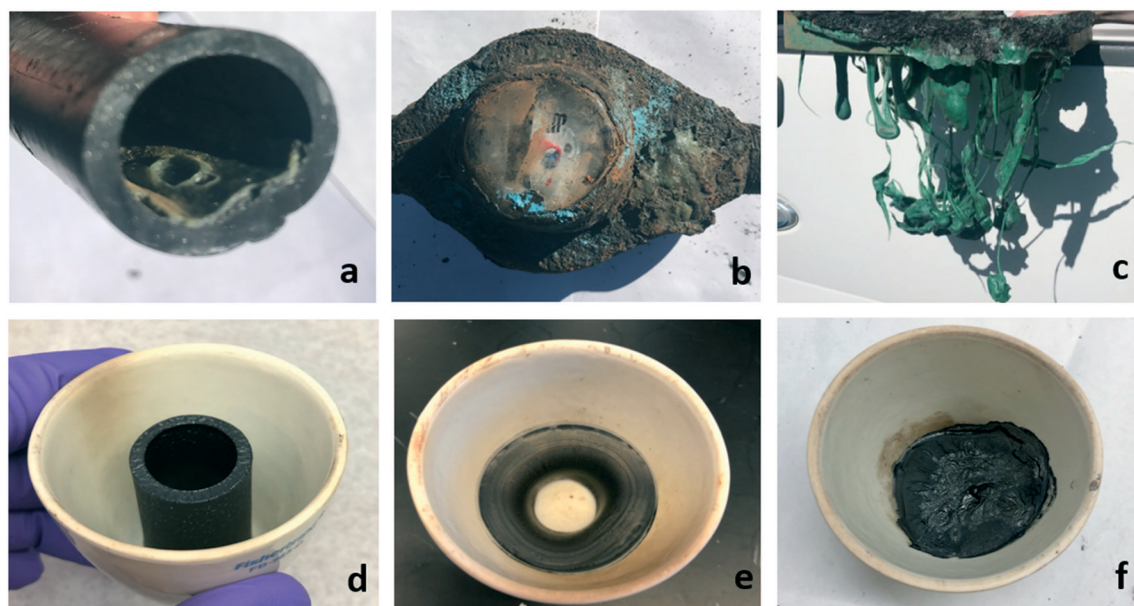
Fig. 1 Images of fire-damaged water system components including (a) a HDPE plastic pipe, (b) a water meter, and (c) a water meter cover following the Camp Fire. Thermally degraded pipe samples in laboratory experiments include the (d) PEX-c pipe degraded at 300 °C, (e) HDPE pipe degraded at 300 °C, and (f) HDPE pipe degraded at 400 °C.
