CRITICAL REVIEW

Ongoing legacy contamination from a military radar station in Iceland: a case study

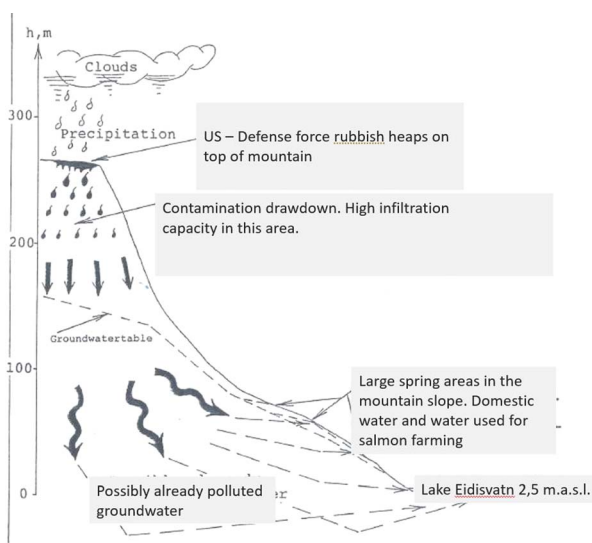
Fig. 2 Transport model of pollution spread at Heiðarfjall.⁴²

The engineering consultant's conclusion was that groundwater pollution would mostly spread southwards towards the farm, the estuary lake Eðisvatn and the sea as shown in Fig. 2. Calculations of the pollution infiltration flow from the top of the mountain indicate that it would take at least 30 years to reach the springs on the south side of the mountain flowing to Eðisvatn.

and it would take at least another 70 years until it had disappeared, but some dilution could be expected.⁴²
