Unravelling and quantifying the aging processes of commercial  $\text{Li}(\text{Ni}_{0.5}\text{Co}_{0.2}\text{Mn}_{0.3})\text{O}_2/\text{graphite}$  lithium-ion batteries under constant current cycling

Cite this: *J. Mater. Chem. A*, 2023, **11**, 41Unravelling and quantifying the aging processes of commercial  $\text{Li}(\text{Ni}_{0.5}\text{Co}_{0.2}\text{Mn}_{0.3})\text{O}_2/\text{graphite}$  lithium-ion batteries under constant current cycling†Jia Guo,<sup>ab</sup> Siyu Jin,<sup>ab</sup> Xin Sui,<sup>a</sup> Xinrong Huang,<sup>c</sup> Yaolin Xu,<sup>\*d</sup> Yaqi Li,<sup>ab</sup> Peter Kjær Kristensen,<sup>b</sup> Deyong Wang,<sup>b</sup> Kjeld Pedersen,<sup>b</sup> Leonid Gurevich<sup>b</sup> and Daniel-Ioan Stroe<sup>a</sup>

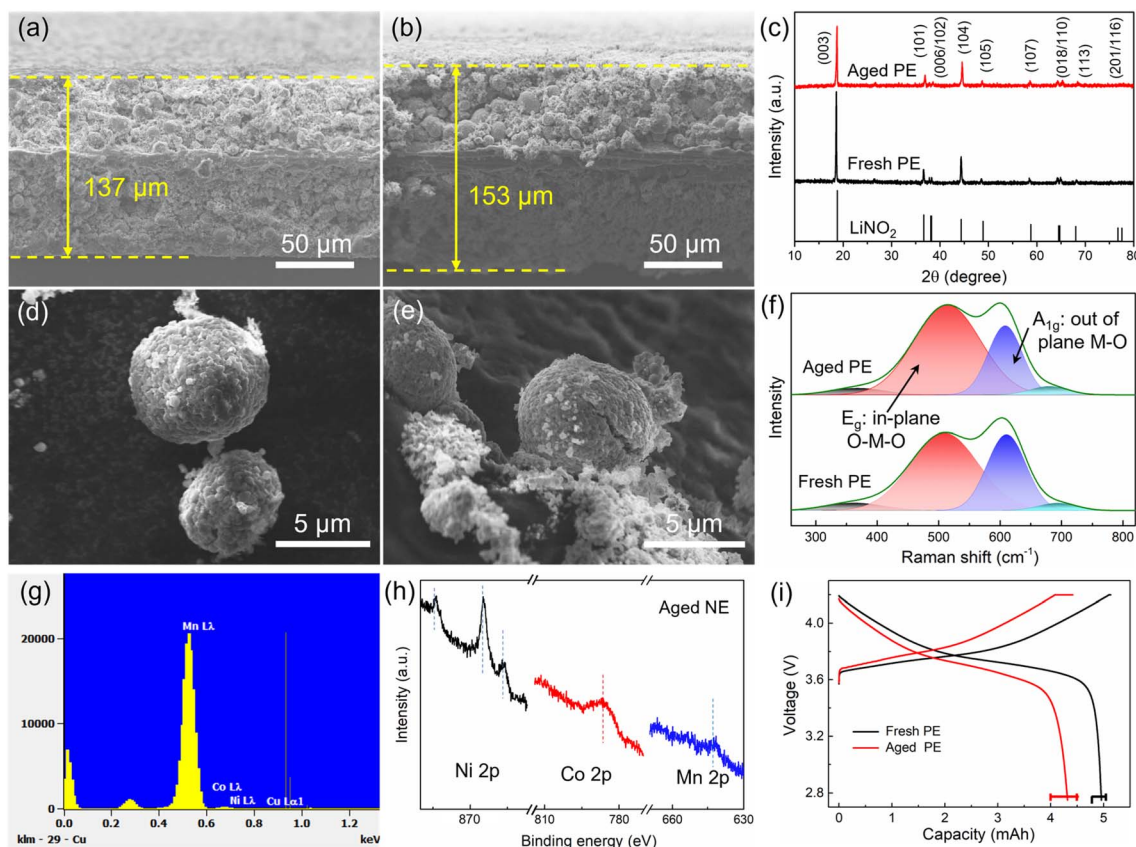
**Fig. 4** Cross-section SEM images of (a) fresh and (b) aged positive electrodes. (c) XRD patterns of the fresh and aged positive electrodes (PE). SEM images of (d) fresh and (e) aged NMC particles. (f) Raman spectra of the fresh and aged positive electrodes. Transition metals (Mn, Co, and Ni) from the positive electrode are deposited on the negative electrode surface, which can be measured by (g) EDS point scan and (h) XPS. (i) The voltage profiles of the fresh and aged positive electrodes were tested against the Li metal electrode with a coin cell in the voltage range of 2.75–4.2 V at 0.05C.

**3.2.2 Materials degradation.** Fig. 4a and b show the cross-section SEM images of the fresh and aged positive electrodes, respectively. The average thickness of the fresh positive electrode is 137  $\mu\text{m}$  (Fig. 4a). After aging, the average thickness increases to 153  $\mu\text{m}$  (*i.e.*, increases by 11.7%) (Fig. 4b). Besides, cracks appeared and extended to the inner part of the electrode, resulting in loose particles and intra-electrode voids, which is one of the reasons for the increased electrode thickness.

Another reason is the increased volume of cathode grains, which can be evaluated by the left shift of the XRD pattern as shown in Fig. 4c. This will lead to an increase in the paths of charge transfer and Li diffusion as well as an increased internal resistance. Besides, the inconspicuous splitting peaks (006/012) mean a decreased crystallinity, and the increased  $I(003)/I(104)$  means increased Li/Ni cation mixing for the aged positive electrode.<sup>28</sup> Furthermore, the deterioration of the material is also reflected in particle morphology. The surface of the fresh cathode particles (Fig. 4d) is smooth, and then, pulverization and cracking happen during aging (Fig. 4e). Besides, the presence of residue powders on the cathode particle surface seems

to be due to interface compositions, and this was tested by XPS as shown in Section 3.2.3. The cracks are also reflected in the Raman spectrum (Fig. 4f), where NMC can be thought of as a solid solution of  $\text{LiNiO}_2$ ,  $\text{LiMnO}_2$ , and  $\text{LiCoO}_2$ . Among them, layered  $\text{LiNiO}_2$  and  $\text{LiCoO}_2$  contribute only two Raman-active modes, one is the  $A_{1g}$  mode at  $609\text{ cm}^{-1}$  and the other is the  $E_g$  mode at  $503\text{ cm}^{-1}$ , corresponding to the out-of-plane M–O stretch and in-plane O–M–O band, respectively.<sup>29</sup> The additional weak bands were contributed by  $\text{LiMnO}_2$ . After aging, the increased  $E_g$  mode means an increase in the amount of the in-plane O–M–O band, which is consistent with the crack formation and inside-surface exposure as shown in Fig. 4e. As reported, the HF from electrolyte decomposition is easy to penetrate into cathode particles and induce serious side reactions, causing the transition metal to dissolve in the electrolyte and then deposit on the negative electrode surface. EDS point scans were performed to verify the presence of transition metal elements Ni, Co, and Mn, as shown in Fig. 4g. Furthermore, Ni, Co, and Mn elements can also be observed by XPS from the surface of the aged negative electrode (Fig. 4h). As reported in ref.<sup>30</sup> and <sup>31</sup>, the Co deposits on the graphite surface can also accelerate the exfoliation of graphite, leading to a severe degradation of the full cell.

electrode capacity degradation, which can be evaluated using coin cells. As shown in Fig. 4i, the aged positive electrode shows a higher charge plateau and a lower discharge plateau, which are caused by polarization. Furthermore, there is no evident constant-voltage charging segment for the aged positive electrode, which means that the positive electrode has been fully charged before the constant-voltage charging period with a  $0.05\text{C}$  current. In contrast, the battery voltage of the aged positive electrode prematurely reaches the upper cut-off voltage during charging due to a high internal resistance, resulting in a long constant-voltage charging period as well as a decreased battery capacity. However, over 86% of the initial capacity is still maintained.

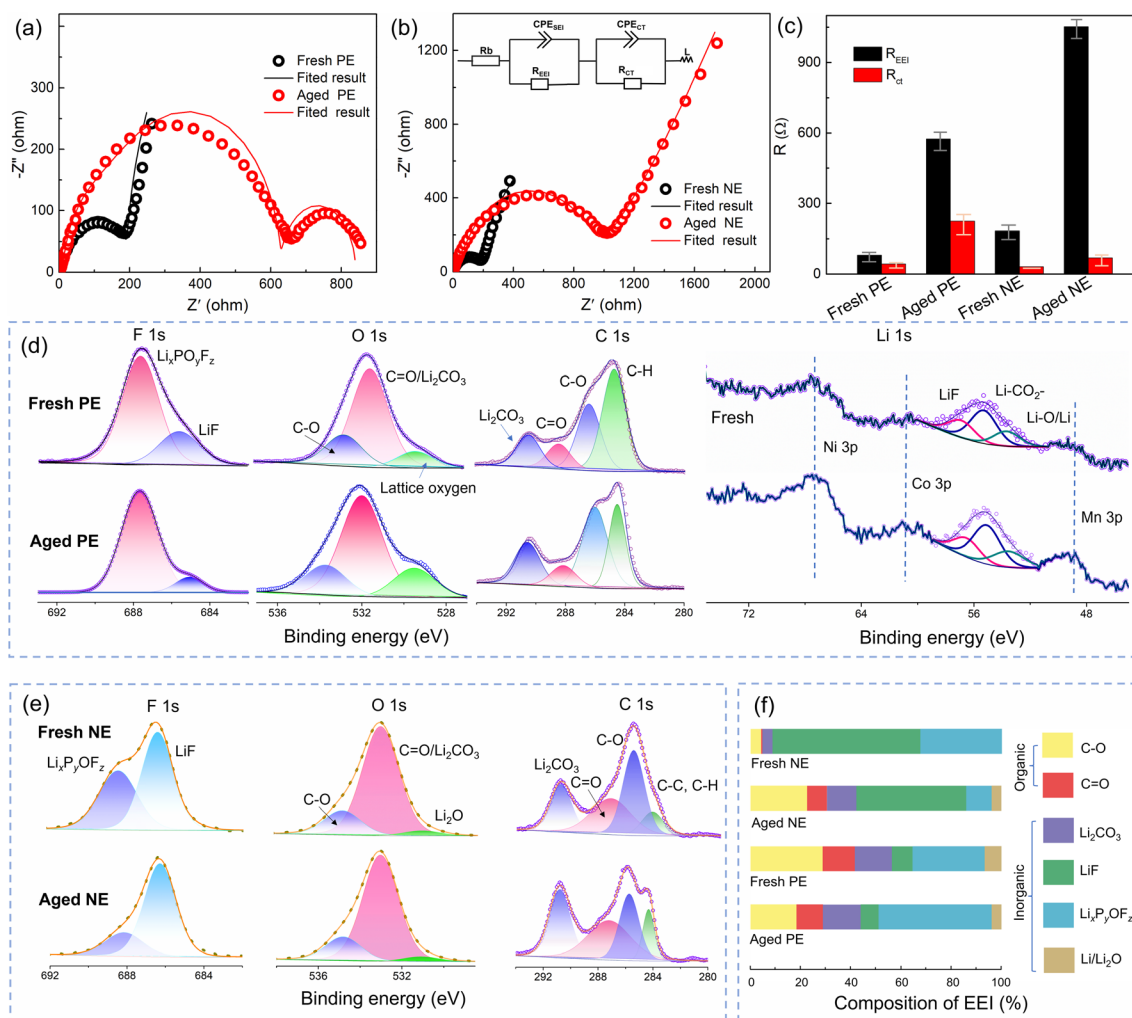
**Fig. 6** Impedance evolution tested using coin cells for the fresh and aged (a) positive electrode (PE), and (b) negative electrode (NE), and (c) fitted results,  $R_{\text{EEI}}$ ,  $R_{\text{SEI}}$  or  $R_{\text{CEI}}$ ; XPS spectra of (d) F 1s, O 1s, C 1s, and Li 1s for the positive electrodes and (e) F 1s, O 1s, and C 1s for the negative electrodes; (f) the chemical composition obtained by quantitative XPS characterization of the SEI film on the negative electrode surface and CEI film on the positive electrode surface.

aged positive electrode (Fig. 6a), indicating deteriorated electronic conductivity,<sup>33</sup> which is related to the cracks and pulverization on the cathode. Furthermore, the impedance spectra of the negative electrode are shown in Fig. 6b. The  $R_{\text{sei}}$  of the aged negative electrode is 1052  $\Omega$ , while the  $R_{\text{sei}}$  of the fresh one is only 183  $\Omega$ . Therefore, the impedance of the positive and negative electrodes is mainly contributed by the interface film.

XPS was performed to identify the CEI composition, and the results of F 1s, O 1s, C 1s, and Li 1s are shown in Fig. 6d. This indicates that CEI films are mainly composed of  $\text{Li}_x\text{P}_y\text{OF}_z$  (peaks at 688.5 eV in the F 1s spectrum), LiF (peaks at 56.5 eV in the Li 1s spectrum, and 686.3 eV in the F 1s spectrum), C–O (peaks at 535.3 eV in the O 1s spectrum), CO (peaks at 288.9 eV in the C 1s spectrum),  $\text{Li}_2\text{CO}_3$  (peaks at 55.6 eV in the Li 1s spectrum and 291.0 eV in the C 1s spectrum), and Li–O (peaks at 51.5 eV in the Li 1s spectrum). It is worth noting that the percentage of lattice oxygen increases obviously for the aged positive electrode in the O 1s spectrum, which is related to the crack formation and exposing a vast fresh surface inside secondary particles,<sup>34</sup> which is consistent with the SEM analysis in Fig. 4e. Furthermore, this was further confirmed by the enhanced bands of Ni–Li, Co–Li, and Mn–Li in the Li 1s spectrum.

For the SEI film (Fig. 6e), the formation of  $\text{Li}_x\text{P}_y\text{OF}_z$  originates from the reactions of trace  $\text{H}_2\text{O}$  and  $\text{LiPF}_6$  in electrolyte,<sup>35</sup> which belongs to the primary precipitated solid and can decompose to form  $\text{Li}_3\text{PO}_4$  and LiF.<sup>36,37</sup> In the Li 1s spectrum,  $\text{Li}_2\text{CO}_3$  is mainly derived from electrolyte decomposition.<sup>36</sup> Besides,  $\text{Li}_2\text{O}$  (peak at 52.4 eV) can be attributed to Li reducing  $\text{CO}_2$  that comes from the decomposition of  $\text{Li}_2\text{CO}_3$  at a high voltage (about 4.2 V).<sup>38</sup>

A quantitative analysis of the XPS data was performed for further analysis. As shown in Fig. 6f, inorganic compositions are the major EEI components, which play an essential role in achieving the electronic insulation of the EEI.<sup>32</sup> For the SEI film, the increased content of organic compositions (such as C–O and CO) on the aged NE originates from the decomposition of ethylene carbonate (EC), which is related to a degraded electrolyte.<sup>35</sup> Furthermore,  $\text{Li}_2\text{CO}_3$  and LiF are the main ionic carriers for  $\text{Li}^+$  diffusion at the interface. The decreased percentage of LiF in the aged anode will hinder the diffusion of Li-ions, as well as lead to an increased  $R_{\text{sei}}$  as shown in Fig. 2d and 6b. Unlike the SEI film, the most occupied components in the CEI film are  $\text{Li}_x\text{P}_y\text{OF}_z$  and organic components, due to  $\text{LiPF}_6$  decomposition at high voltage on the positive electrode side.<sup>35</sup> Besides, the percentage of inorganic compounds ( $\text{Li}_x\text{P}_y\text{OF}_z$ ,  $\text{Li}_2\text{CO}_3$ , LiF, and  $\text{Li}_2\text{O}$ ) changed after aging, due to the further reformation of the CEI and SEI that is more easily damaged at high operation temperature. As a result, the interface
