Cite this: *Environ. Sci.: Adv.*, 2024, 3, 972

Ongoing legacy contamination from a military radar station in Iceland: a case study

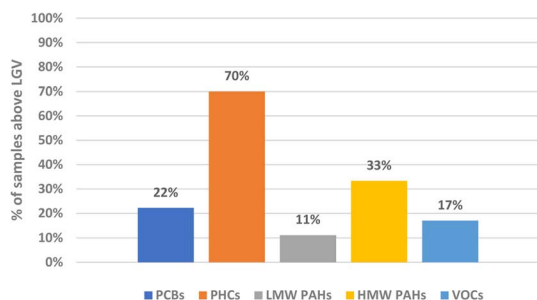
Fig. 5 Non-compliance of POPs with the LGV (lowest guideline value) in samples.¹⁰

POPs are non-compliant to the lowest guideline value, as shown in Fig. 5, from 11% for low molecular weight PAHs to
