Unravelling and quantifying the aging processes of commercial  $\text{Li}(\text{Ni}_{0.5}\text{Co}_{0.2}\text{Mn}_{0.3})\text{O}_2/\text{graphite}$  lithium-ion batteries under constant current cycling

Cite this: *J. Mater. Chem. A*, 2023, **11**, 41Unravelling and quantifying the aging processes of commercial  $\text{Li}(\text{Ni}_{0.5}\text{Co}_{0.2}\text{Mn}_{0.3})\text{O}_2/\text{graphite}$  lithium-ion batteries under constant current cycling†Jia Guo,<sup>ab</sup> Siyu Jin,<sup>ab</sup> Xin Sui,<sup>a</sup> Xinrong Huang,<sup>c</sup> Yaolin Xu,<sup>\*d</sup> Yaqi Li,<sup>ab</sup> Peter Kjær Kristensen,<sup>b</sup> Deyong Wang,<sup>b</sup> Kjeld Pedersen,<sup>b</sup> Leonid Gurevich<sup>b</sup> and Daniel-Ioan Stroe<sup>a</sup>

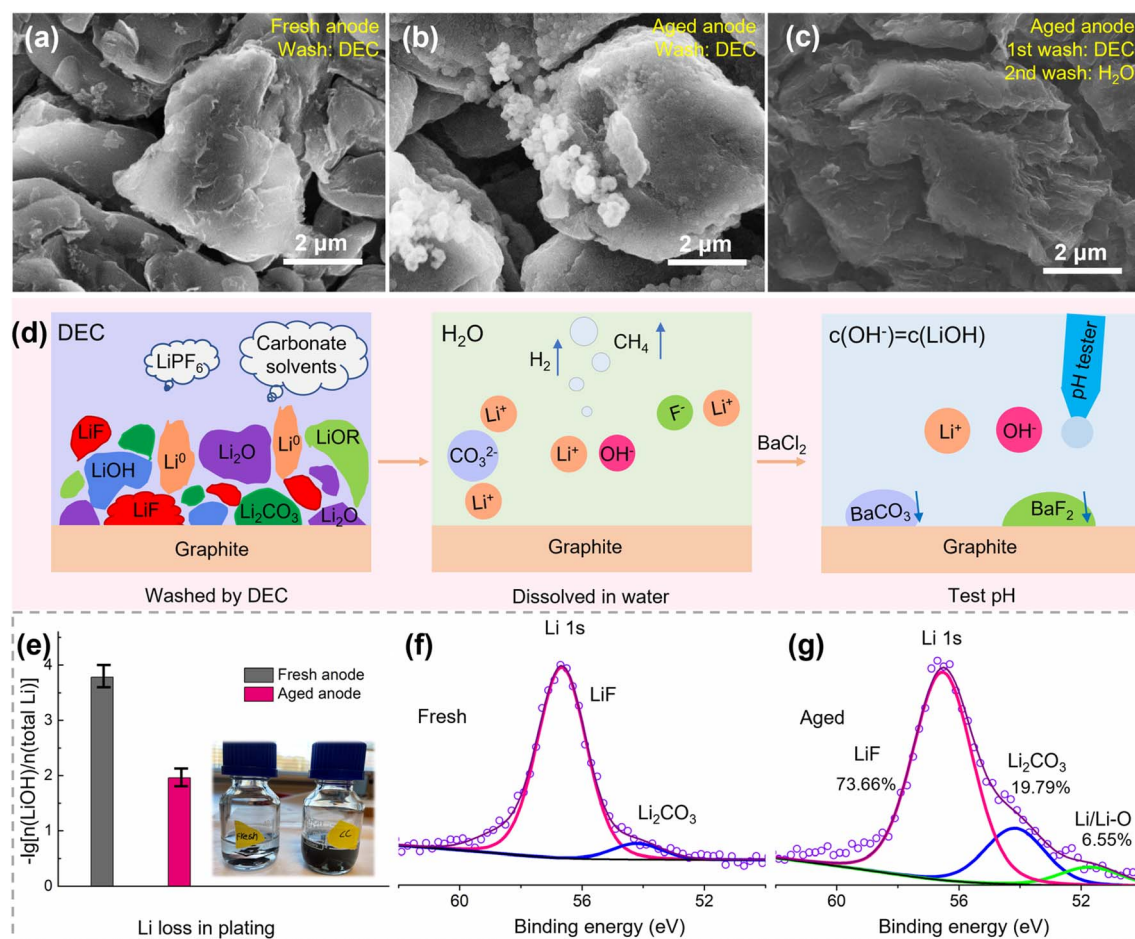
**Fig. 3** Lithium loss on the negative electrode surface. SEM images of the graphite anode from (a) the fresh cell, (b) the aged cell after washing with DEC, and (c) the aged cell after washing with DEC and then with water; (d) the mechanism diagram of the dissolution of lithium compounds in water and quantified by the pH test, and the quantified result of the LiOH content is shown in (e); Li 1s XPS spectra of the negative electrode from (f) fresh cell and (g) aged cell.

violently reacted with water producing significant bubbles, as shown in Fig. S3.† After reaction with water, the negative electrode shows a clean surface, and the SEM image is shown in Fig. 3c. Most of the particles and rough surface layer have disappeared, and then a collapsed graphitic shape and a smooth surface appear. This is due to the reactions between the water and Li or Li compounds. The possible reactions and solubility of these Li compounds are summarized in Table 1.<sup>15</sup> The reaction product is mainly alkaline soluble LiOH. pH measurement

The pH values are 10.64 and 8.81 for the aged and fresh negative electrodes, respectively, corresponding to a lithium loss of 1.10% and 0.02% in the form of  $\text{Li}^0$ ,  $\text{Li}_2\text{O}$ ,  $\text{LiOH}$ ,  $\text{CH}_3\text{Li}$ , and  $\text{ROLi}$ , as shown in Fig. 3e. Furthermore, the XPS spectrum of Li 1s was measured for the electrodes of Fig. 3a and b, as shown in Fig. 3f and g, respectively. There are three fitted peaks for the aged negative electrode, which belong to  $\text{LiF}$ ,  $\text{Li}_2\text{CO}_3$ , and  $\text{Li/Li-O}$  compounds, corresponding to an amount of 73.66%, 19.79%, and 6.55% Li, respectively. Here, the  $\text{Li/Li-O}$  compounds correspond to the pH quantified part (1.10%). Therefore, the lithium loss in the aged negative electrode can be quantified as 16.82%. Note that some active Li inserted in graphite during the voltage recovery from a fully discharged state. So, the pH test and XPS results establish that the lithium loss is much lower compared with the capacity loss (over 50%). This further proves that there is no significant amount of
