Cite this: *Energy Environ. Sci.*, 2025, 18, 264

# Removal of residual contaminants by minute-level washing facilitates the direct regeneration of spent cathodes from retired EV Li-ion batteries†

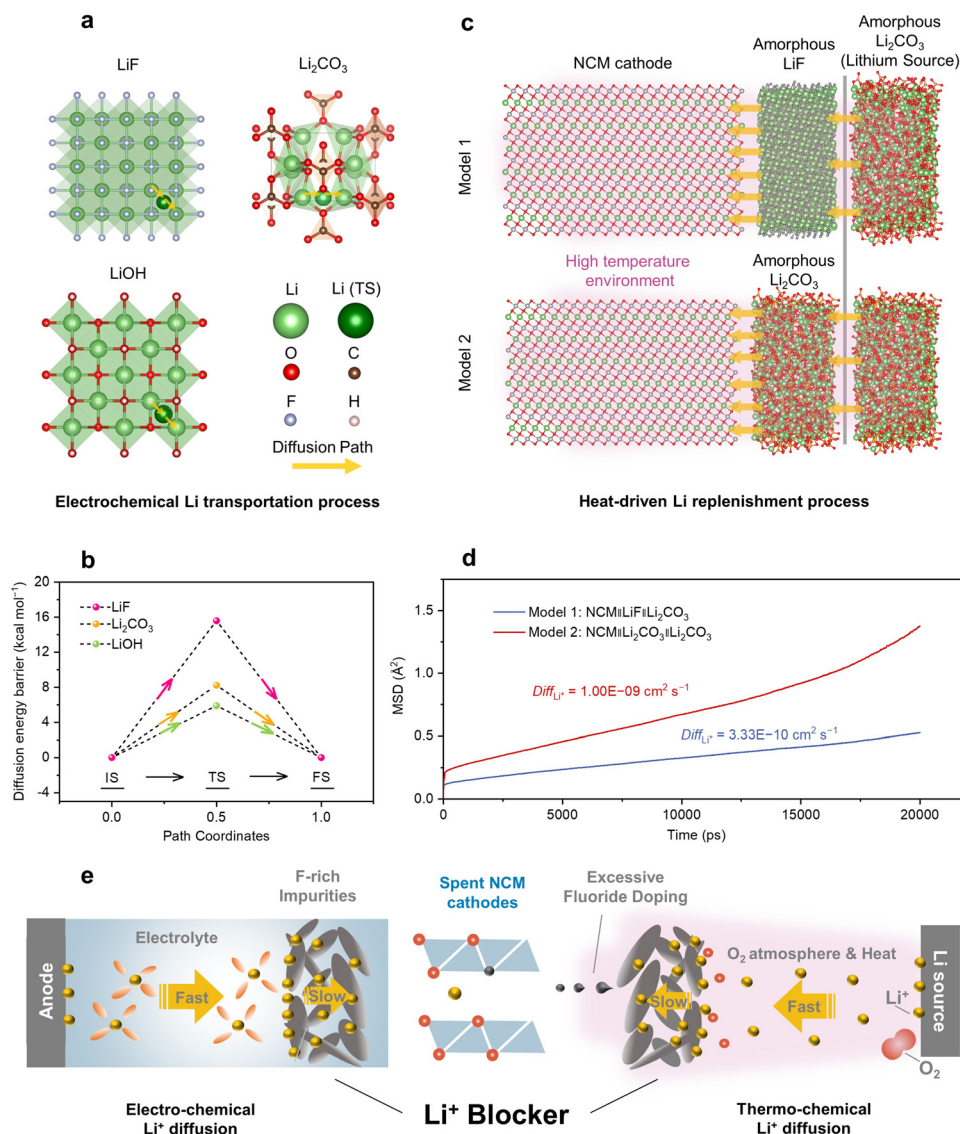
**Fig. 5** Role of the F-rich impurities as a blocker in electrochemical and thermochemical  $\text{Li}^+$  diffusion as ascertained from thermodynamic and kinetic simulations. (a) Illustrations of the selected migration pathways with a similar distance for  $\text{Li}^+$  inside the crystal lattice of three common components. The initial state, transition state, and final state of  $\text{Li}^+$  transportation are denoted as IS, TS, and FS, respectively. (b) Calculated energy diffusion barrier for Li ions in selected phases. (c) Two models for stimulating the kinetics of Li transportation in direct regeneration. Model 1 consists of the NCM cathode substrate, the amorphous LiF layer, and  $\text{Li}_2\text{CO}_3$  as a lithium source in direct regeneration, which is denoted as NCM||LiF|| $\text{Li}_2\text{CO}_3$ . In Model 2 (NCM|| $\text{Li}_2\text{CO}_3$ || $\text{Li}_2\text{CO}_3$  in short), the middle LiF layer is replaced by a common residual alkali ( $\text{Li}_2\text{CO}_3$ ), which is used to simulate the regeneration of NCM cathodes after cleaning pretreatment. Each shape symbol is the same as for Fig. 5a. (d) MSD of the Li atoms in 20 ns and calculated  $\text{Li}^+$  diffusivity based on the above model. “E – 9” means  $10^{-9}$ . (e) Mechanism diagram for preventing the NCM cathodes from reusing and directly regenerating under the influence of impurities.

Fig. 5b. Therefore, this result confirmed that the presence of fluoride-rich impurity residuals on the cathode surface significantly increased the diffusion resistance of Li ions when cycling, ultimately exacerbating the cell impedance and interfacial parasitic reactions (Fig. 1d). To comprehend the larger-scale kinetic characteristics and understand the effect of impurity coatings during heating for regeneration of the spent cathodes, two molecular dynamics models were established for simulating  $\text{Li}^+$  transportation at 1000 K over 20 ns. Specifically, Model 1 was devised to include an impurity barrier consisting of a  $\text{LiF}$  layer (Fig. 5c and Fig. S33, ESI†). Through computing the mean square displacement (MSD) of Li atoms and fitting curves (Fig. 5d), we determined that the Li diffusivity ( $\text{Diff}_{\text{Li}^+}$ ) of Model 1 was  $3.33 \times 10^{-10}$ , which was an order of magnitude lower than that of Model 2 ( $1.00 \times 10^{-9}$ ). The differences in molecular dynamics models under practical conditions suggest that fluoride-rich impurity coatings increase the resistance to Li-ion diffusion into spent cathodes with Li deficiencies during thermo-driven regeneration, leading to inadequate compositional and structural recovery.

As illustrated in Fig. 5e, the impurity phase containing the F element served as an electro- and thermo-diffusion blocker of Li ions hindering the reuse and direct regeneration of the spent cathode. In the spent cathodes collected by physical pretreatment and collection from used lithium-ion batteries, the ubiquitous electrolyte was decomposed to form an ion barrier with slow ion diffusivity. However, these impurities have long been overlooked in most studies (Table S2, ESI†), mainly due to the use of lab-scale degraded cathodes and fine manual separation pretreatment. In previous studies,<sup>12–16,42</sup> the latent impact of the residual impurities on direct regeneration remains untouched because impurities are easily converted into other inconspicuous matter in extreme physical or chemical regeneration environments. Looking ahead, the direct regeneration of next-generation sensitive cathode materials, such as Li-rich Mn-based, Co-free, and ultra-high-Ni cathode materials, faces serious challenges from these latent impurities if they enter the recycling circle. From another perspective, establishing the controlling law for the inherent impurities doping within the closed-loop material flow could instructively enhance the performance of such recycled materials in the future. Moreover, only by revealing the effect of the overlooked impurities or by getting rid of impurities, can evolving technologies and mechanisms for direct regeneration and upcycling be reasonably evaluated.<sup>50</sup>
