Cite this: *Environ. Sci.: Water Res. Technol.*, 2021, 7, 274

Drinking water contamination from the thermal degradation of plastics: implications for wildfire and structure fire response†

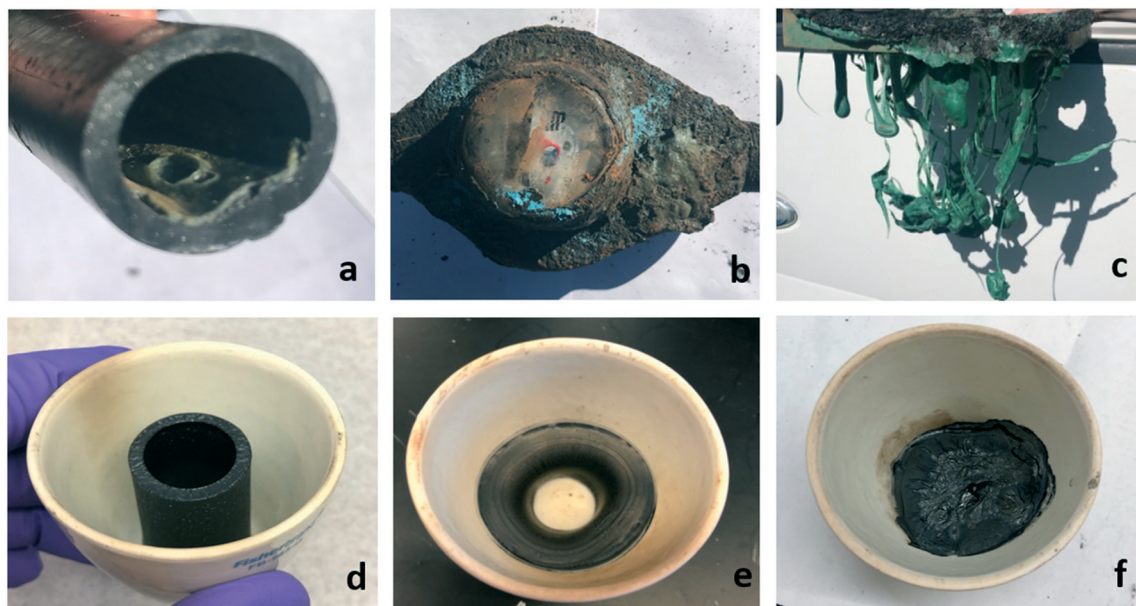
Fig. 1 Images of fire-damaged water system components including (a) a HDPE plastic pipe, (b) a water meter, and (c) a water meter cover following the Camp Fire. Thermally degraded pipe samples in laboratory experiments include the (d) PEX-c pipe degraded at 300 °C, (e) HDPE pipe degraded at 300 °C, and (f) HDPE pipe degraded at 400 °C.
